BEHAVIOR OF REINFORCED WALL SYSTEM DURING THE 1999 KOCAELI (IZMIT), TURKEY, EARTHQUAKE

A four-span bridge together with a 10 m-high and 100 m-long bridge approach fill was one of the highway facilities damaged due to surface faulting along the Trans-European Motorway during 1999 Kocaeli Earthquake (Mw 7.4). The fault rupture crossed beneath an overpass bridge within a few meters away from the bridge abutment while damaging the approach fill which was reinforced with a double-faced mechanically stabilized earth wall (MSEW) system. The faulting-induced excessive tectonic ground deformations including near-field seismic shakings were the main sources of damage in the walls. Such effects, along with the others, caused cracks and panel separations in wall faces as a result of a liquefaction-induced differential settlement in the cross section. The performance of the reinforced walls was satisfactory that there was no significant structural damage despite the total collapse of the bridge decks. The wall system provided a unique case history under extreme loading conditions, while proving that they are flexible and can withstand large ground deformations. This paper discusses how the wal

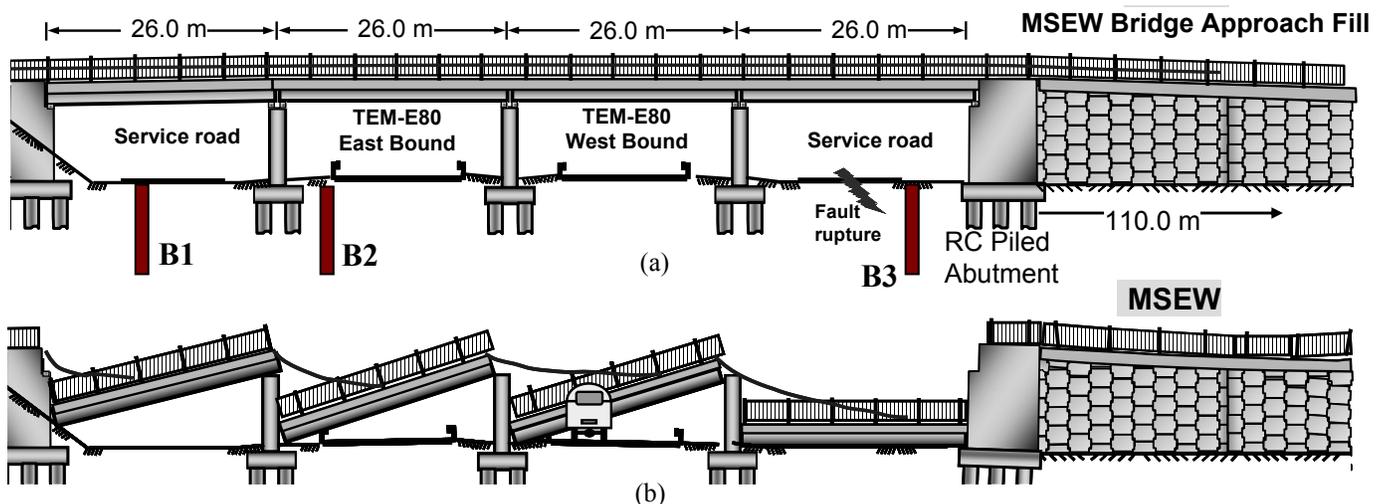
During the earthquake, the majority of the highway facilities performed well, except that the bridge overpass in Arifiye (Fig.2), located less than 50 km eastward of the epicenter, collapsed due to tectonic movement along the fault zone. The surface fault rupture passed beneath the northernmost span of the overpass while causing substantial surface deformations. The collapsed bridge blocked the TEM and caused serious delays in transporting immediate disaster-caused emergency needs in the epicentral area. Moreover, nearly a dozen people died when a passenger bus crashed into a collapsed deck while passing under the overpass.

the earthquake. Major damage to the walls was not from seismic design, but a combination of adverse effects by the nearby fault movement and, possibly, bearing capacity problems associated with underlying foundation soil. Figure 2 depicts the overpass and the reinforced walls before and after the damage, respectively.

Fig. 2. The bridge overpass at Arifiye and mechanical stabilized bridge approach fill walls (a) before, and (b) after the earthquake.

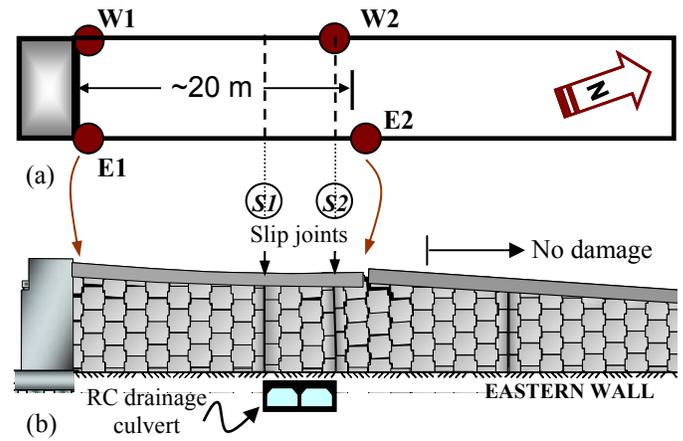
A reinforced concrete culvert was designed beneath the approach ramp possibly to facilitate storm or flood water discharge in approach ramp area (Fig. 5b). However, the culvert was not useful as it appeared inactive due to road fill at both sides of the approach ramp. Two slip joints (S1 and S2, Fig. 5) were also designed on each wall face on top of the rigid culvert to protect the walls damaged from differential settlement.

Fig 5. MSE bridge approach (a) plan view of approach fill with damage-concentration; (b) schematics of eastern wall after the earthquake.

Only a limited section of the MSEW approach ramp was damaged to a great extent in between the bridge abutment and RC culvert. This section constituted approximately 20% of the entire length of the reinforced earth structure. The most damage-affected locations within this section along the eastern and western wall faces are highlighted in Fig. 5a as E1 and E2, and W1 and W2, respectively, whilst their detailed views are presented in Figs. 6 and 7.

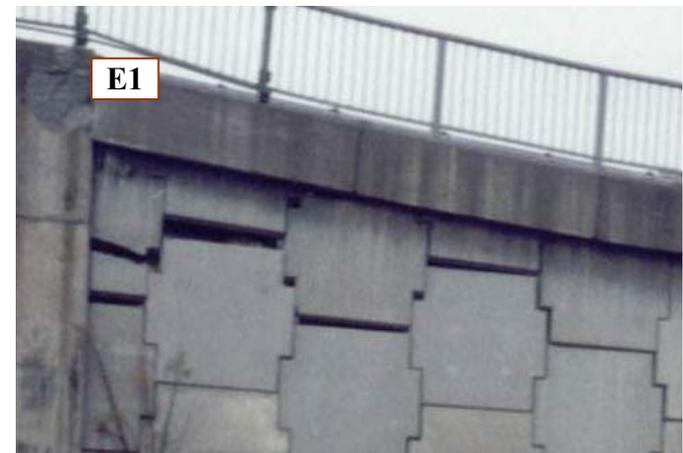
Fig 6. Damage details for (a) E1 and (b) E2 on eastern MSEW face (photos after Ozbakir).

both locations were also different. At E1, the vertical ground deformation was so large that the flexible wall face was forced to be displaced both vertically and longitudinally. However, the movement in the longitudinal direction was greatly prevented by the rigid abutment. This caused large panel separations and cracks at the higher levels (Fig. 6a), but no damage observed at lower wall elevations.

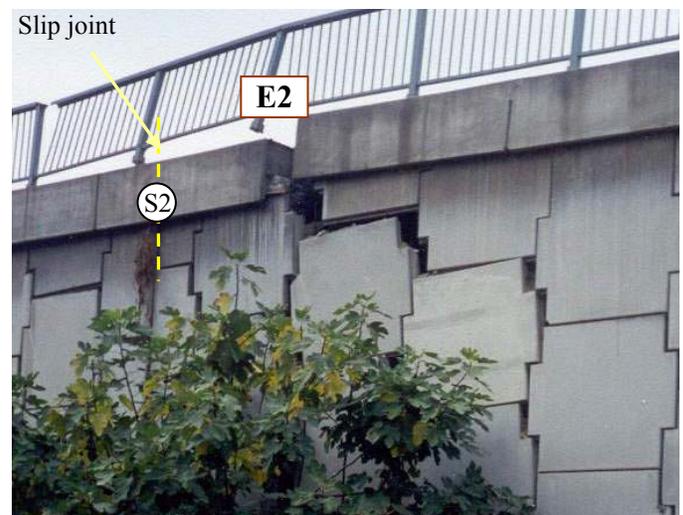
(b)

The tilting in the cross section resulted in different damage states above the culvert at E2 and W2 such that the western wall buckled in the vicinity of W2 (Fig. 7a), whereas the eastern wall face were stretched outward (Fig. 6). The buckled side increased compression on the facing panels at W2, whilst crashing and forcing the panels displaced (Fig. 7b). On the other hand, the largest damage in the reinforced walls was observed at E2 as shown Fig. 6b. At this location, the wall displaced both vertically and horizontally for about 25-30 cm. The displacements at this locality was so large that they exceeded the allowable design limitations for an independent panel movement. Thus, the panels could not accommodate the ground deformation, and finally, large panel separations and cracks (especially at lower elevations of the wall) occurred. However, the facing panel connections with the metallic reinforcements did not fail, and their flexible joints allowed large displacements and differential settlements.

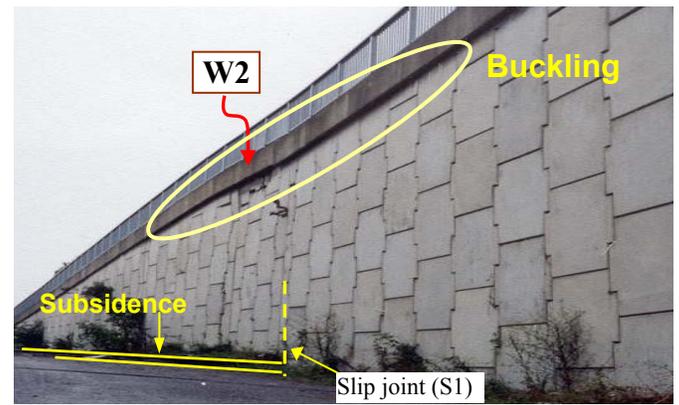
Fig 7. Western MSEW face: (a) buckled wall, looking from south to north; (b) damage details at W1 and W2, looking from north to south (photos after Ozbakir).

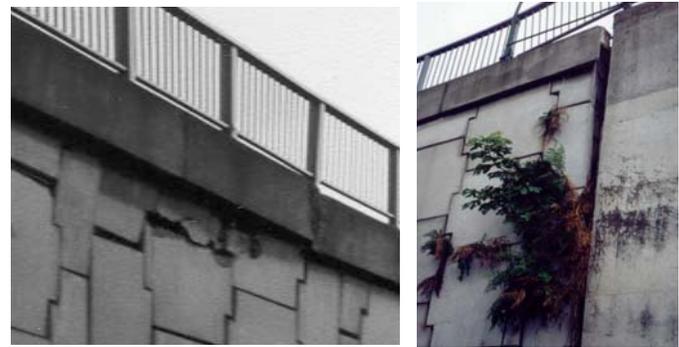
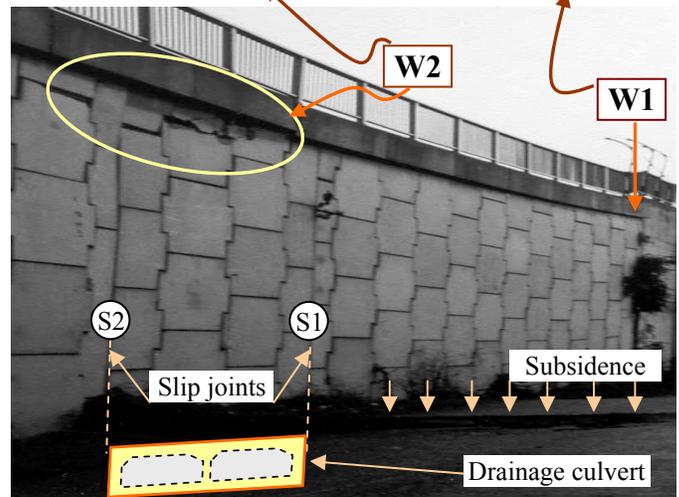
(b)

large compared to E1. On the other hand, a gap of about 10 cm occurred between the panels and the abutment as shown in Fig. 7b. This gap appeared to be resulted from the buckling in the same wall face in vicinity of W2 (Fig. 7a). That is, once the wall buckled at W2, the wall face was pulled longitudinally (northwardly) as a whole. This behavior along the western side of the approach ramp did not cause any damage in the facing panels between W1 and W2. This was an interesting observation indicating that the reinforced wall system was very flexible.
