USGS INSTRUMENTED BUILDINGS ANCHORAGE, ALASKA

Earthquake Science Center
United States Geological Survey

Instrumented Buildings

- Five buildings in 18 km radius of the 2018 M7 earthquake's epicenter

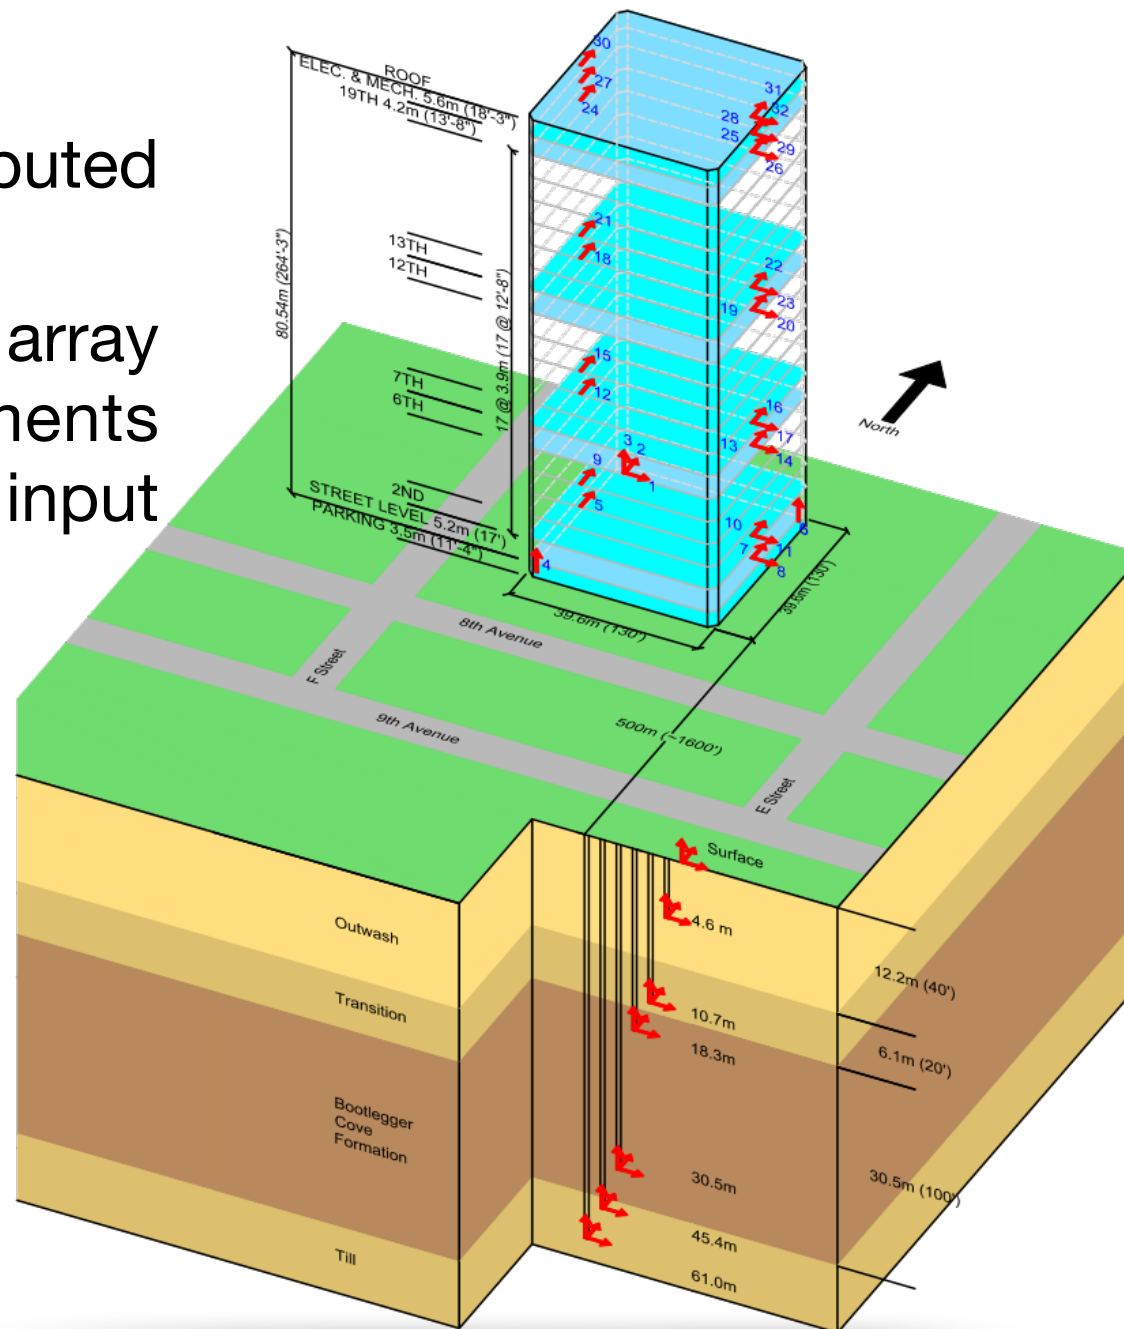
Atwood Building

- Non-structural ceiling & sheetrock damage
-
- PGA = 20.8% g
 - Peak Str. Acc. = 44.4% g

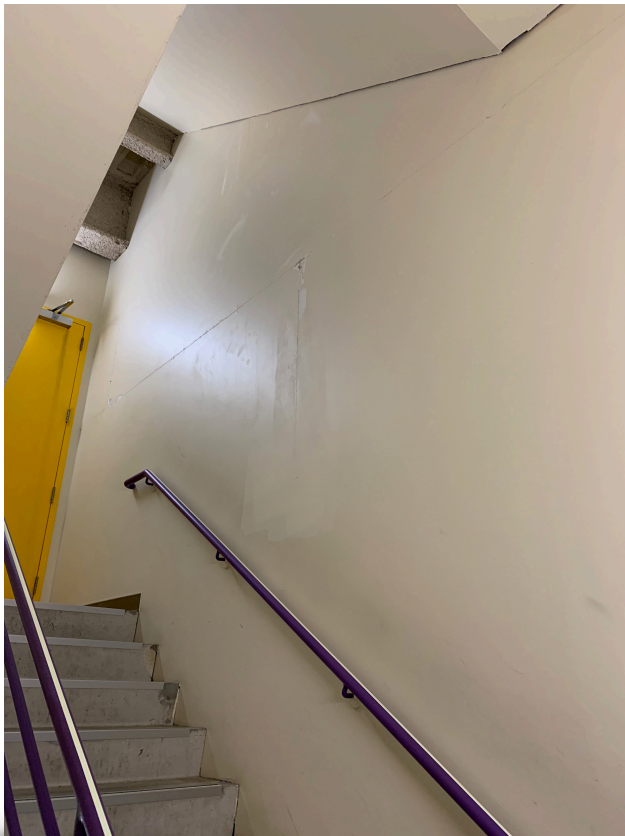
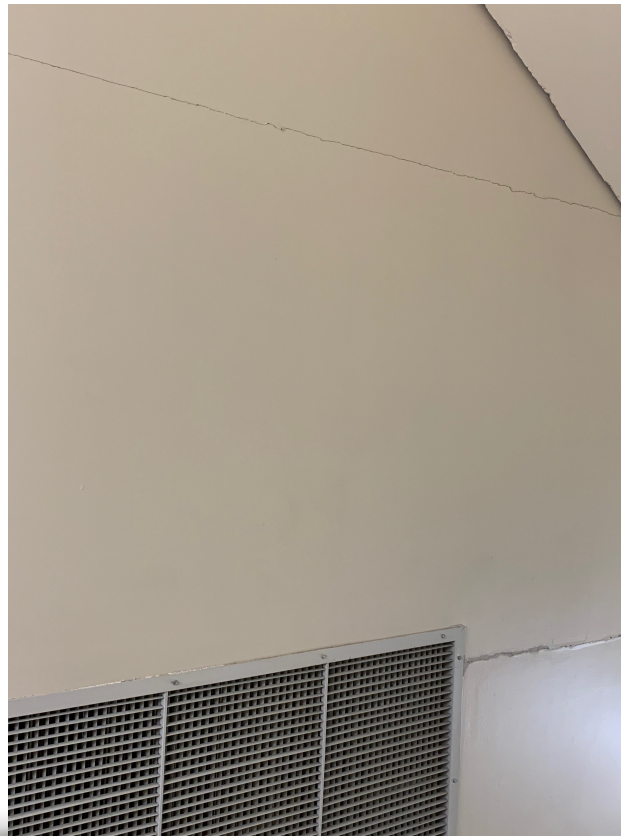
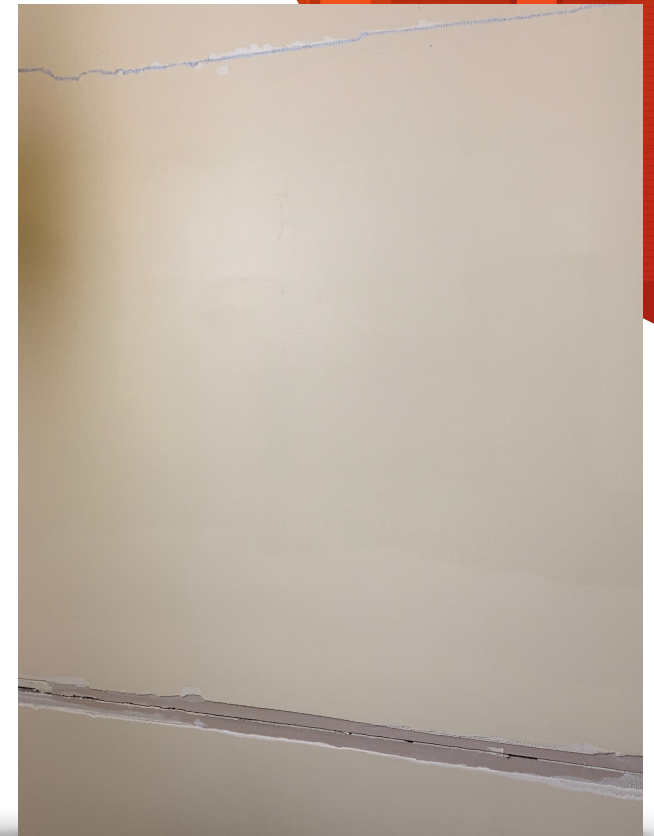
BP Building

- Non-structural ceiling & sheetrock damage
- PGA = 28.3% g
- Peak Str. Acc. = 33.6% g

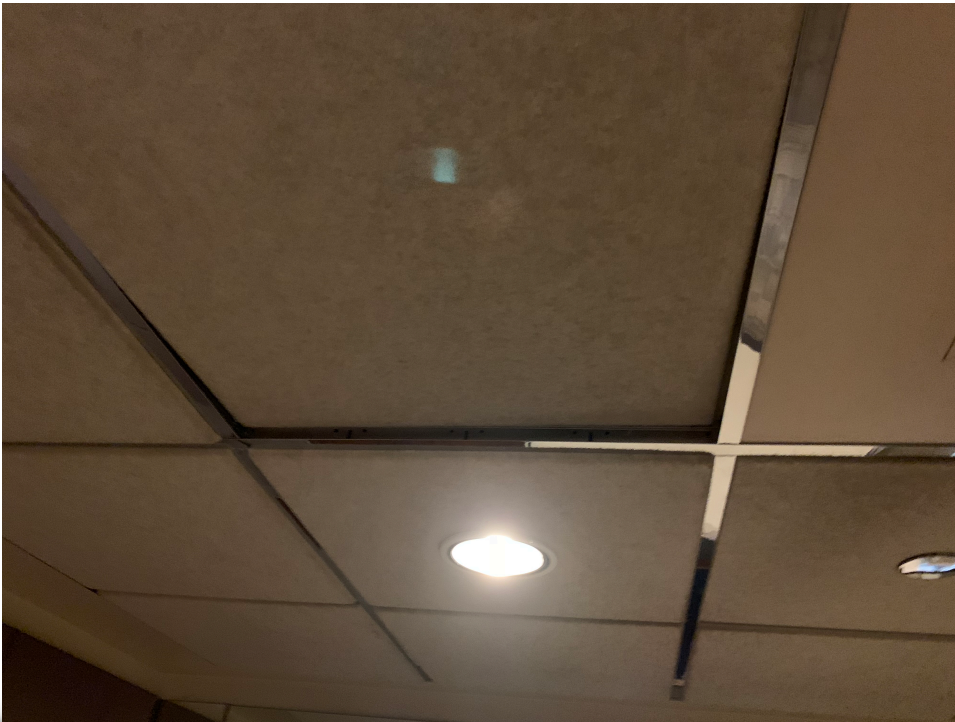
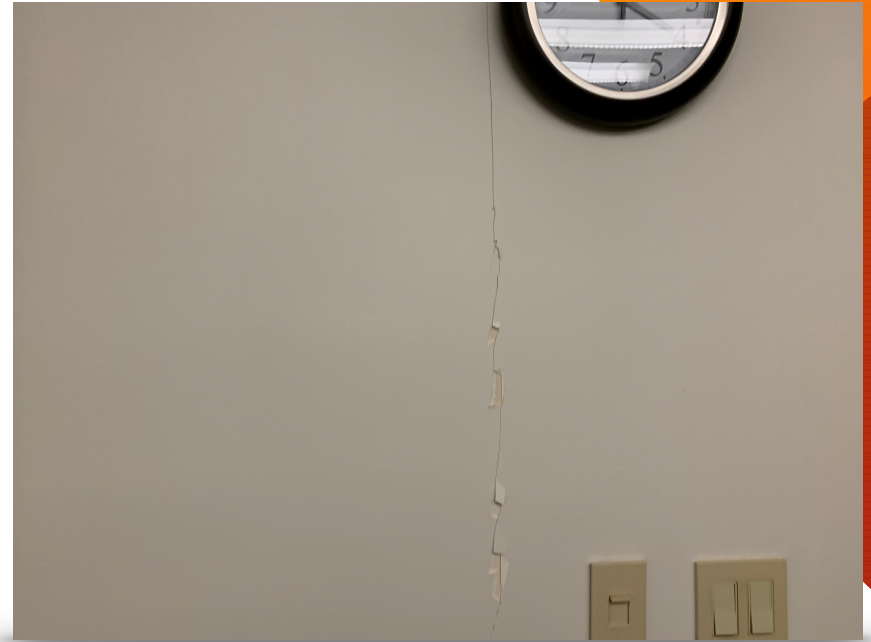
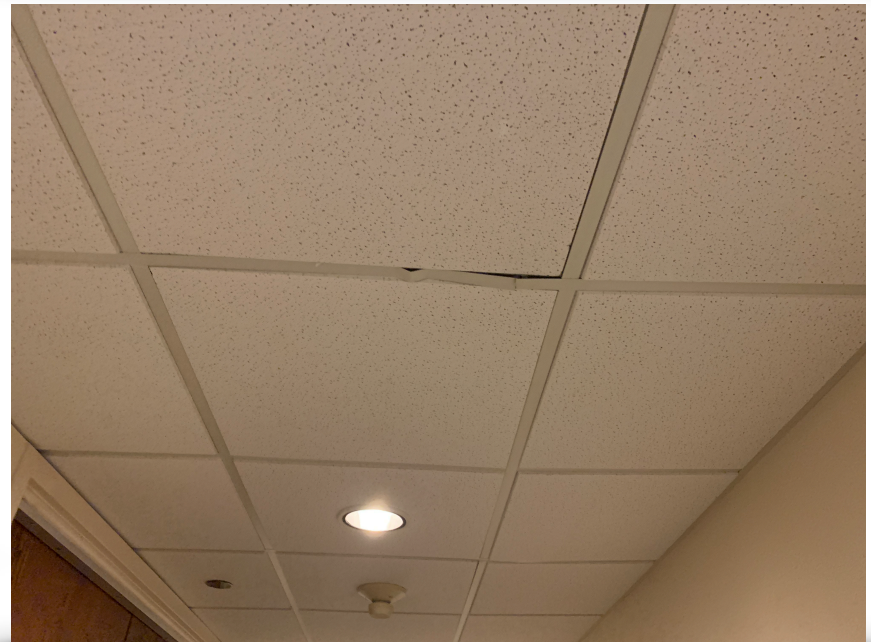
Frontier Building

- Non-structural ceiling & sheetrock damage
- PGA = 19.3% g
- Peak Str. Acc. = 22.3% g

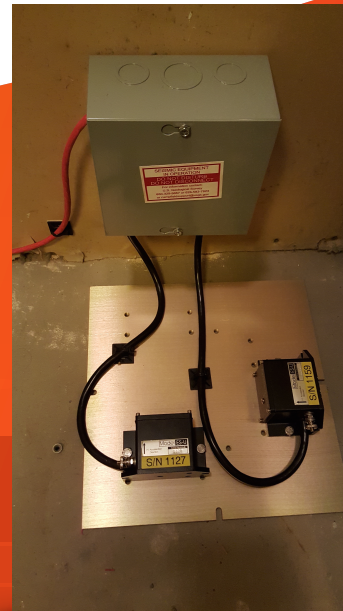
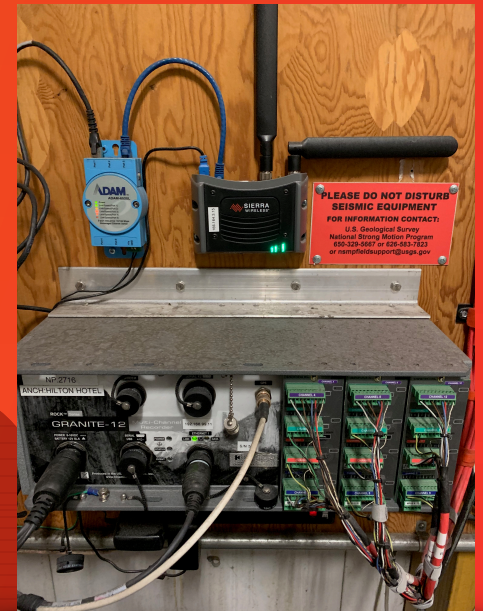
Hilton Building

- Non-structural ceiling & sheetrock damage
- PGA = 21.4% g
- Peak Str. Acc. = 65.1% g

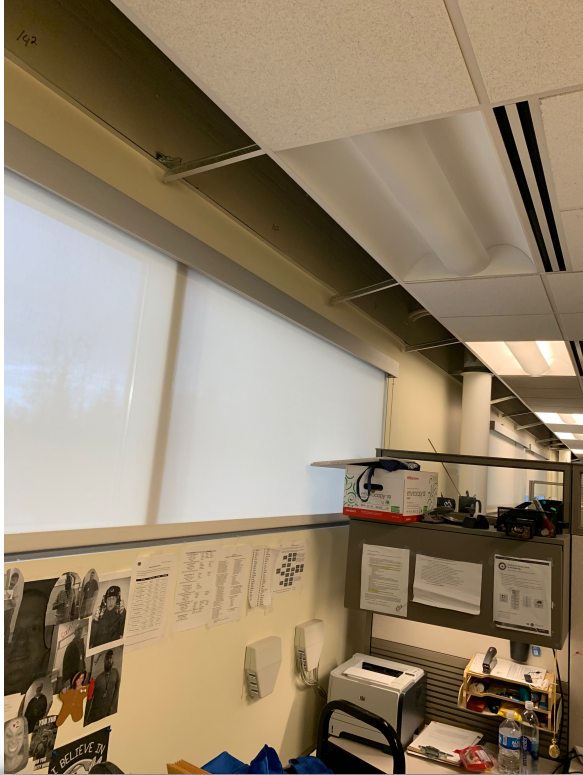
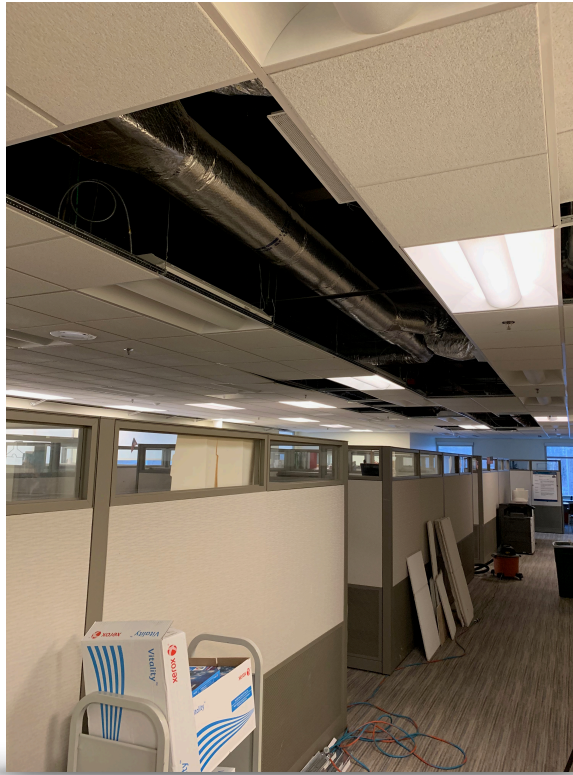
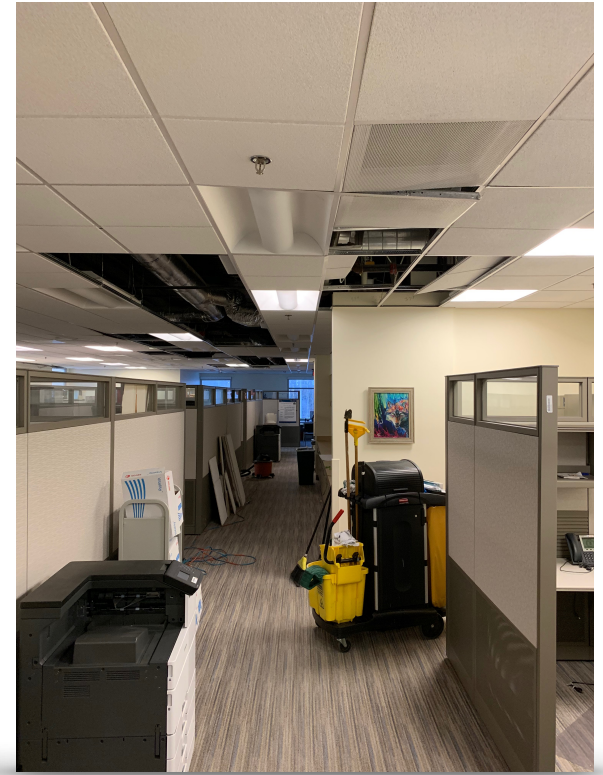
VA Medical Center

- Non-structural ceiling damage at second floor
- PGA = 24% g
- Peak Str. Acc. = 111% g
(recordings are under review)
