# Highlights of Worst Devastation in Turkey

- Two back-to-back M7.8 and M7.6 earthquakes occurred in Eastern Turkey within 9 hours
- Affected 15 highly populated provinces
- Over 47,000 people lost their lives
- More than 5,000 buildings collapsed

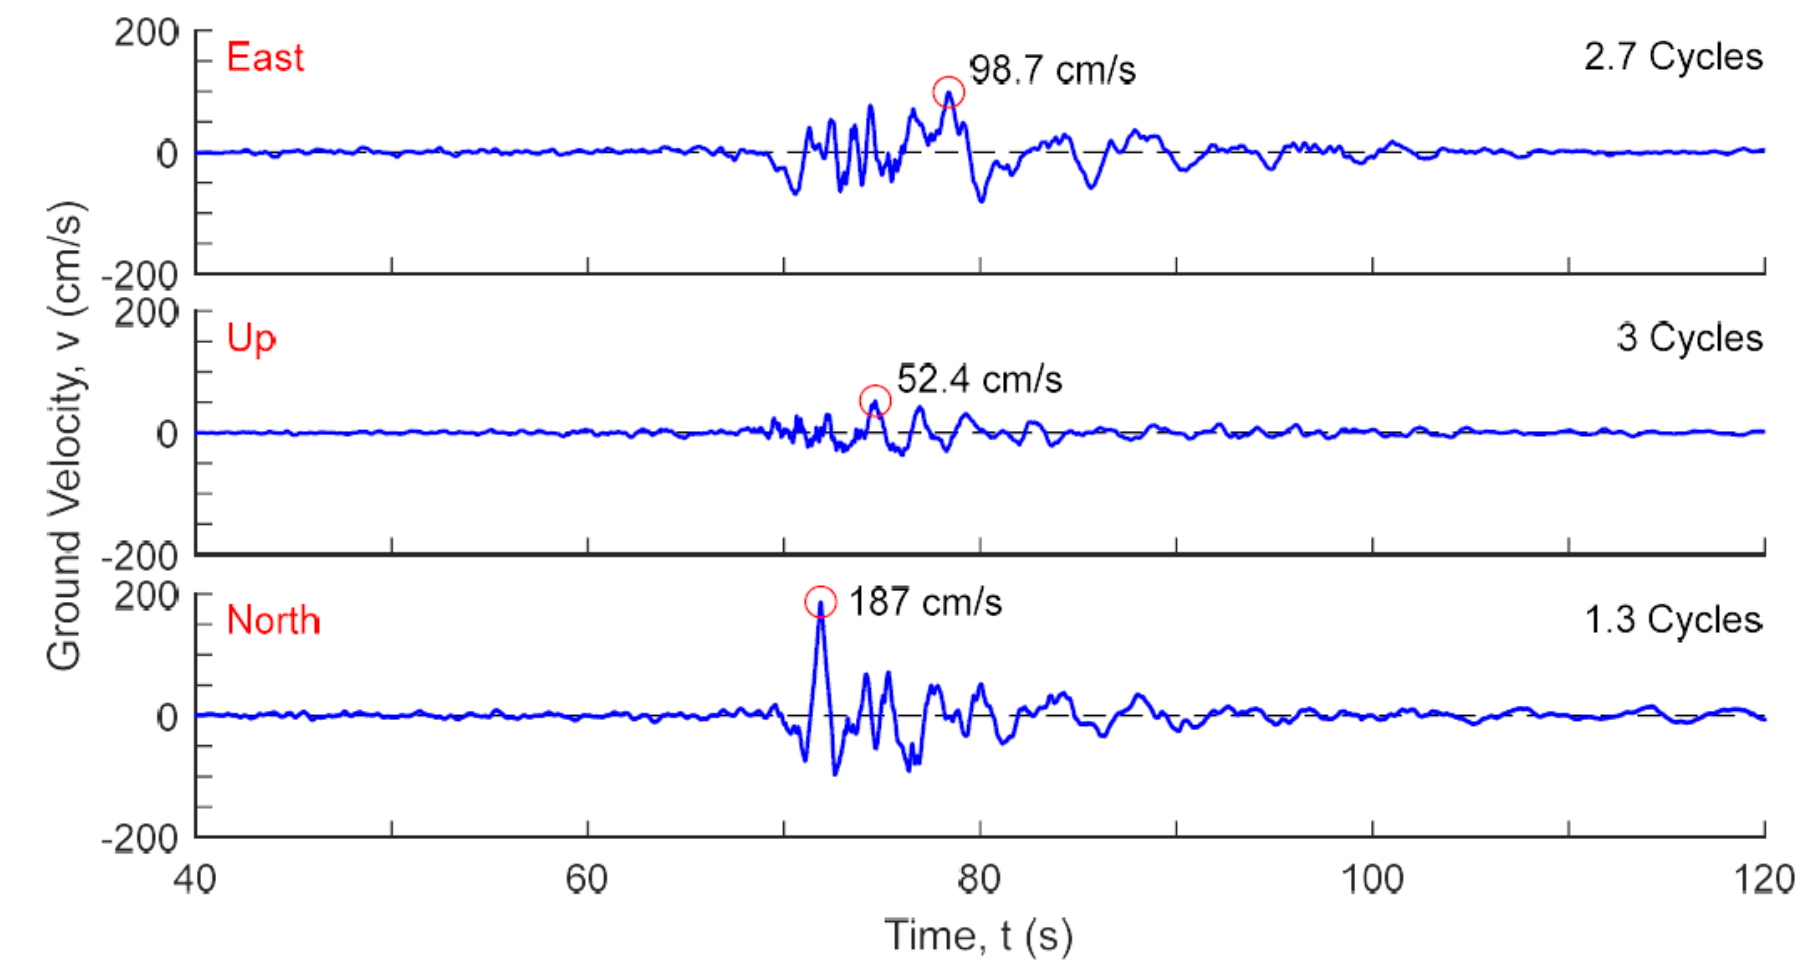
- The severity of structural damage in the city of Hatay could be due to several factors, including the earthquake's proximity to the city, the local geology and soil conditions, the age and quality of the buildings, and the area's vulnerability to earthquakes.
- One observation from ground motion data is so striking that peak ground velocity (PGV) reached 188 cm/s at the seismic station in Hatay. This is the largest PGV recorded during this earthquake.

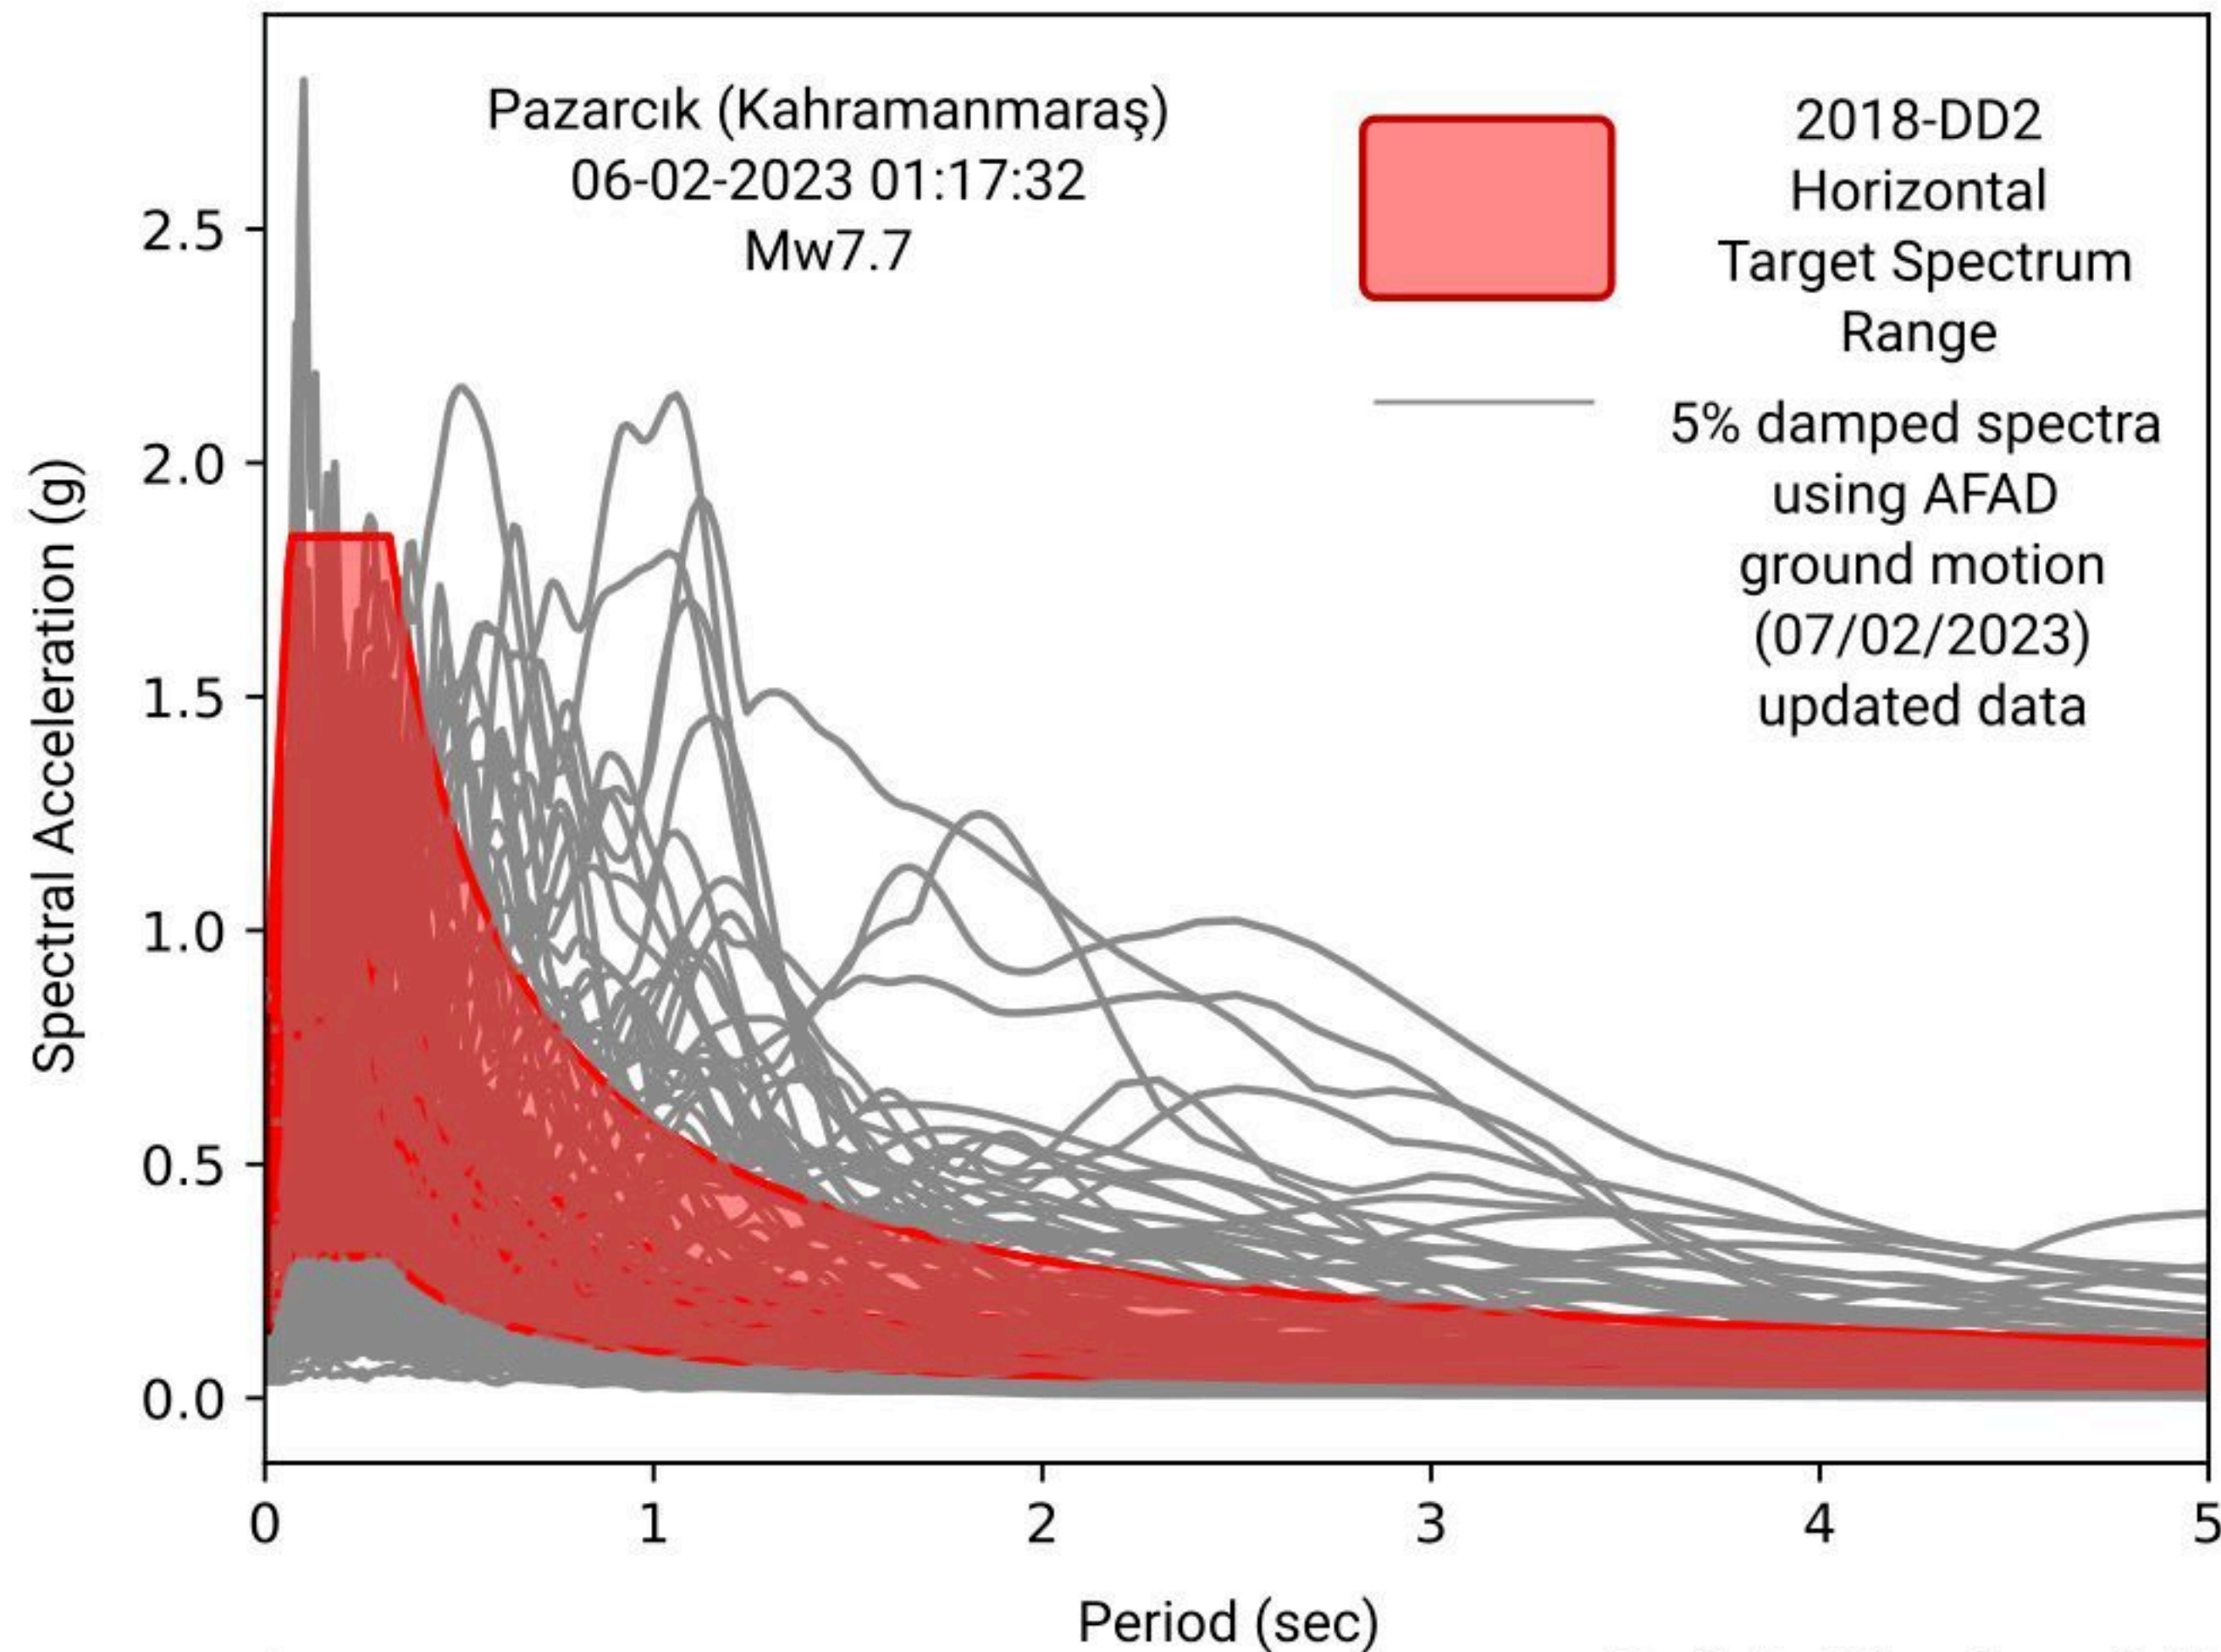
- Spectral ordinates at 0.5 second and above periods were much higher than the design values.
- These plots show only the spectral accelerations. Equally important were the large deformation demands associated with high ground velocities responsible for widespread structural damage.

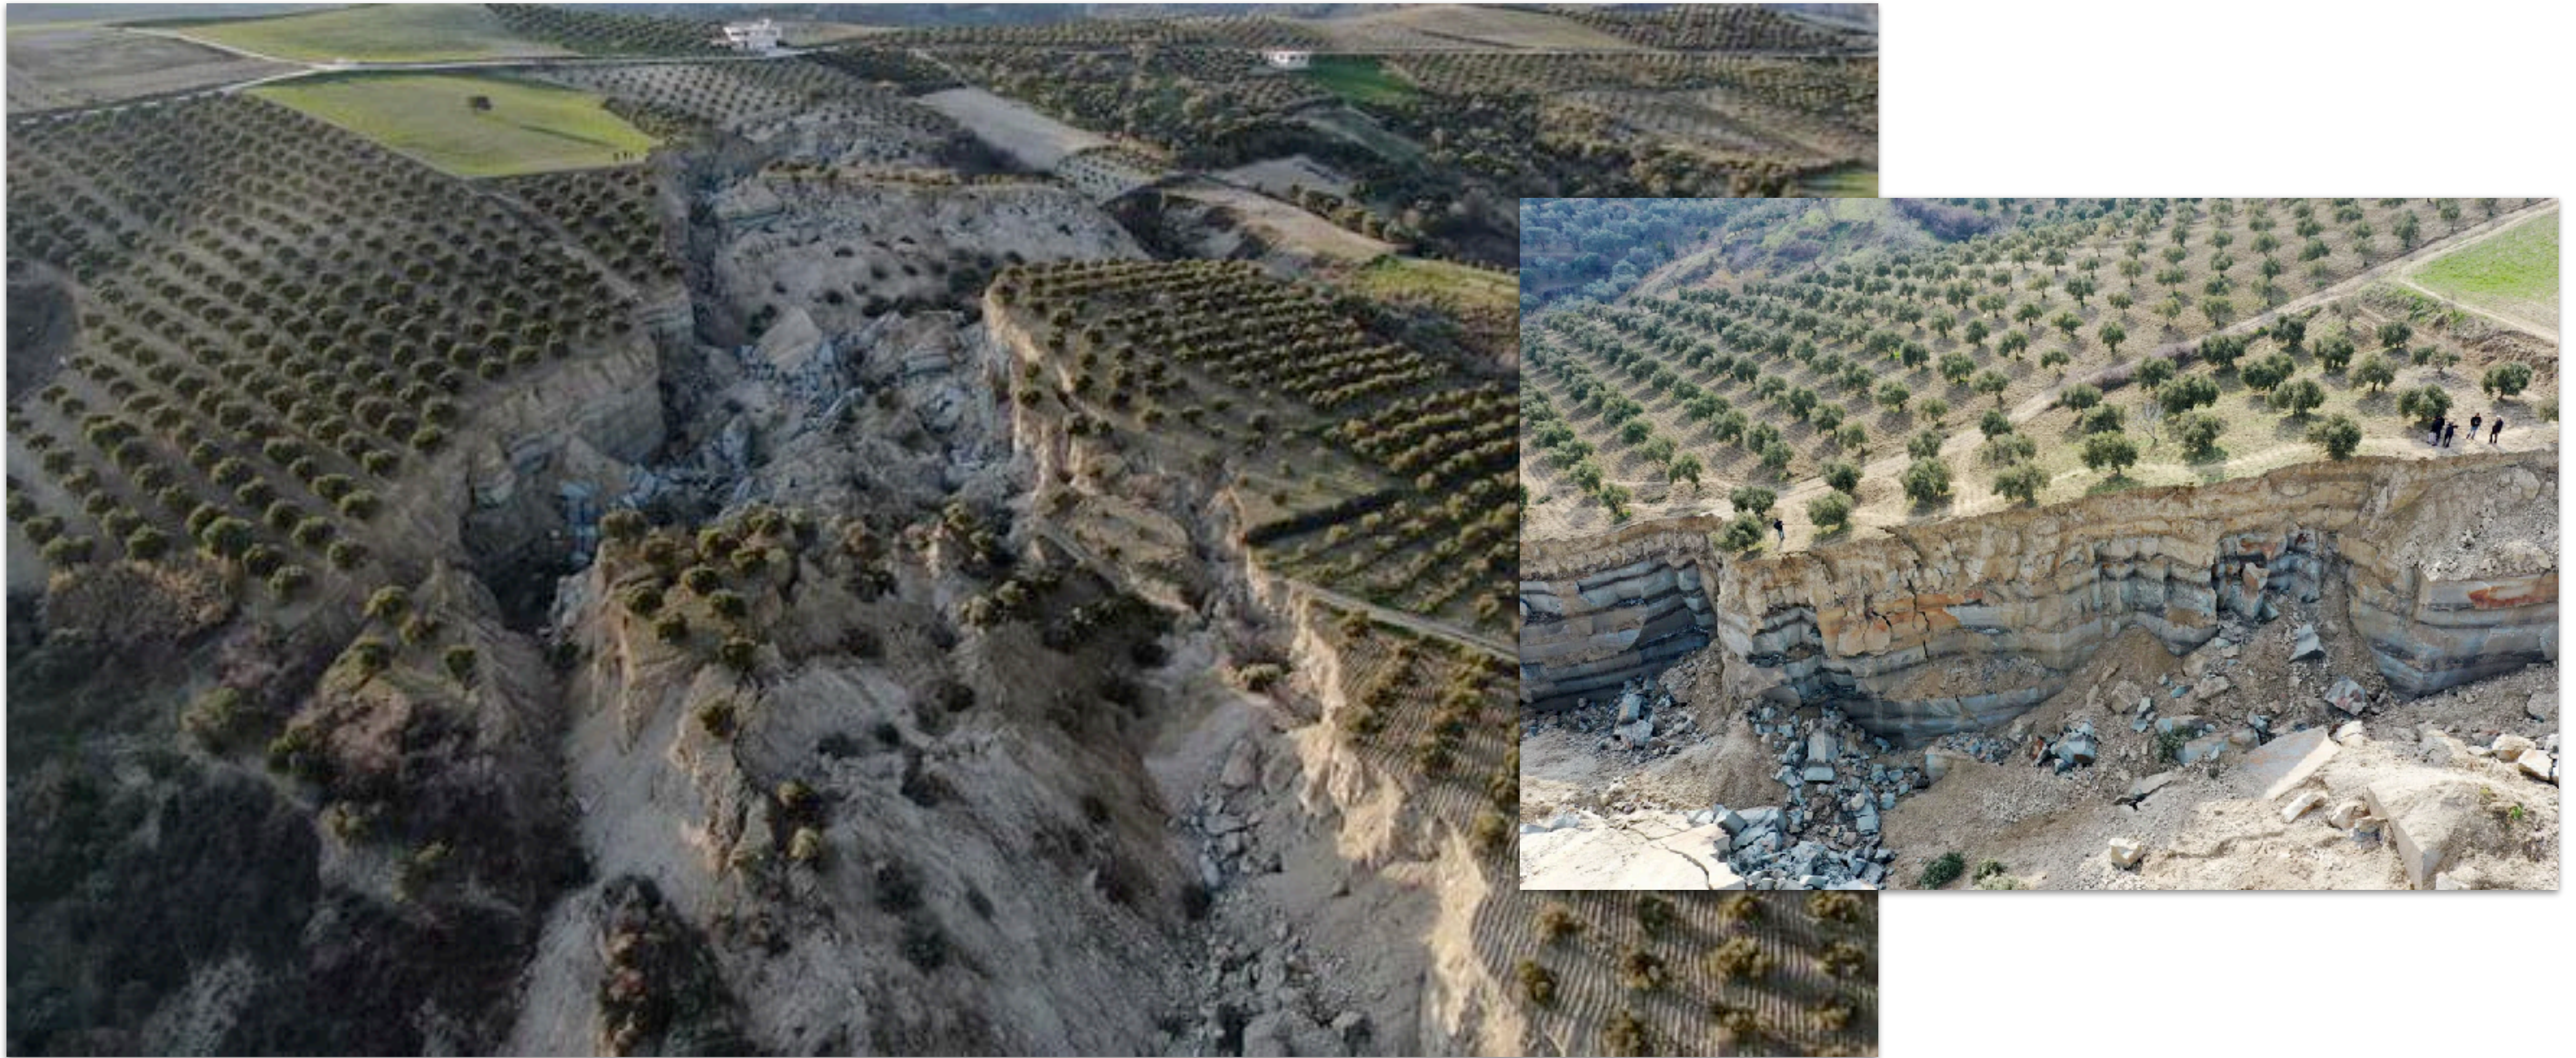
- Earthquake split an olive field in Hatay. A giant rift, 30 meters deep, about 200 meters wide, formed as the ground was coming down.

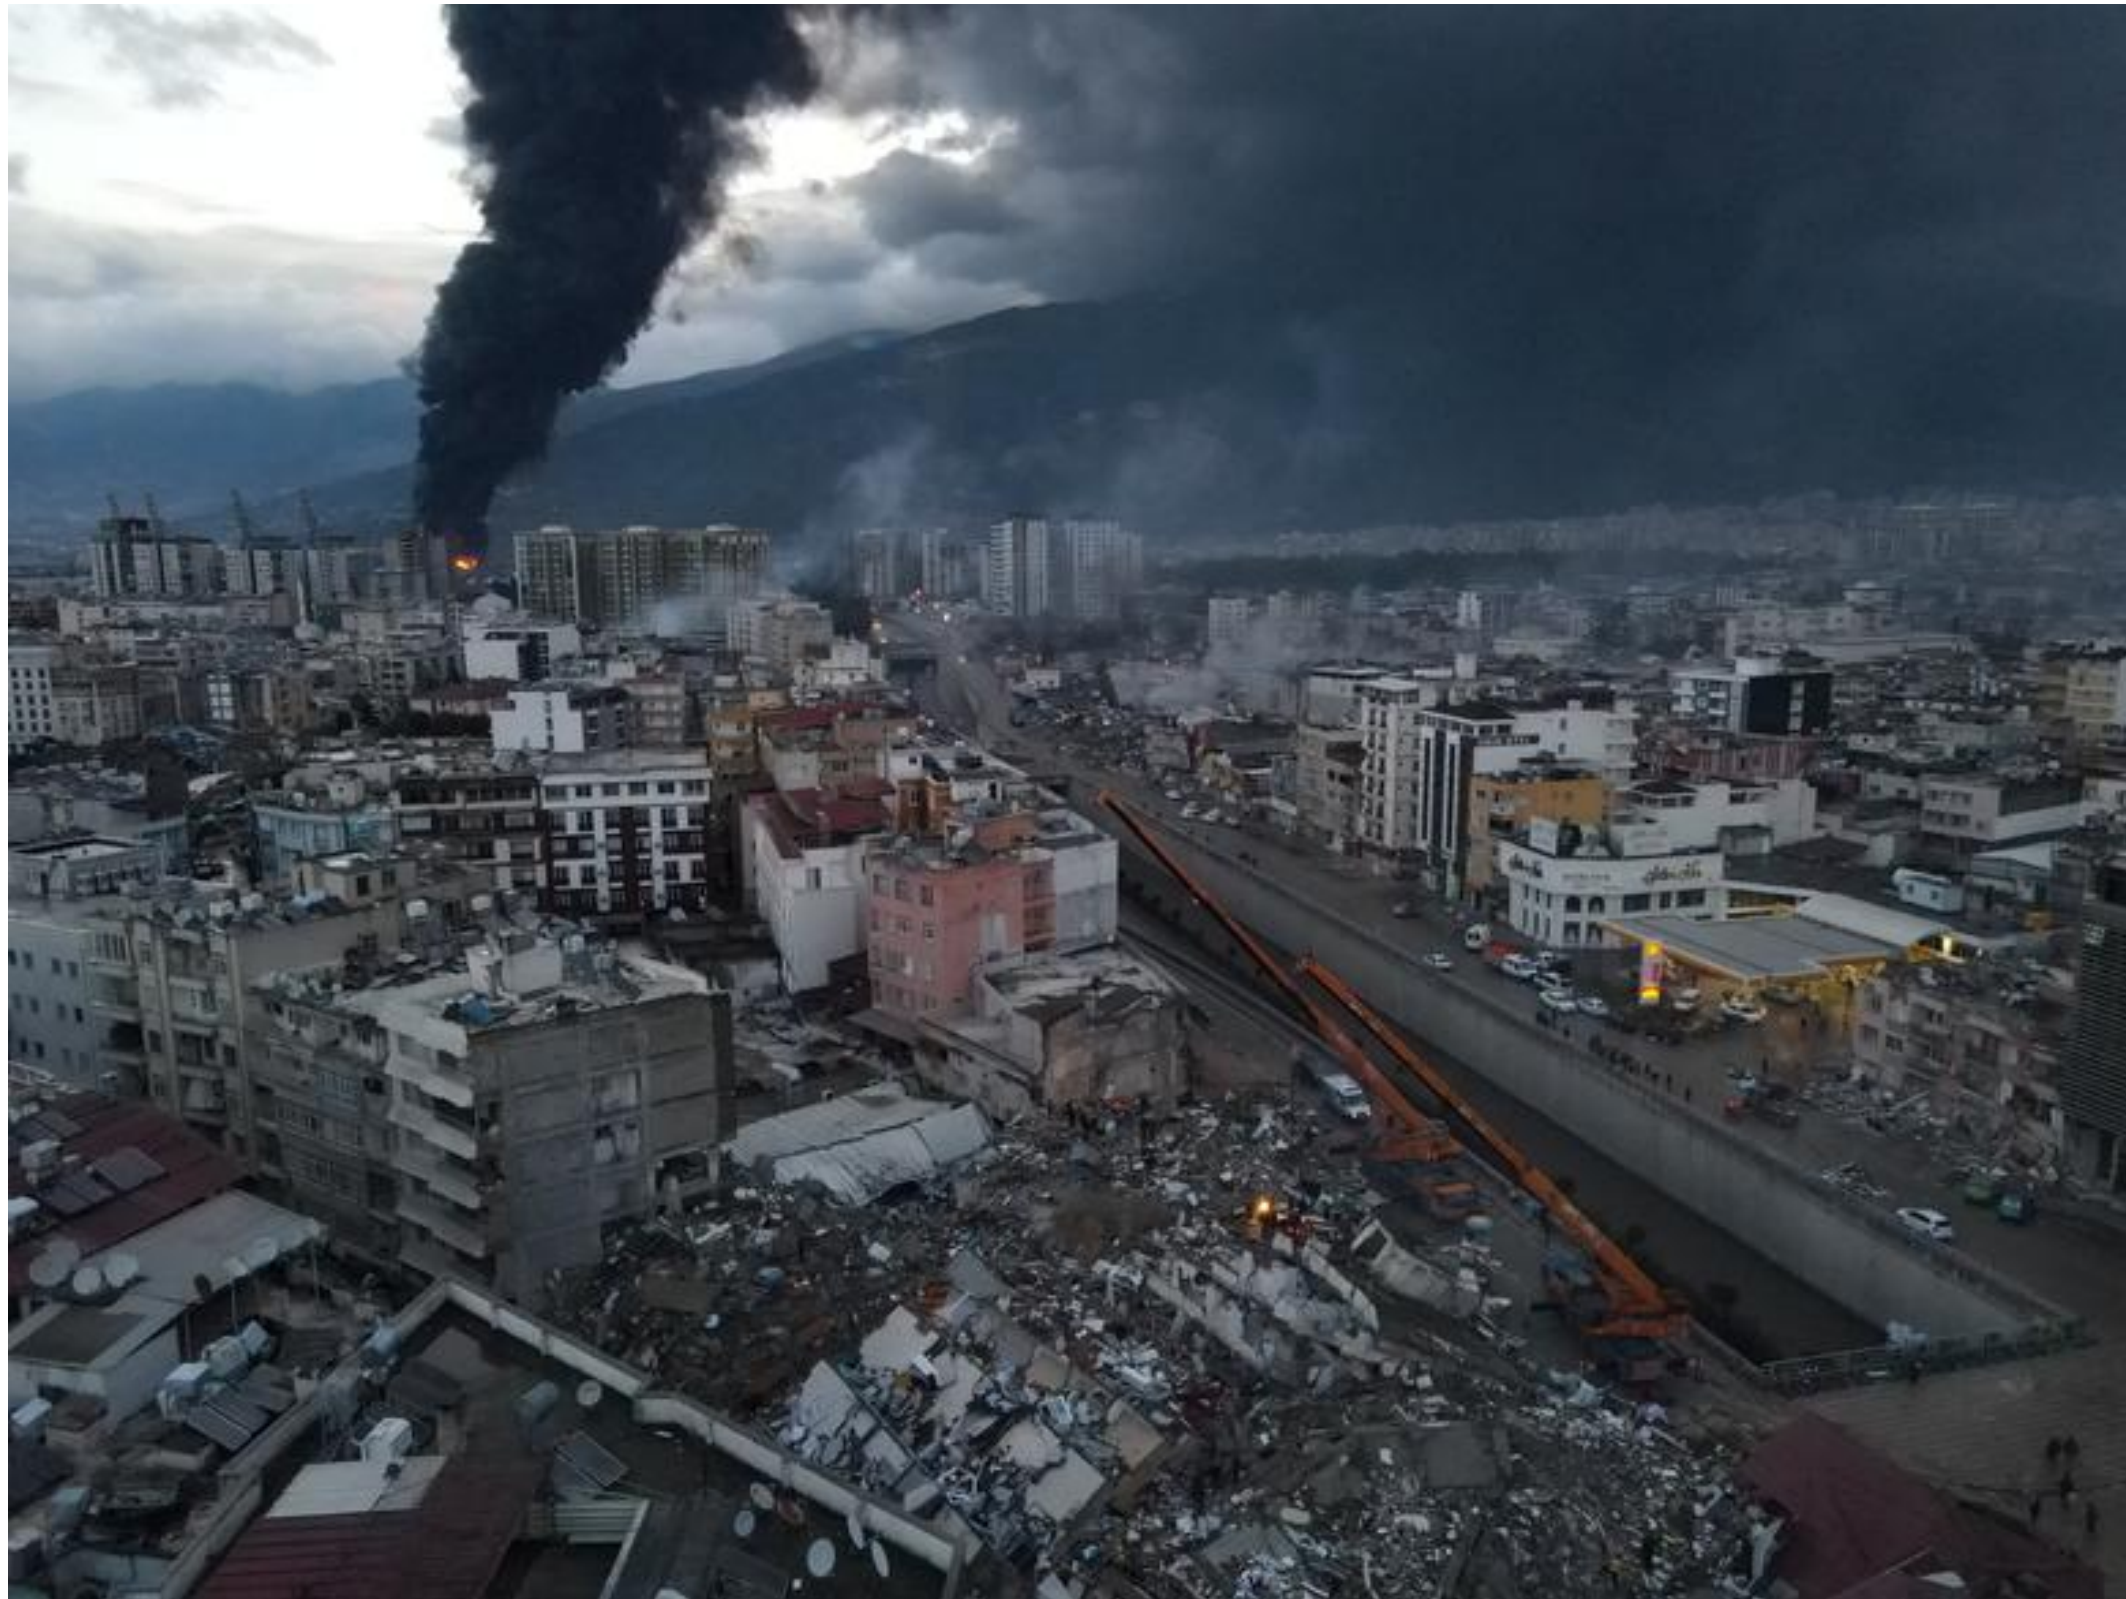
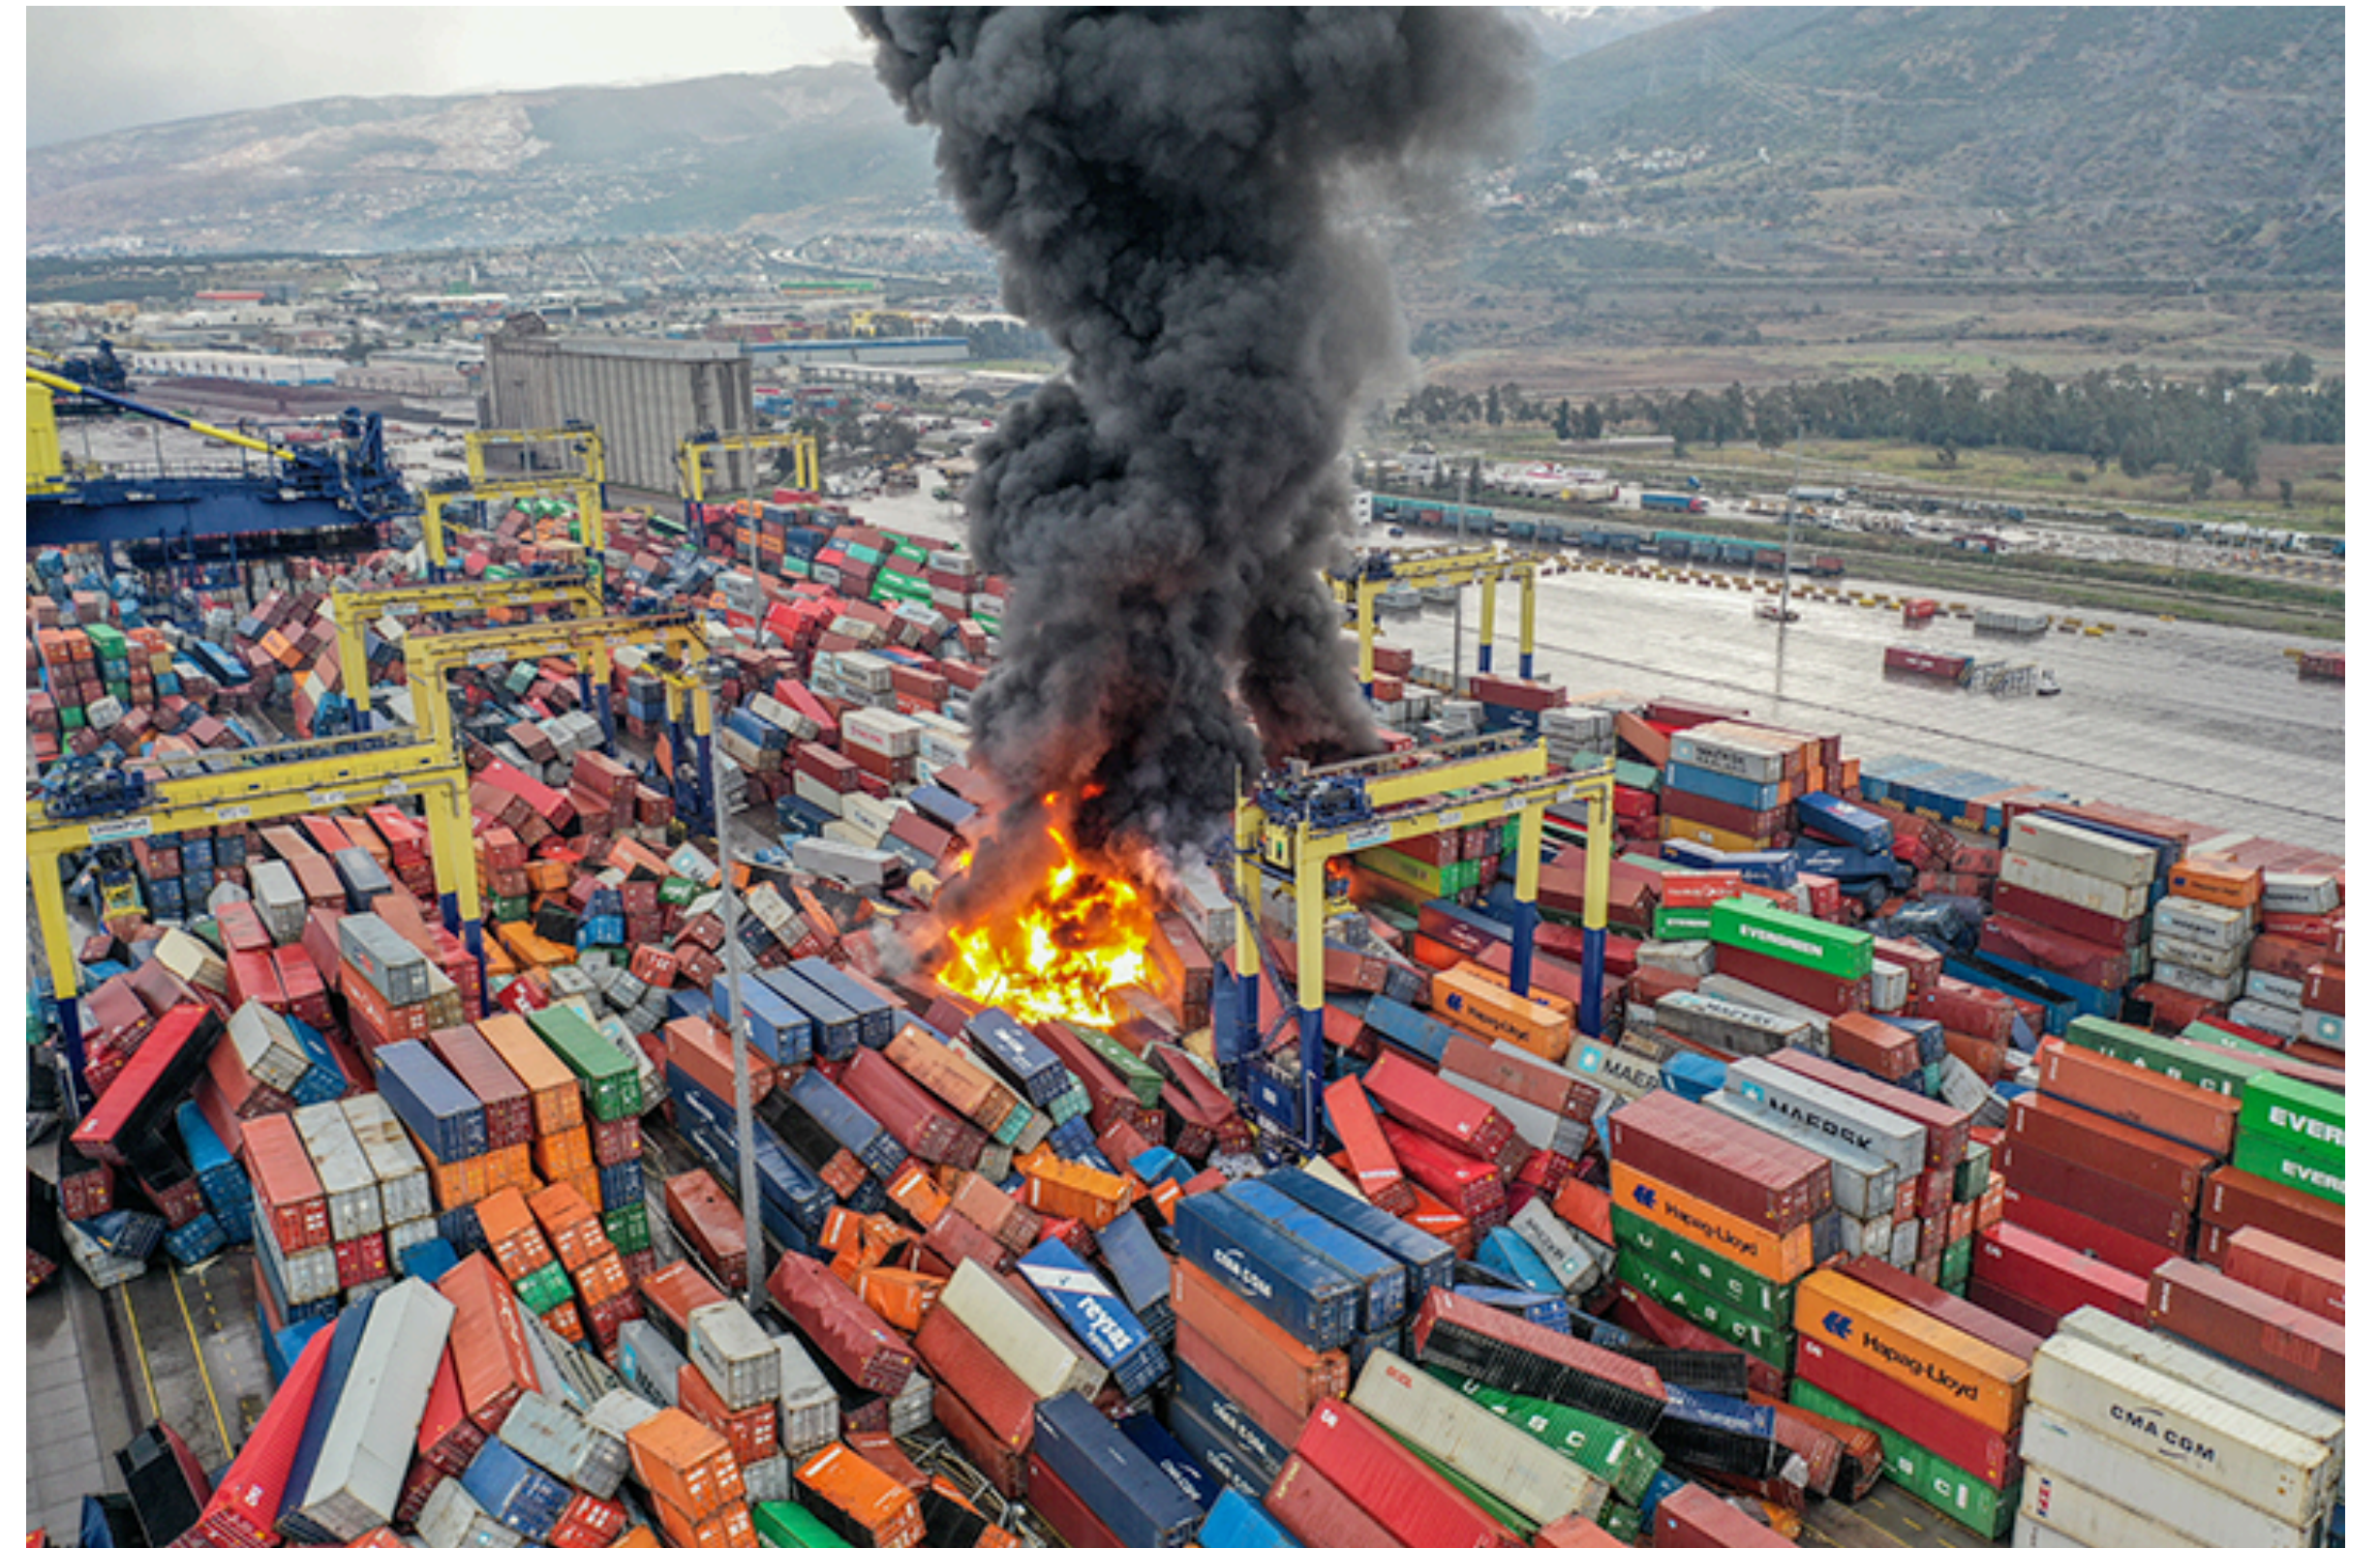
- Fire in Iskenderun port after the earthquake

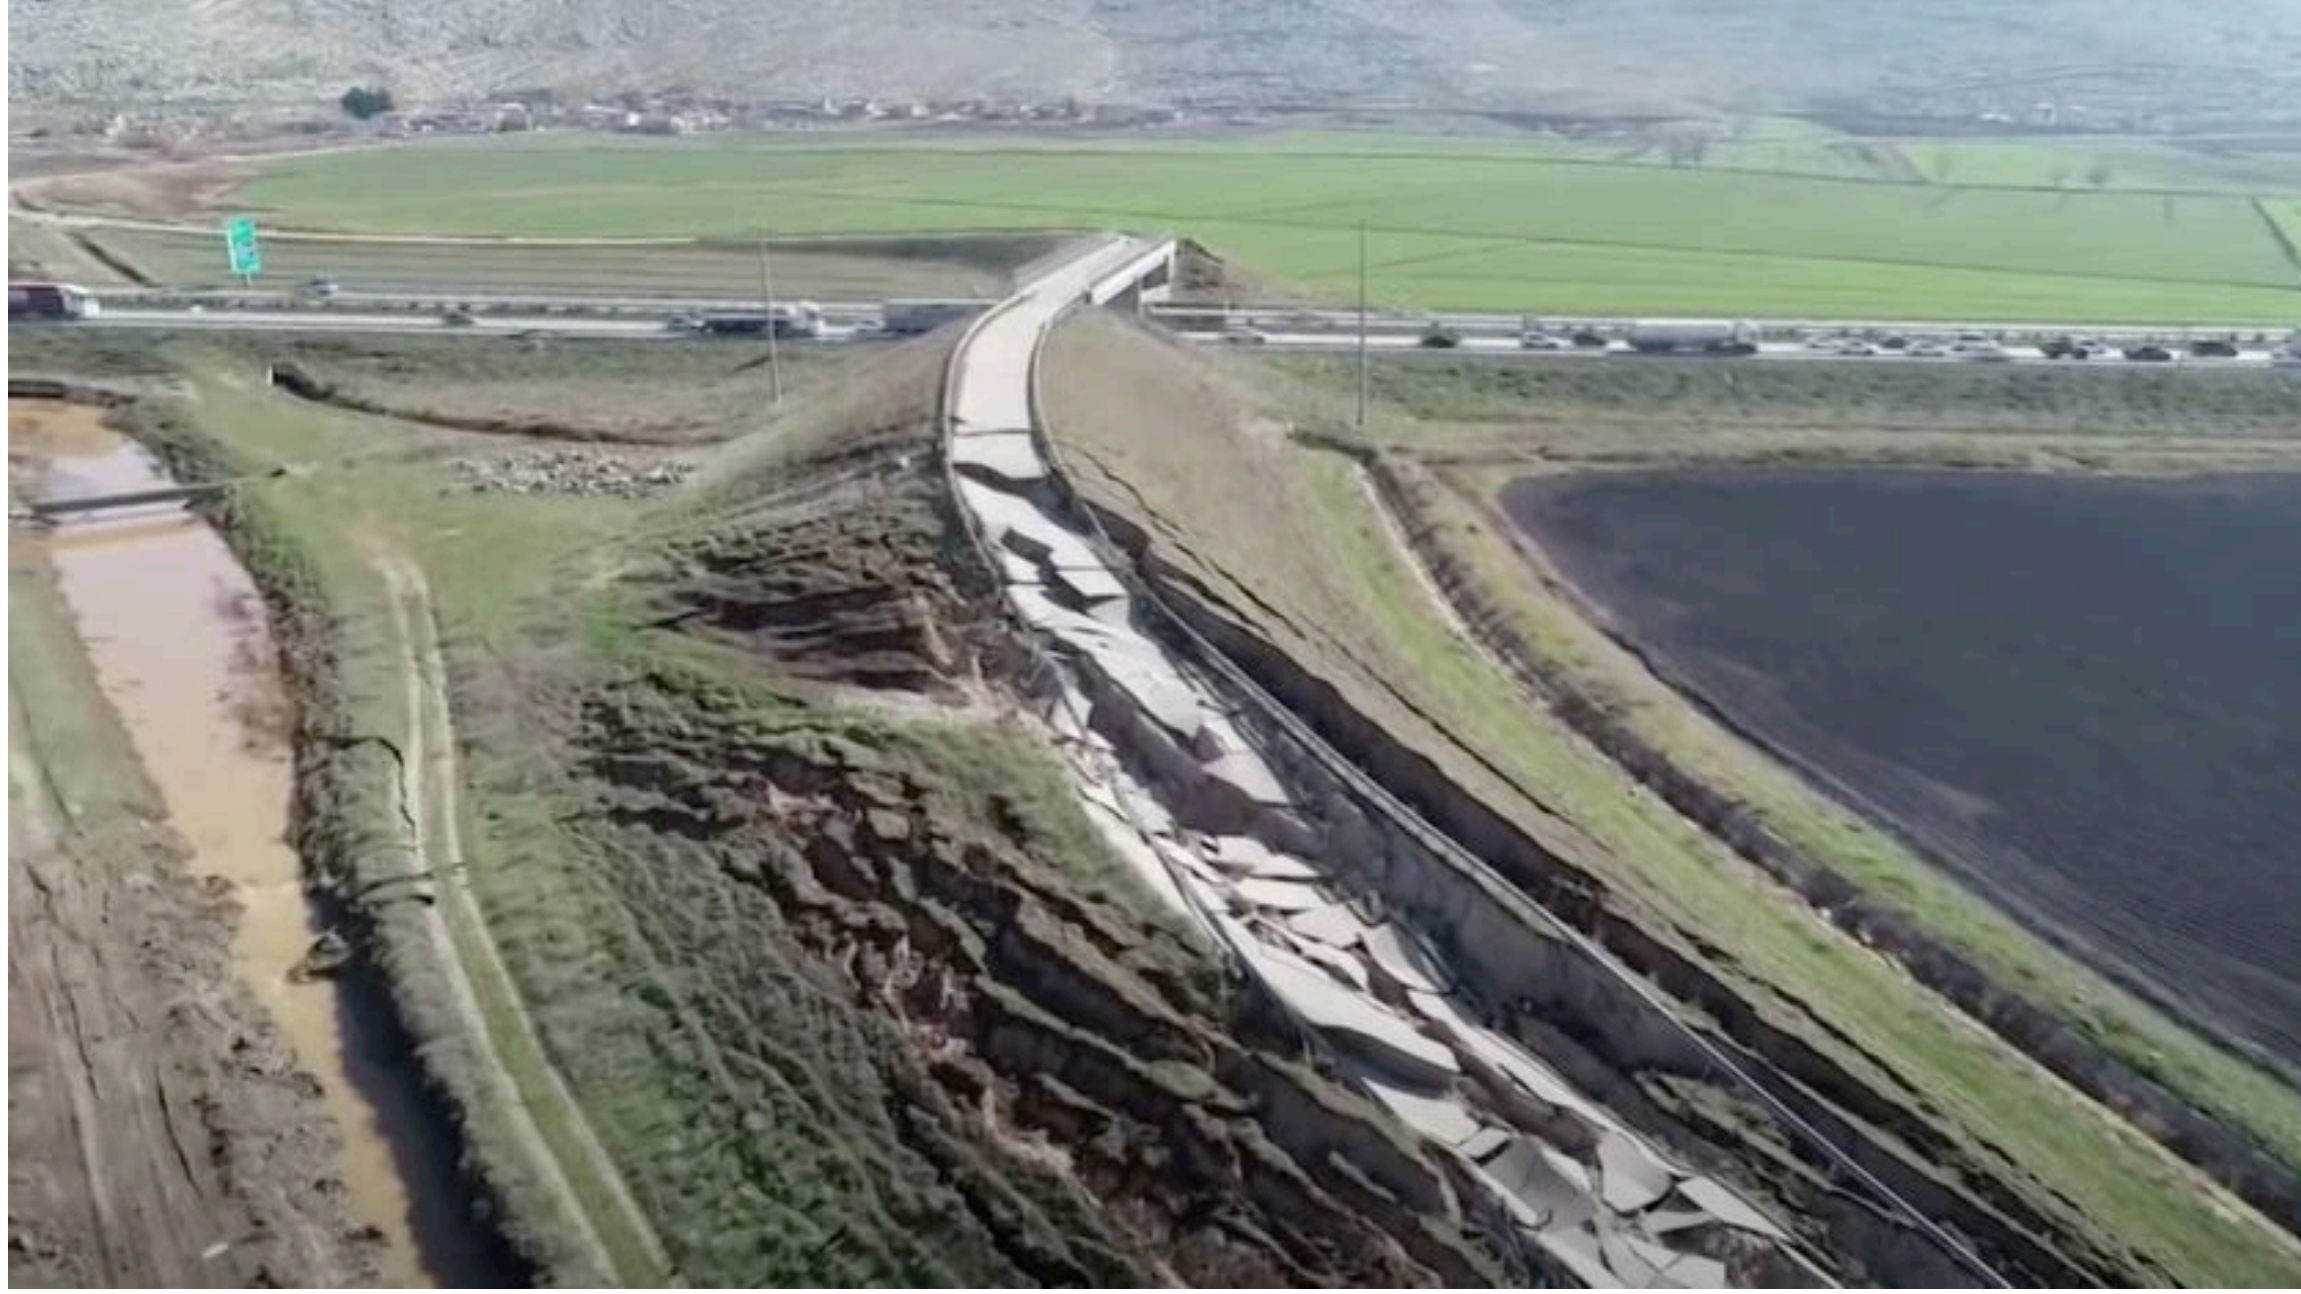
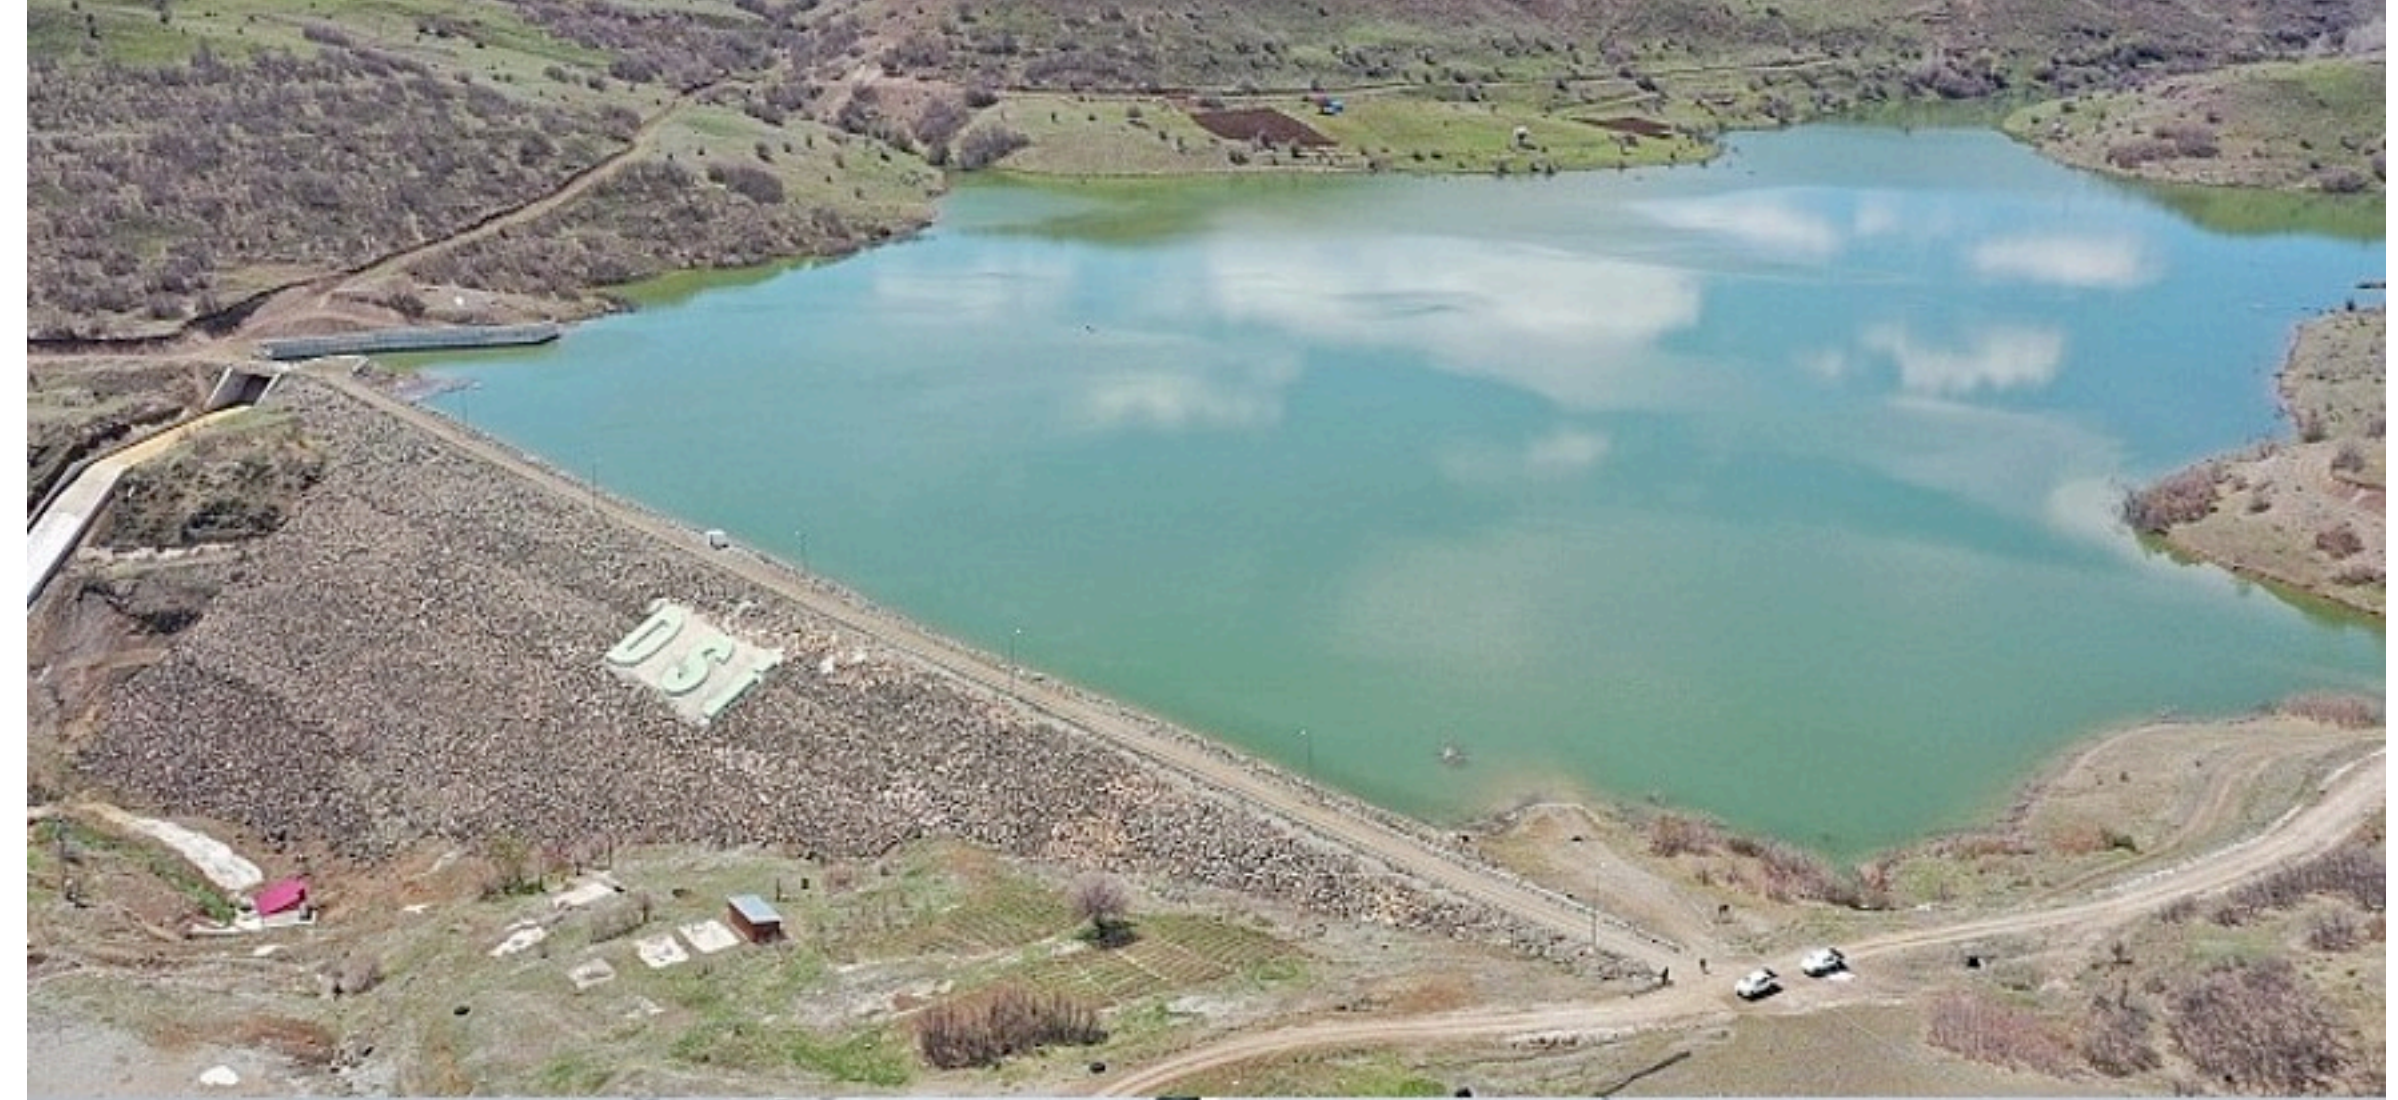
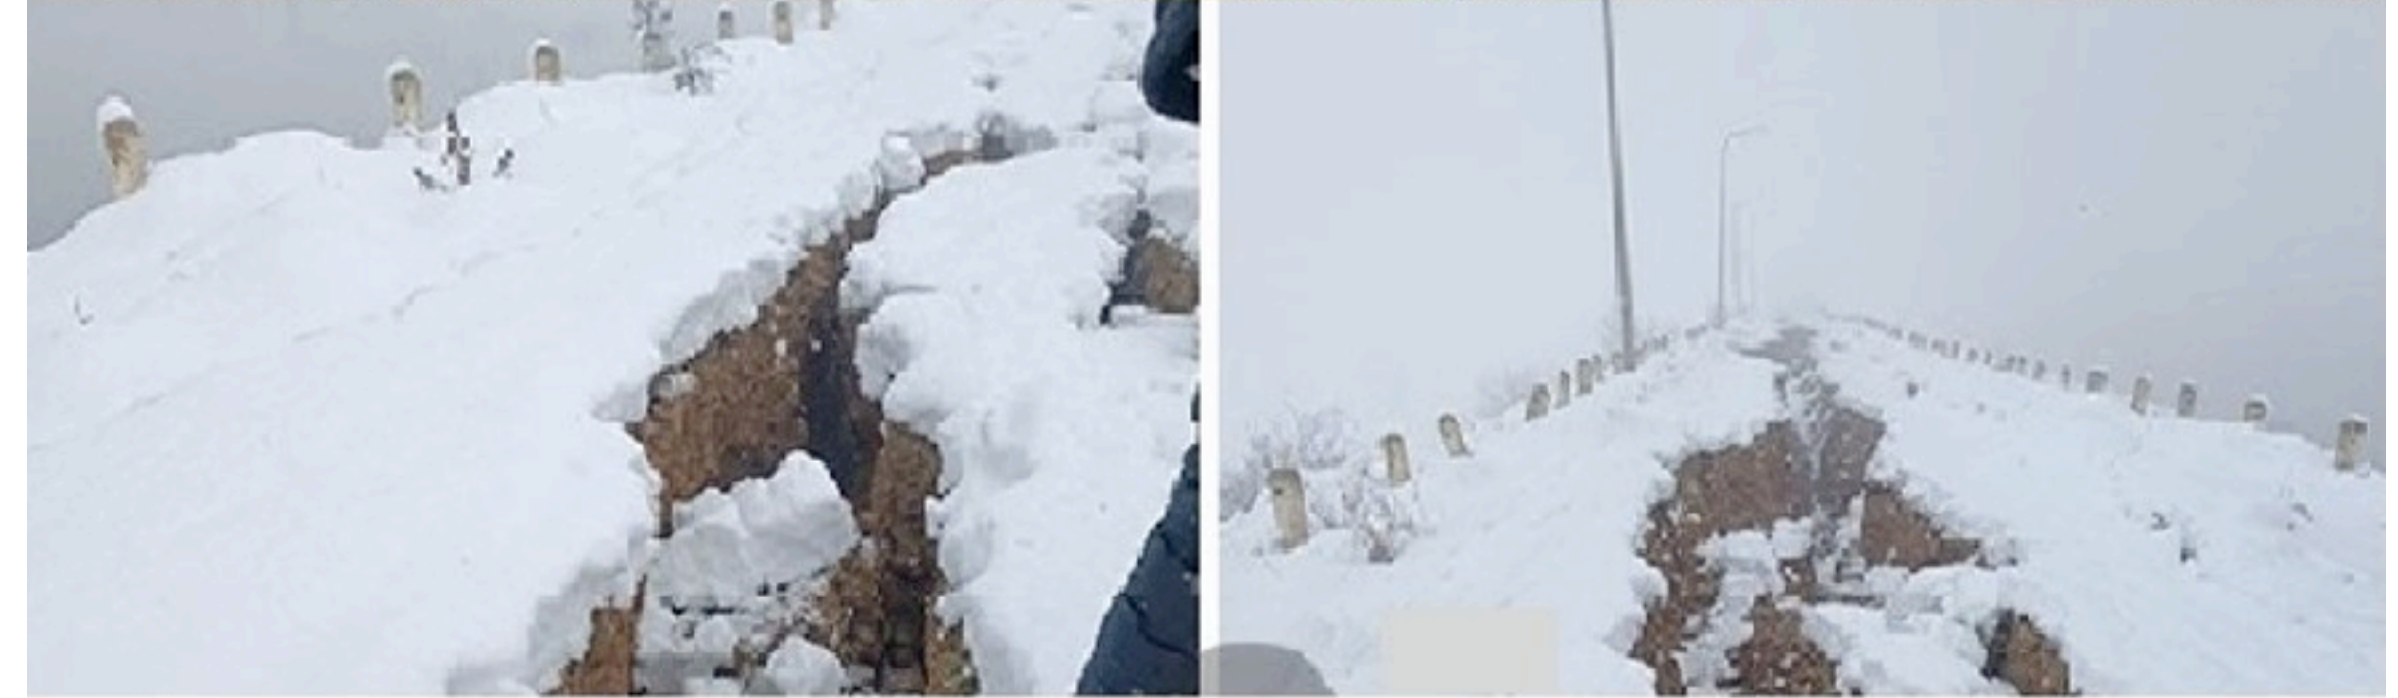
- Embankment failures during the earthquake
