# Highlights of Worst Devastation in Turkey

- Two back-to-back M7.8 and M7.6 earthquakes occurred in Eastern Turkey within 9 hours
- Affected 15 highly populated provinces
- Over 47,000 people lost their lives
- More than 5,000 buildings collapsed

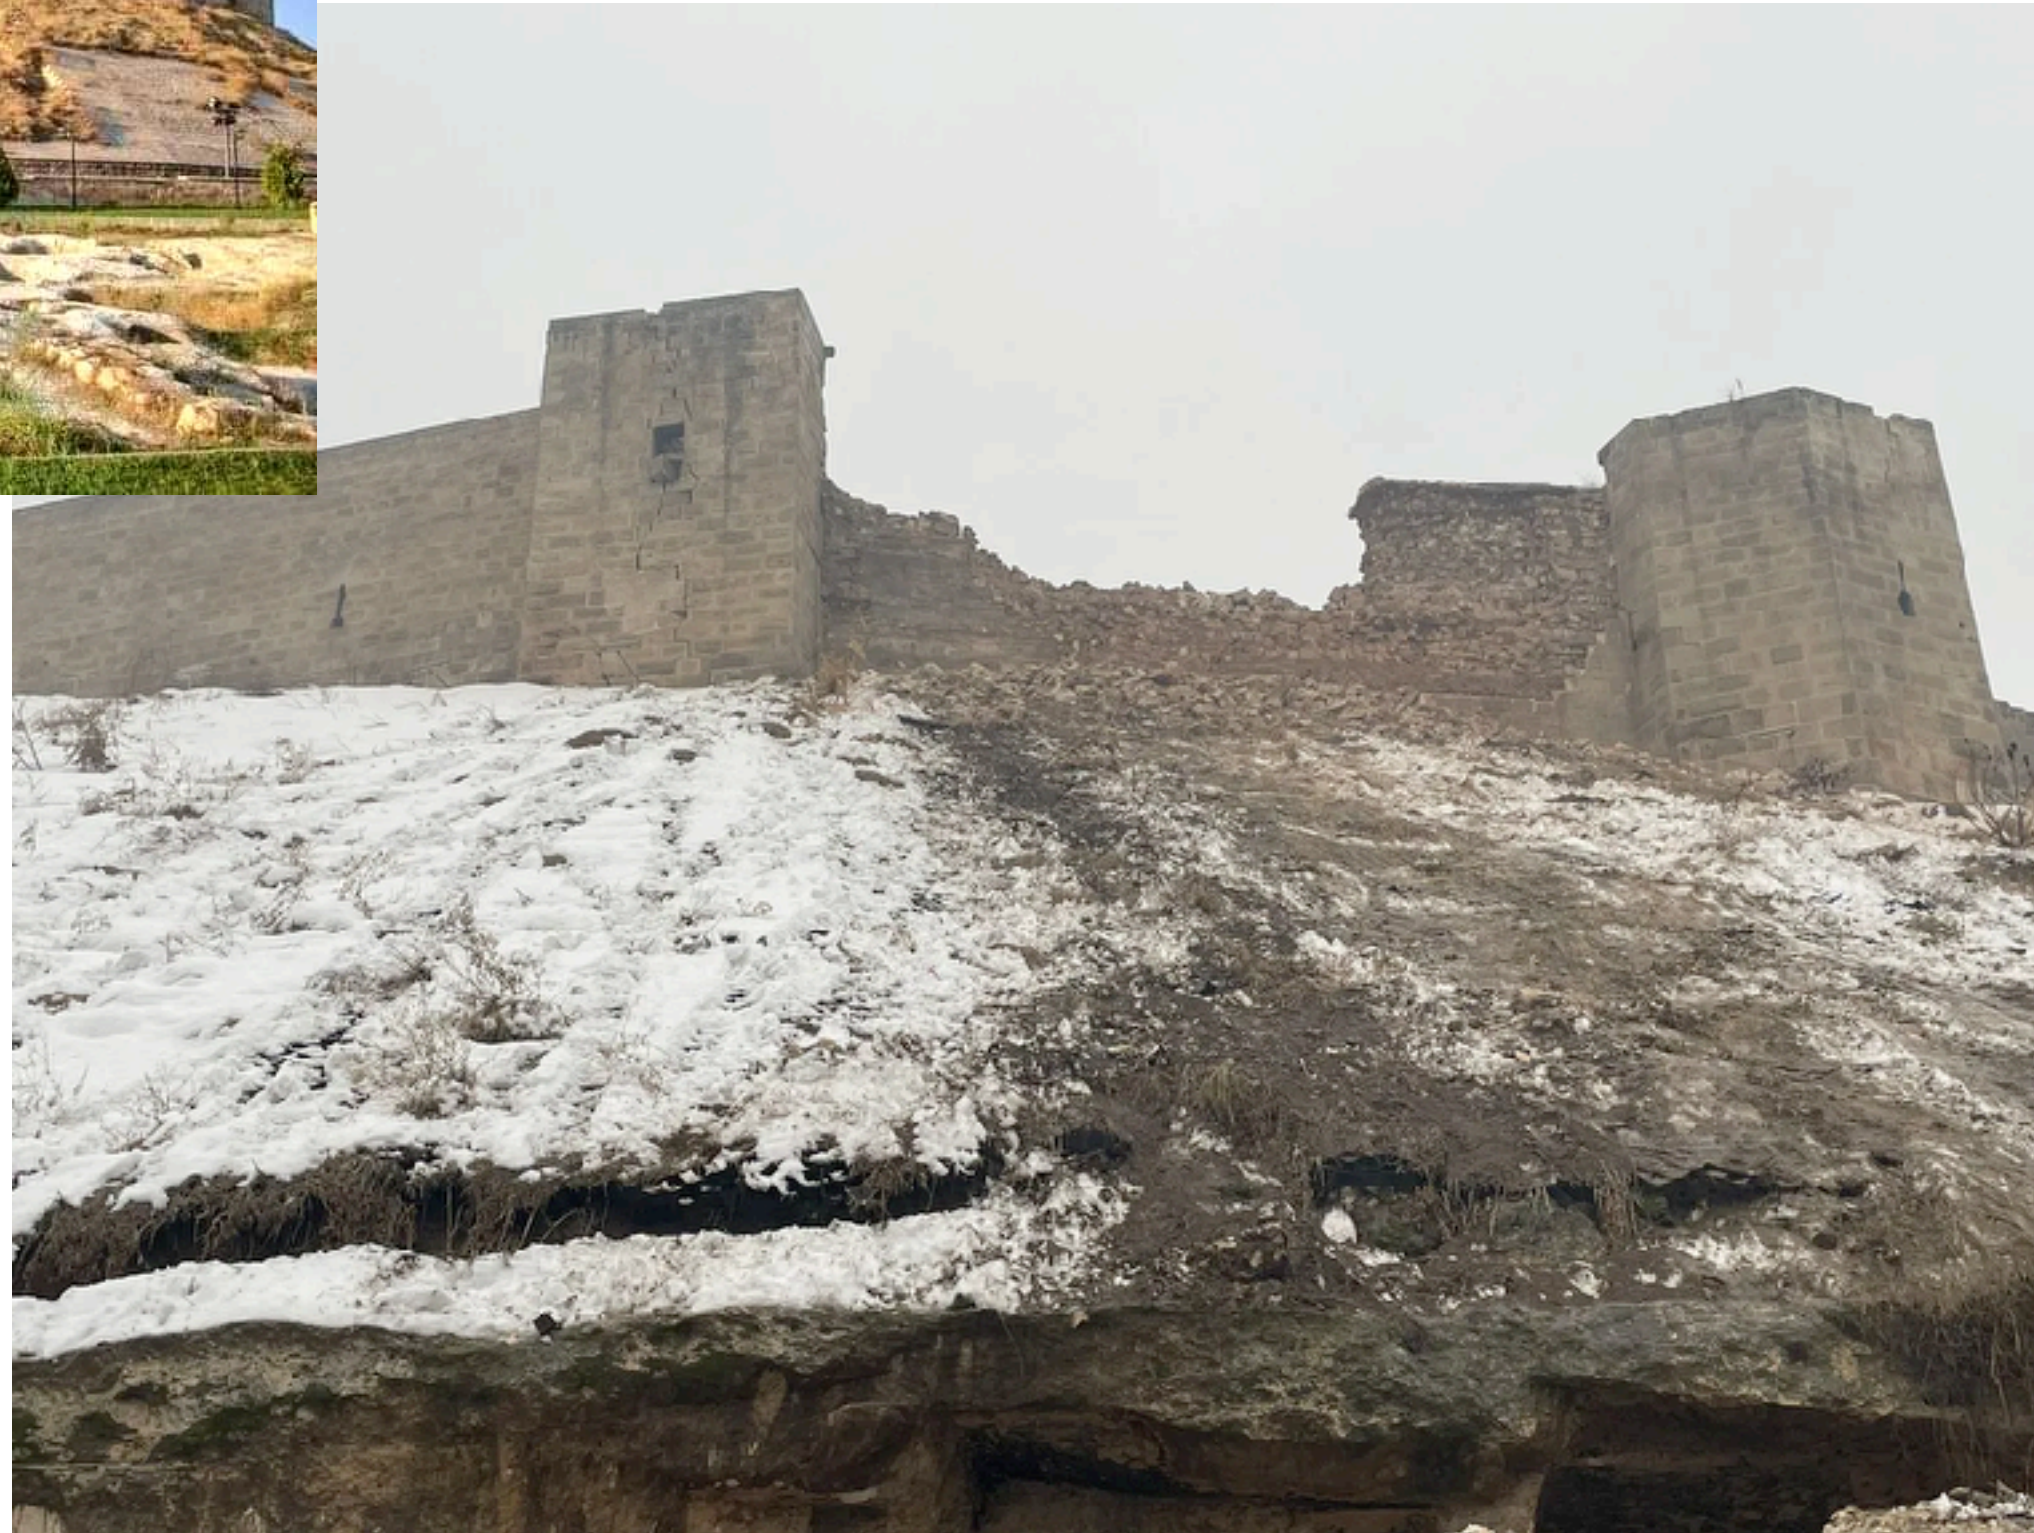
# Collapse of 2,200 Years Old Heritage

- Dating back to the Roman empire, around the second, third, and fourth centuries A.D., the structure was originally built as a lookout.

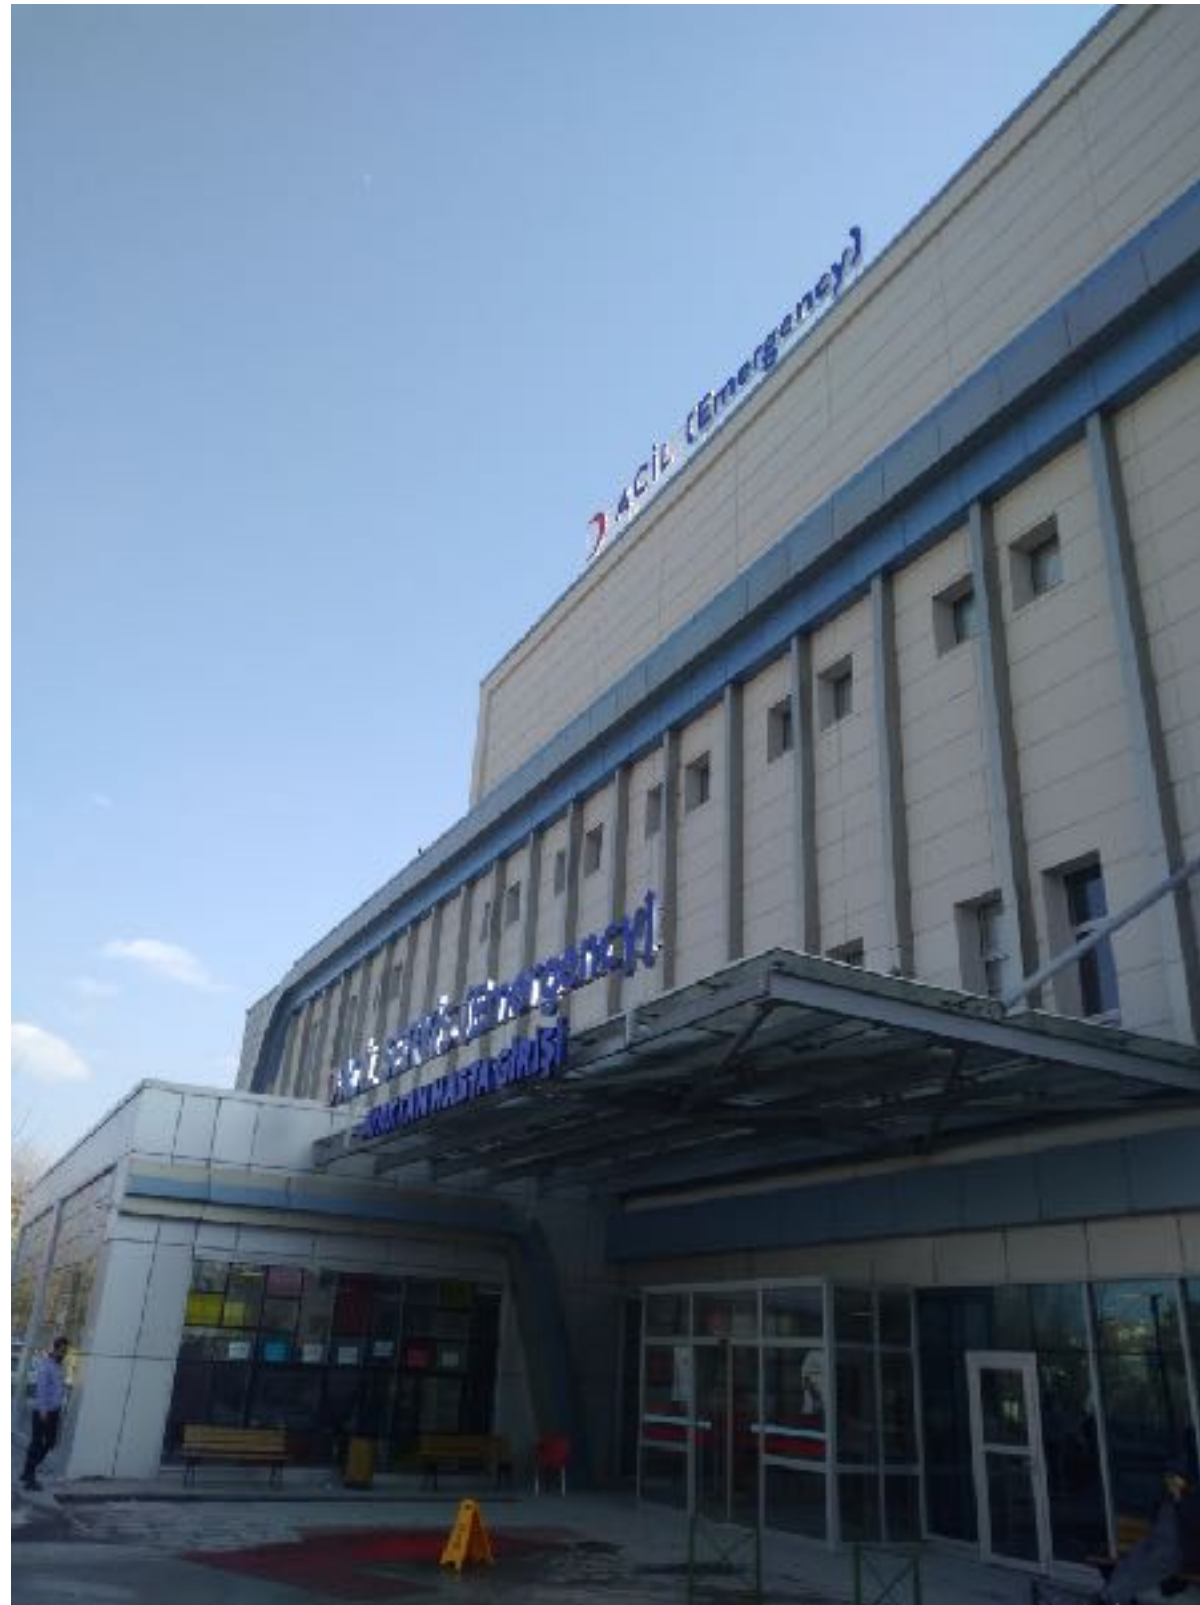
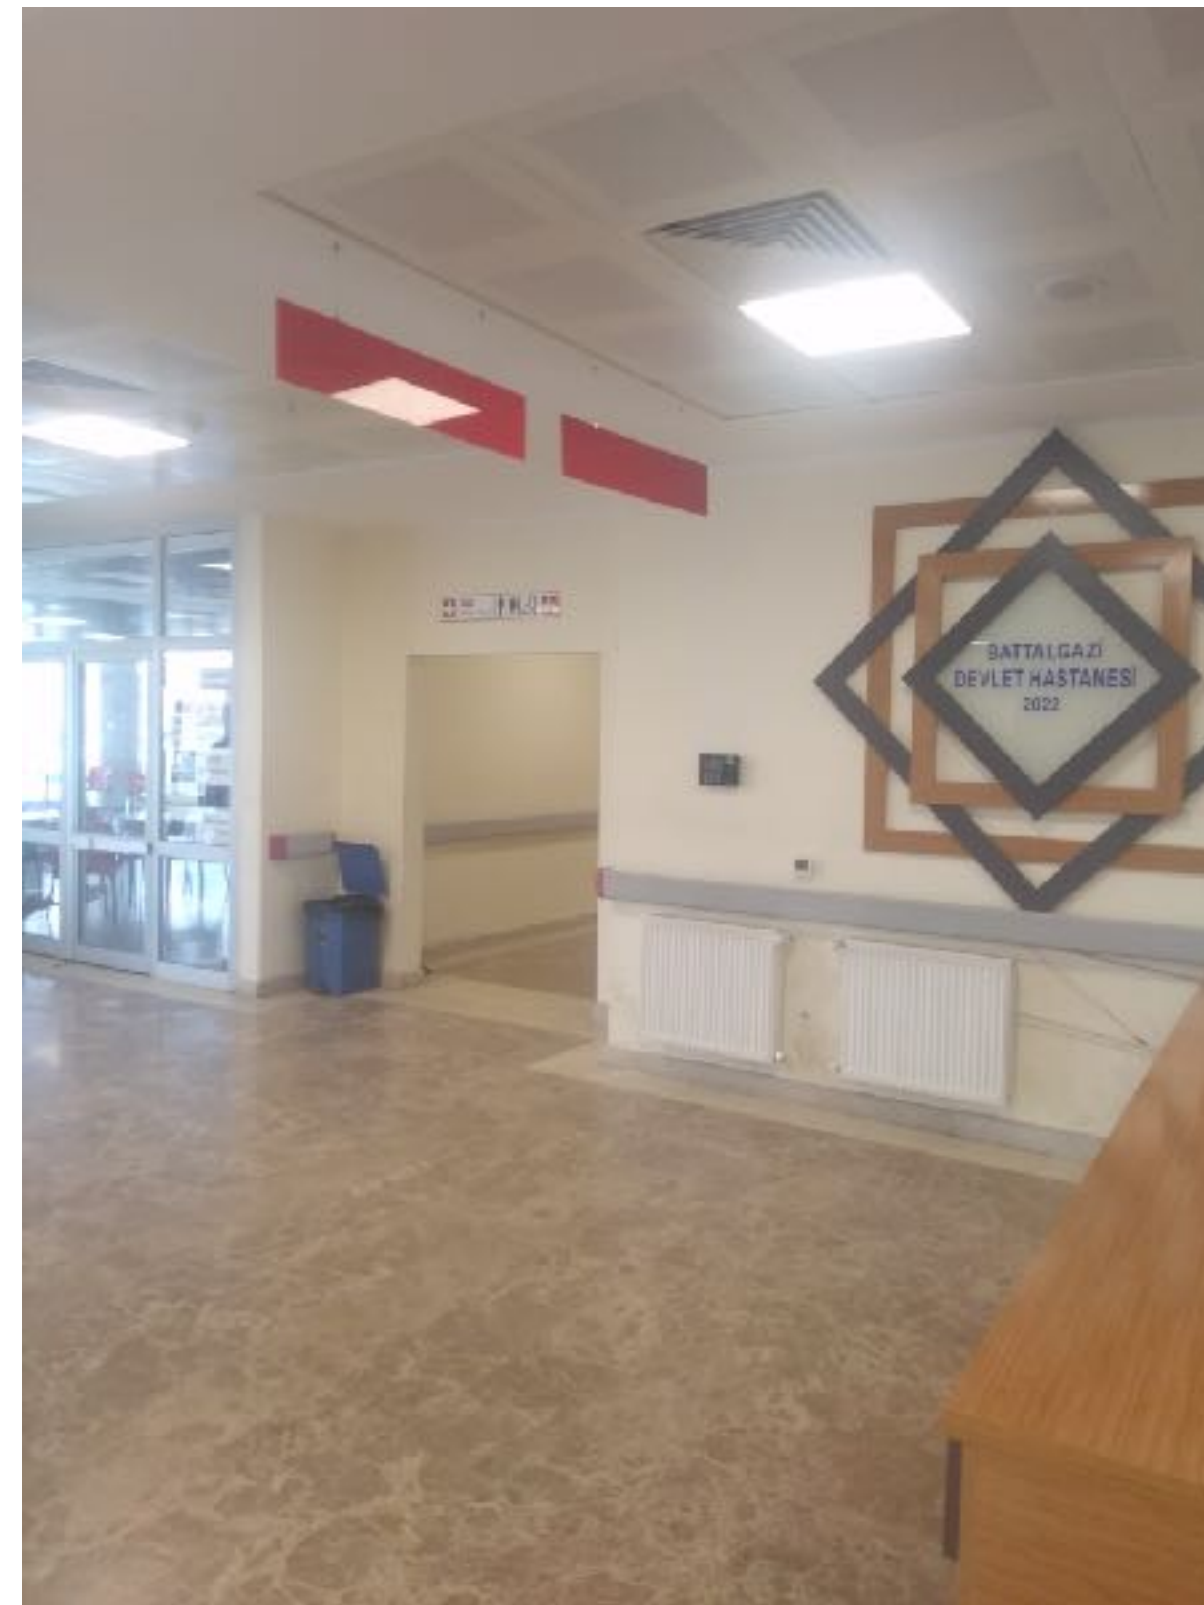
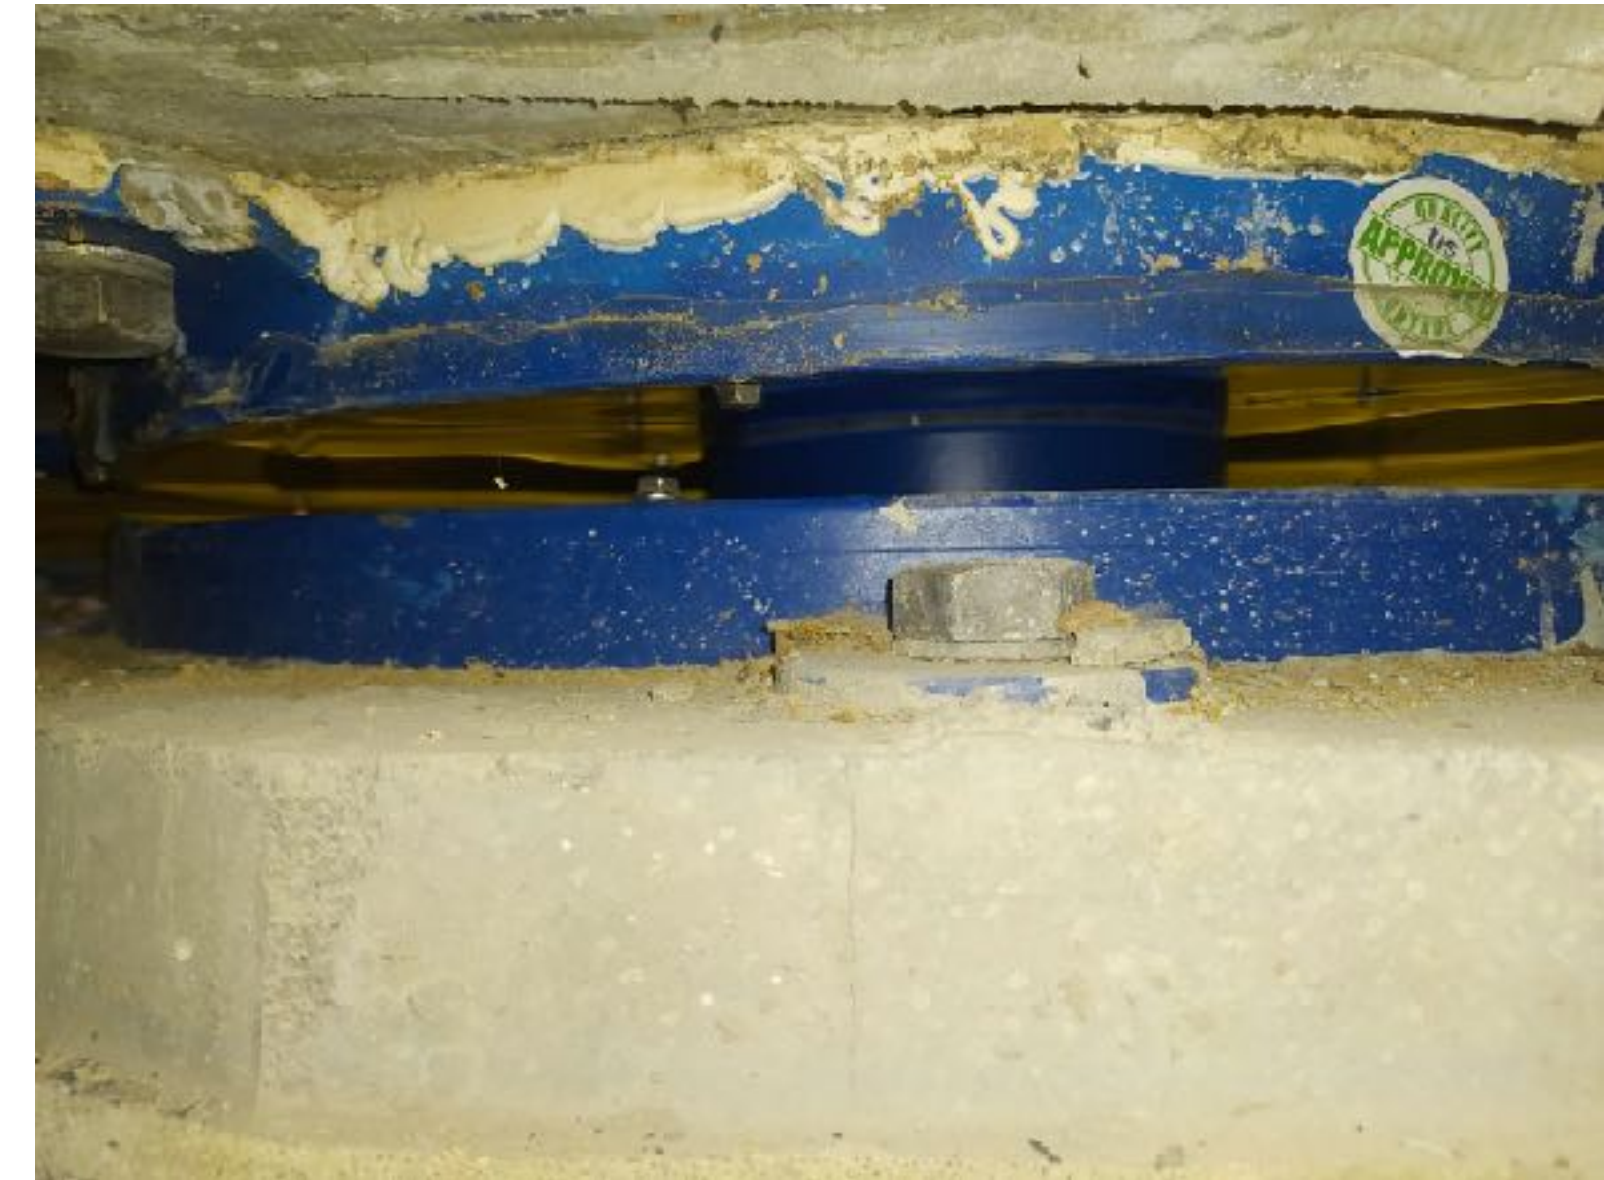
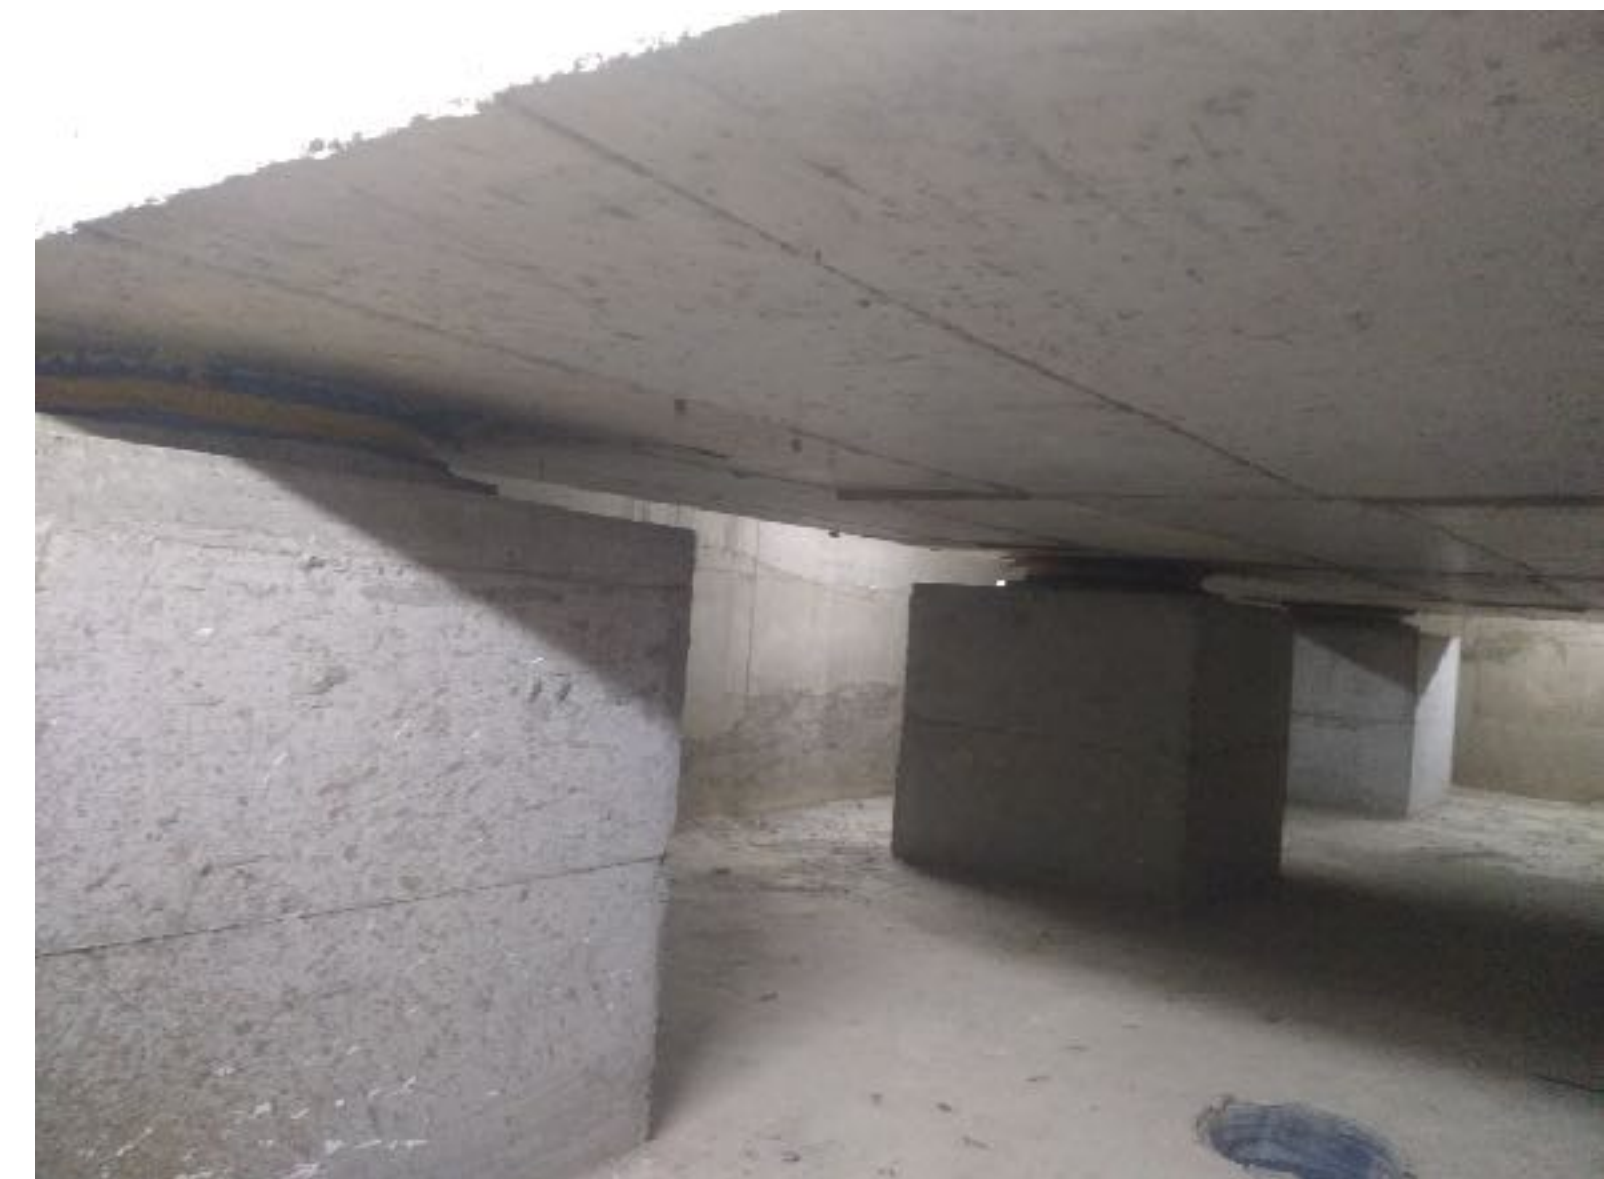
- No structural damage
- Base-isolators have residual displacement of 1.2 cm
- Total displacement +/- 9 cm

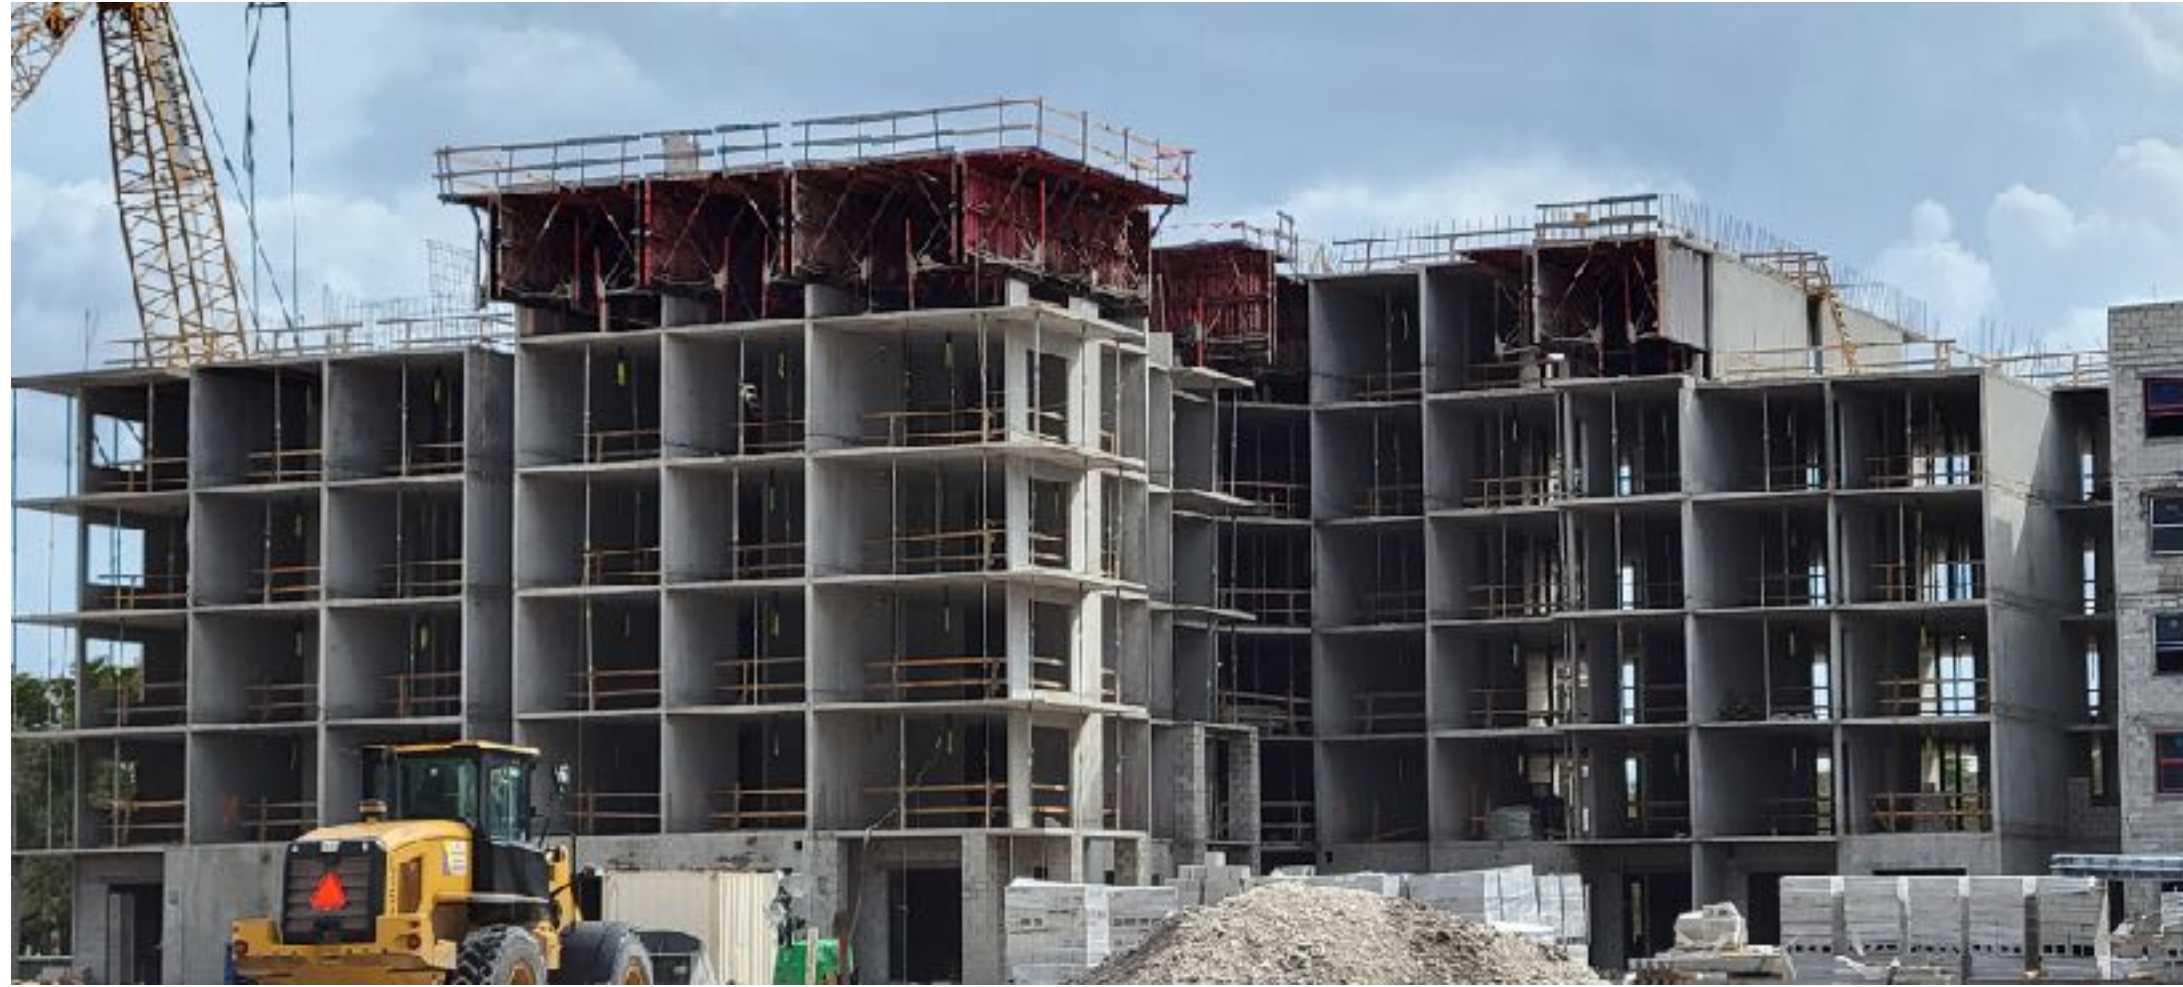
- 130,000 condo unit exposed to earthquakes
- No collapse
- Minor repairable structural damage
