# Structural and Geotechnical Impacts of Surface Rupture on Highway Structures

A. Pamuk<sup>1</sup>, E. Kalkan<sup>2</sup>, H.I. Ling<sup>3</sup>

**Abstract**—The most dramatic and significant damages on highway bridges during the recent earthquakes in Turkey (Mw 7.4 Kocaeli and Mw 7.2 Duzce earthquakes) and Taiwan (Mw 7.6 Chi-Chi earthquake) were the result of the fault rupture traversing the bridge span that devastated many of such transportation structures. The veiling of this phenomenon during the design of highway bridges and its unfortunate consequences accentuated the need to examine the surface rupture hazard, identify possible risk of failures and present remedial actions from both structural and geotechnical engineering stand points. Towards that purpose, damage conditions of highway bridges during these events were overviewed in general, and a totally collapsed highway overpass located in Arifiye during the Kocaeli earthquake was investigated in details. The major problem under consideration is twofold: first, dislodging of bridge span, and consequently, total separation of the reinforced concrete (RC) girders from their decks, that phenomenon necessitates the revision

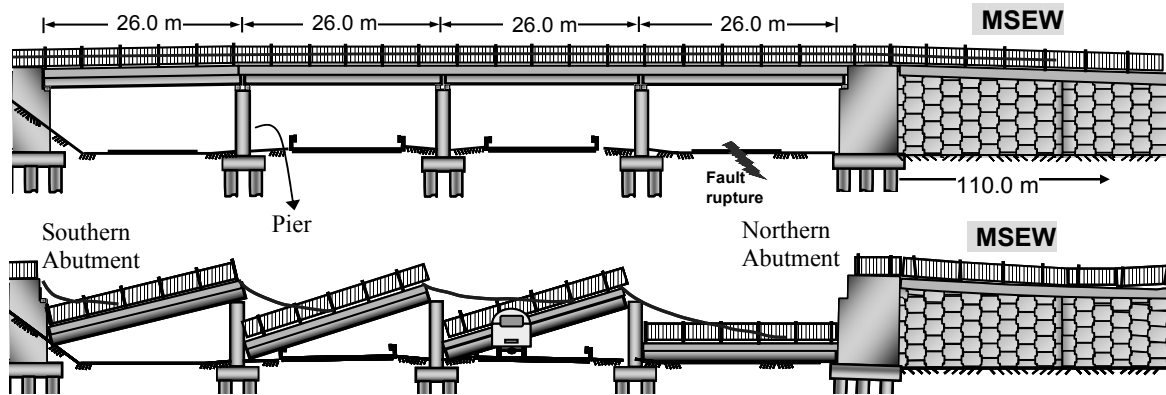
Fig. 2: The bridge overpass in Arifiye and mechanical stabilized bridge approach fill walls before and after the Kocaeli earthquake.

It was observed that the major damage to MSEW system was not due to its seismic design, yet a combination of adverse effects by the nearby fault movement and possibly bearing capacity problems associated with underlying foundation soil. Figs. 2, 5, and 6 show the overpass and the reinforced walls before and after the shaking. Regarding this, the collapse of Arifiye Overpass may reveal the following deficiencies that may also valid for the other bridges that suffered surface fault rupture hazard during the recent earthquakes. The fault traversing at Arifiye caused 1.40m of displacement of adjacent piers due to high right-lateral permanent

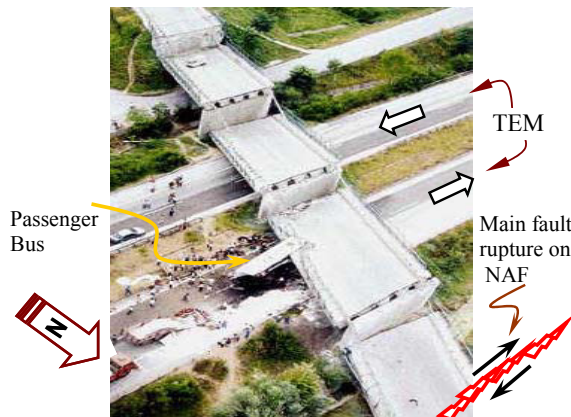
Fig. 5: Aerial view of the Arifiye Overpass, after [8].

deformations in the longitudinal direction that was more than the available seating length of deck girders 0.60m. In addition, tilting of bridge piers located in the north direction and close to surface rupture (Fig. 5) exacerbated the dislodging of girders from their elastomeric bearing supports. Insufficient seating length of deck girders and elastomeric bearings, as well as dysfunctional shear keys (Fig. 7b) triggered the total collapse of the bridge span.

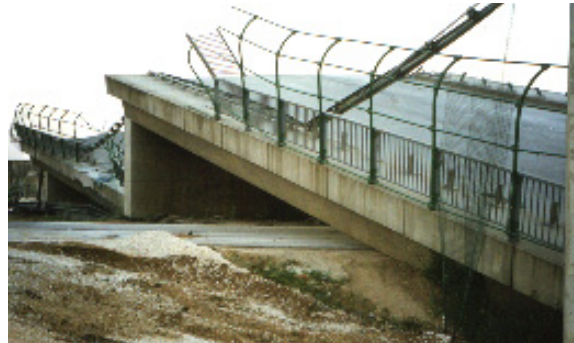
associated strong near-field effects caused unseating of the bridge girders and their collapse as well as damage to MSEW of the reinforced approach fill.

Fig. 6: Unseating of bridge deck from piers of the Arifiye Overpass traversed by surface fault during Kocaeli earthquake.

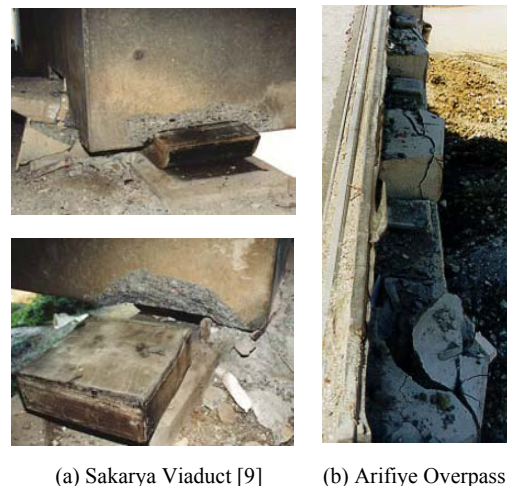
observed in several places during the recent earthquakes. The observed damages in other TEM bridges also showed that shear keys for purpose of restraining the transverse movement of these bridge girders were not designed and detailed or constructed properly. Therefore the fault tectonic movement could not be tolerated by their superstructures. In fact, if the shear keys were able to provide tolerable lateral restraining to those TEM bridges and overpasses, much of the associated damage could have been eliminated. For that reason, the capacity of shear keys should be in consistent with other superstructure components.

(a) Sakarya Viaduct [9] (b) Arifiye Overpass

Fig. 7: Bearing damages in elastomeric bearing supports and shear-keys during Kocaeli earthquake.

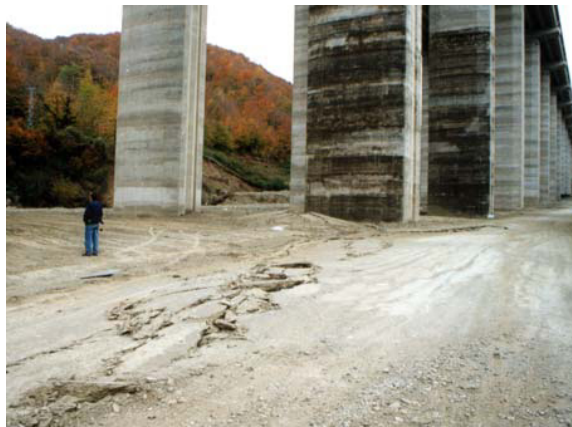
Fig. 9: Piers of Bolu Viaduct traversed by surface fault rupture during 1999 Duzce earthquake.

Another possible solution to prevent span failures might be the installation of cable restrainers across the deck joints. In fact, during Duzce earthquake the Bolu viaduct had the similar misfortune of surface rupture hazard crossing the bridge span. This viaduct is the longest (2.5km in length) in Turkey, and composed of a pair of independent sixty parallel decks (each has 40m long and 17.5m width). Although the bridge deck was equipped by seismic dampers mounted between pier caps and end of the diaphragms of the deck, they were completely damaged during the main shock of the Duzce event when the tectonic movement caused 1.50m of right lateral fault offset under the viaduct as shown in Fig. 9. However, at the expansion joints of its decks, cable restrainers prevented end girders from falling off from their supports [10]. Fig. 10 shows a typical hinge joint restrainer installed to prevent excessive longitudinal joint separation. In fact, such retrofit measurements were shown to be effective during the 1989 Loma Pieta earthquake [11].

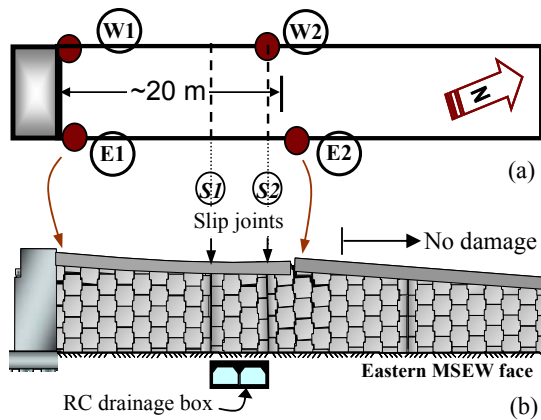
Fig. 12: Reinforced bridge approach (a) plan view of damage-concentrated locations; (b) schematics of eastern wall face after the earthquake.

damage in the MSEW system in Arifiye. These are (i) large tectonic movements along the main fault line, (ii) presence of a drainage culvert, (iii) strong near-field shaking, and possibly, (iv) cyclic-induced soil densification and settlement. Only a limited section of the MSEW approach ramp was damaged to a great extent in between the bridge abutment and RC culvert as shown in Fig. 12. The most damage-affected locations within this section along the eastern and western wall faces are highlighted in Fig. 12a as E1 and E2, and W1 and W2, respectively, while their detailed views are presented in Figs. 14 and 15. Right-lateral strike-slip fault rupture along the main fault line passed under the northernmost span of the bridge (Figs. 2 and 5) with large transverse and vertical displacements of approximately 3.5m and 0.5m (e.g., [15], [16]), respectively. Among these, the vertical ground deformation appeared to be the main source of the damage state in the reinforced walls of the approach ramp. The deformation on the main fault rupture extended through the RC culvert under the reinforced ramp (Fig. 12). Cracks due to vertical deformation were clearly observed on asphalt-covered side roads, especially on the western side of the ramp (Fig. 15). It should also be pointed out that the final permanent ground deformation in this section may possibly include cyclic-induced settlement due to soil densification in addition to the subsidence from the fault rupture. However, the undamaged section of the wall did not exhibit any settlement due to earthquake shaking, indicating that the majority of the ground failure under the MSEW was from the nearby tectonic activity.

The greatest disturbance in the wall faces was concentrated at higher elevations above the culvert. Because the vertical displacement in the eastern wall face was larger than other side, the approach ramp tilted eastward in the cross section above the RC drainage box

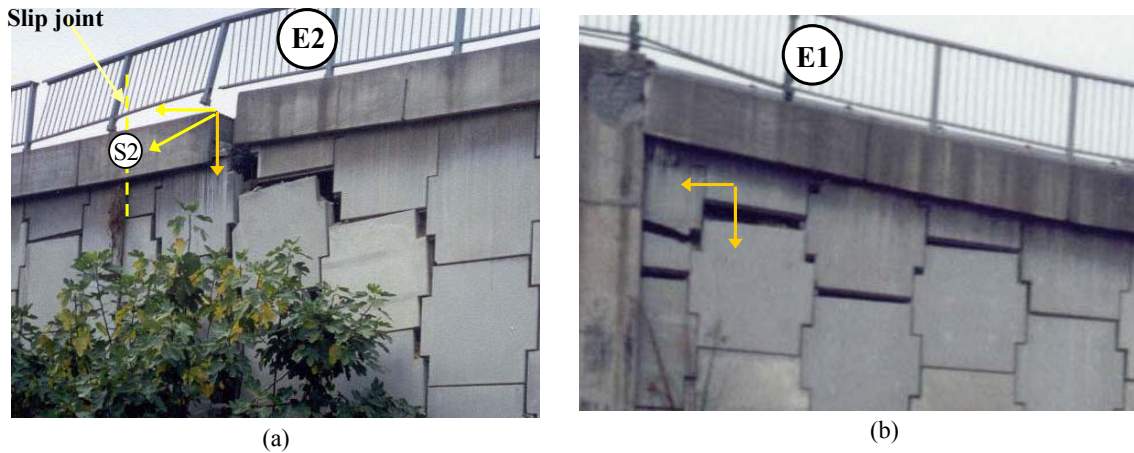
Fig. 14: Damage details on eastern wall face (photos after Ozbakir).

culvert. This tilting was most probably due to the presence of the rigid culvert which prevented interaction between the ramp and its foundation soil; therefore, the walls could not uniformly accommodate the underlying fault-induced ground deformations and cyclic-induced soil densification. The tilting in the cross section resulted in different damage states above the culvert at E2 and W2 such that the western wall buckled in the vicinity of W2, whereas the eastern wall face were stretched outward (Figs. 15a and 14a). The buckled side increased compression on the facing panels at W2, while crashing and forcing the panels displaced at this locality. On the other hand, the largest damage in the reinforced walls was observed on the eastern side at E1. At this location, the wall displaced both vertically and horizontally for about 25-30cm. The displacements at this location were so large that they exceeded the allowable design limitations for an independent panel movement. Thus, the panels could not accommodate the ground deformations, and finally, large panel separations and cracks occurred. However, the

At E1 and W1 (Figs. 14b and 15b), the facing panels interacted with the pile supported bridge abutment. The damage states at both locations were also different. At E1, the vertical ground deformation was so large that the flexible wall face was forced to be displaced both vertically and longitudinally. However, the movement in the longitudinal direction was greatly prevented by the rigid abutment. This caused large panel separations and cracks at the higher levels, but no damage observed at lower wall elevations. At W1, the vertical ground deformation was not appreciably large as opposed to E1. On the other hand, a gap occurred between the panels and the abutment as shown in Fig. 15b. This gap appeared to result from the buckling in the same wall face as indicated in Fig. 15a. That is, the buckling pulled the western wall face longitudinally through W2 as a whole. However, this did not cause any damage in the facing panels between

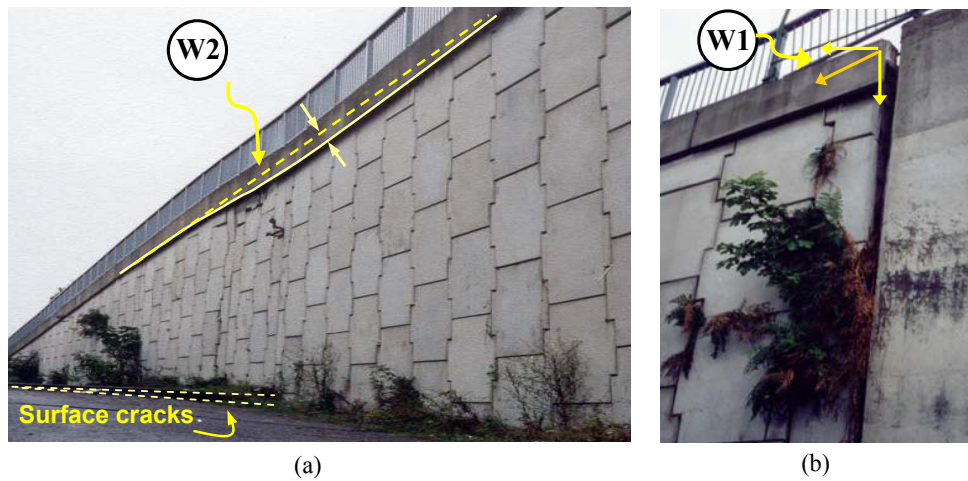
Fig. 15: Damage details on the western wall face (photos after Ozbakir).

W1 and W2, indicating that the reinforced wall system was highly flexible, and the large ground deformations were abruptly accommodated by the flexible joints of the facing panels during the earthquake.
