Recorded Motions of the 6 April 2009 M_w 6.3 L'Aquila, Italy, Earthquake and Implications for Building Structural Damage: Overview

The normal-faulting earthquake of 6 April 2009 in the Abruzzo Region of central Italy caused heavy losses of life and substantial damage to centuries-old buildings of significant cultural importance and to modern reinforced-concrete-framed buildings with hollow masonry infill walls. Although structural deficiencies were significant and widespread, the study of the characteristics of strong motion data from the heavily affected area indicated that the short duration of strong shaking may have spared many more damaged buildings from collapsing. It is recognized that, with this caveat of short-duration shaking, the infill walls may have played a very important role in preventing further deterioration or collapse of many buildings. It is concluded that better new or retrofit construction practices that include reinforced-concrete shear walls may prove helpful in reducing risks in such seismic areas of Italy, other Mediterranean countries, and even in United States, where there are large inventories of deficient structures. [DOI: 10.1193/1.3450317]

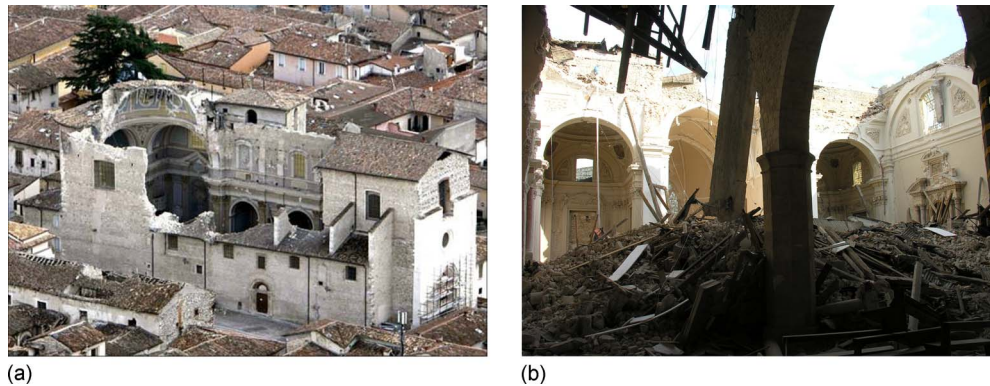
Figure 2. Most historical masonry buildings did not fare well during the shaking: (a) Santa Maria in Paganica, (b) Transept of Santa Maria in Collemaggio, L'Aquila.

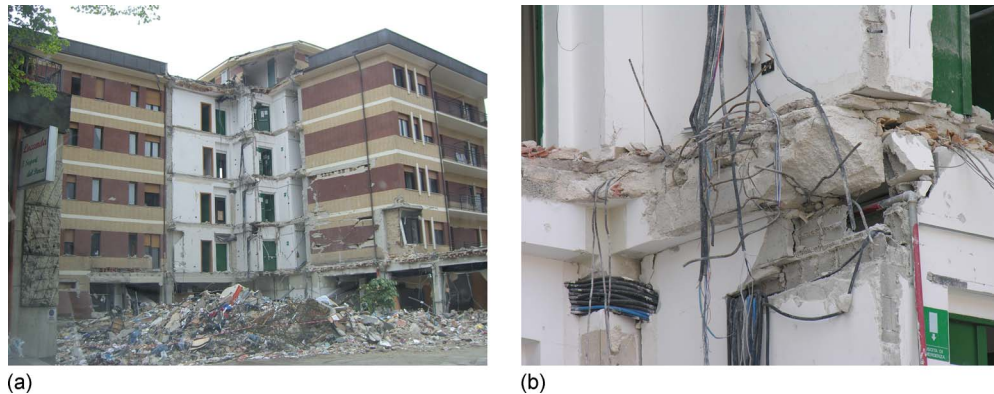
Figure 3. (a) Post-earthquake view of the site where a reinforced concrete framed building with infill walls collapsed during the earthquake. The visible rubble is due to the demolition of the heavily damaged part of the building. (b) Poor detailing of joints and apparently poor concrete quality may have contributed to its fate. The pictures are of a college student dormitory building that partially collapsed and killed about eight students.

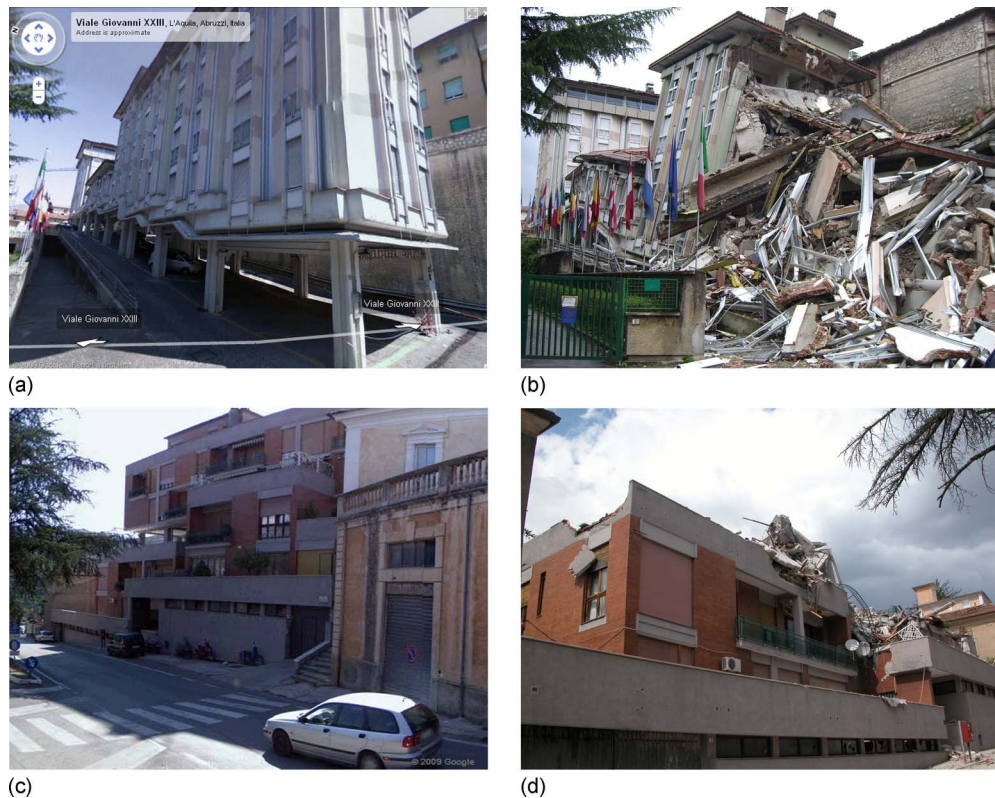
Figure 4. (a) Condition of Hotel Duca Degli Abruzzi in L'Aquila before the earthquake as obtained from Google Maps Street View and (b) the post-earthquake condition observed from the ground. It is possible to observe the presence of a significant irregularity in elevation between the ground and the first floor. (c) Before and (d) after earthquake condition of another collapsed building (irregularity in elevation at intermediate floor) in L'Aquila assessed by similar methods.

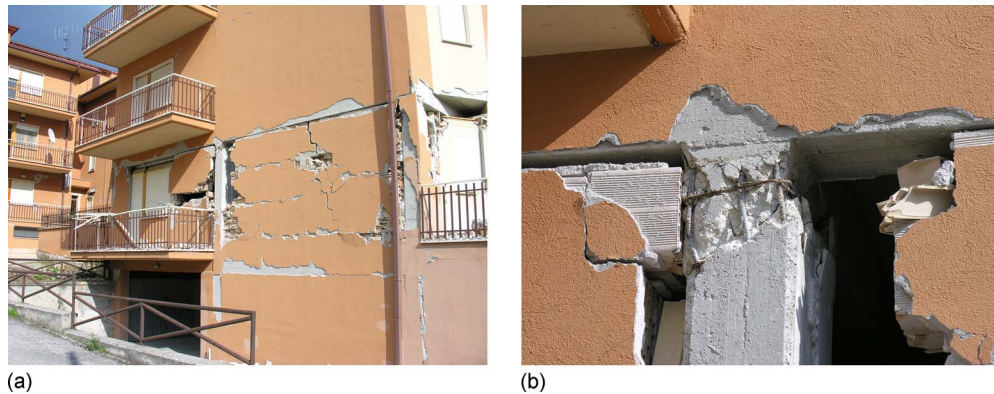
Figure 5. Although damaged and with poor shear rebar detailing, the infill walls (b) may have prevented more severe damage and/or collapse of this building (a).

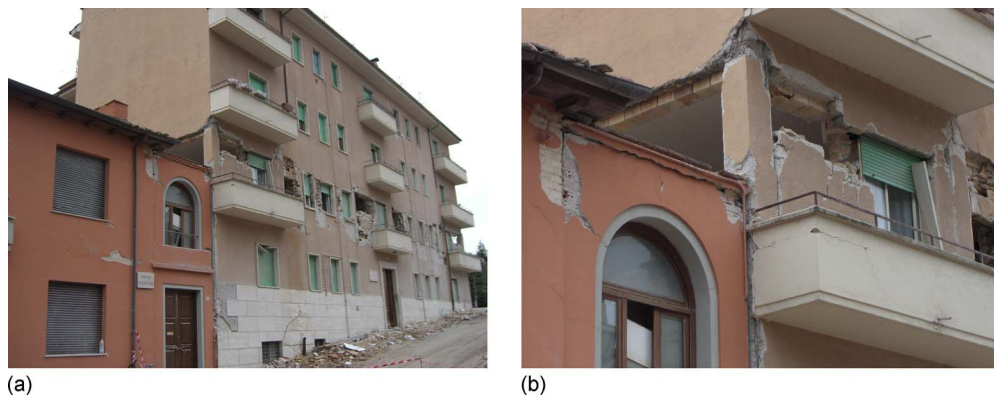
Figure 6. Perhaps unintentional vertical layout error (with the new building close to the older one with unmatched floor and roof elevations) caused pounding damage to the new building on the right.

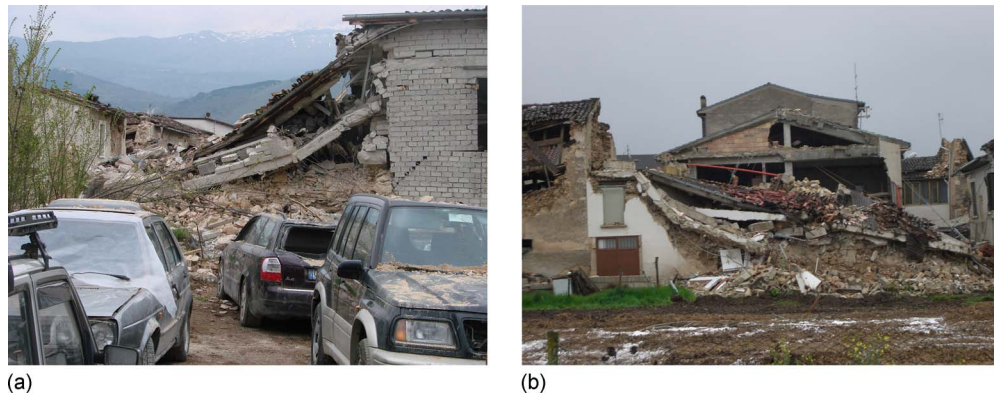
Figure 7. A majority of buildings in Onna (MCS 9.5 according to Galli and Camassi 2009). Mostly older, poor, nonductile masonry and un-engineered suffered heavy damage or collapsed.

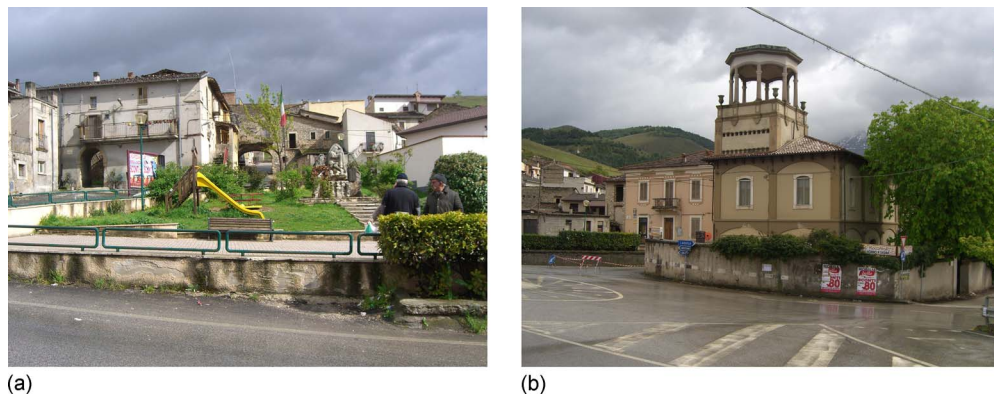
Figure 8. Although very close to Onna, the village of Monticchio suffered minimal damage (MCS 6.0 according to Galli and Camassi 2009). This is attributed to Monticchio being on firmer (Pleistocene) mainly silty and clayey lacustrine deposits, while Onna is on Holocene alluvial deposits (APAT 2006).

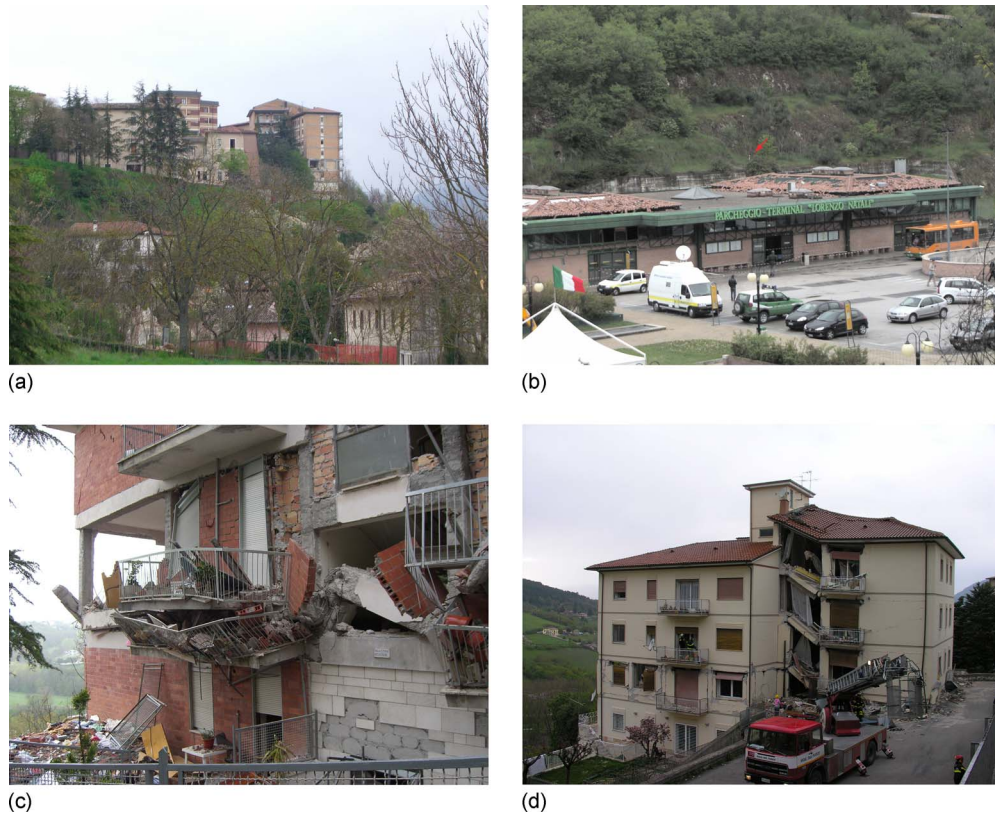
Figure 9. Cases where topographical effects may have played a role influencing the shaking imposed on these buildings. (a) A building with damages to the infill walls. (b) The bus depot behind which there is a retaining wall above which station AQK is housed. Arrow shows GPS antenna of the station. (c) Via Gualtieri d'Ocra, L'Aquila: mid-story pancake collapse, (d) another partial collapse of a building founded on a slope.

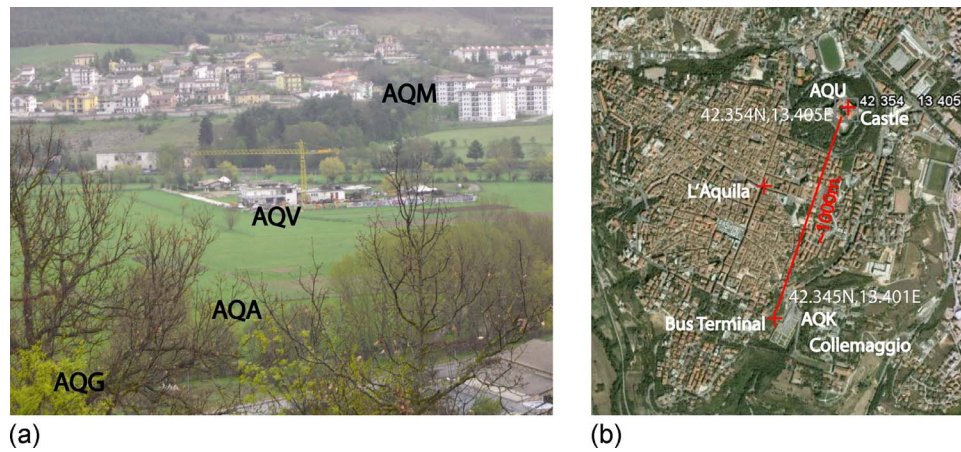
Figure 10. (a) Strong-motion stations AQG (hill), AQA (valley edge), AQV (valley center), and AQM (slope) as seen from near the location of AQG at Colle dei Grilli (rock site). AQM, close to heavily damaged area of Pettino reportedly recorded >1 g. (b) Relative locations of strong-motion station AQK and broadband station, AQU, both at the perimeter of the town of L'Aquila. AQU is within grounds of the damaged L'Aquila castle.

General views of the topography and geology of some of these important stations recording the earthquake are shown in Figures 10 and 11. An updated version of the geology map can be found in DiCapua et al. (2009). Relative locations of stations AQK and AQU are provided in Figure 10 also. A calcareous geological formation characterizes L'Aquila and its neighborhoods from south to east as detailed in several references (De Luca et al. 2005, APAT 2006, DiCapua et al. 2009, GEER 2009); in Italy, this calcareous rock is known as the “Scaglia formation.” In a more descriptive detail, L'Aquila is set on an alluvial terrace that forms the left bank of Aterno River. The alluvial depos-

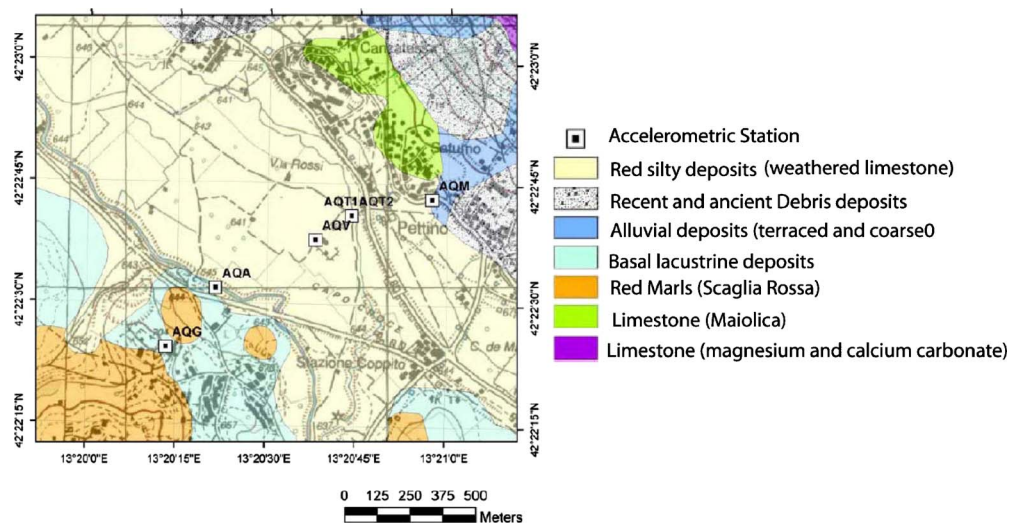
Figure 11. General geology of the area where strong-motion stations that recorded the largest peak accelerations are deployed (Figure adapted from RAN web site of DPC: <http://www.protezionecivile.it/>, also in Ameri et al. 2009). Station AQM recorded >1 g. Stations AQT1 and AQT2 have been removed before the earthquake.

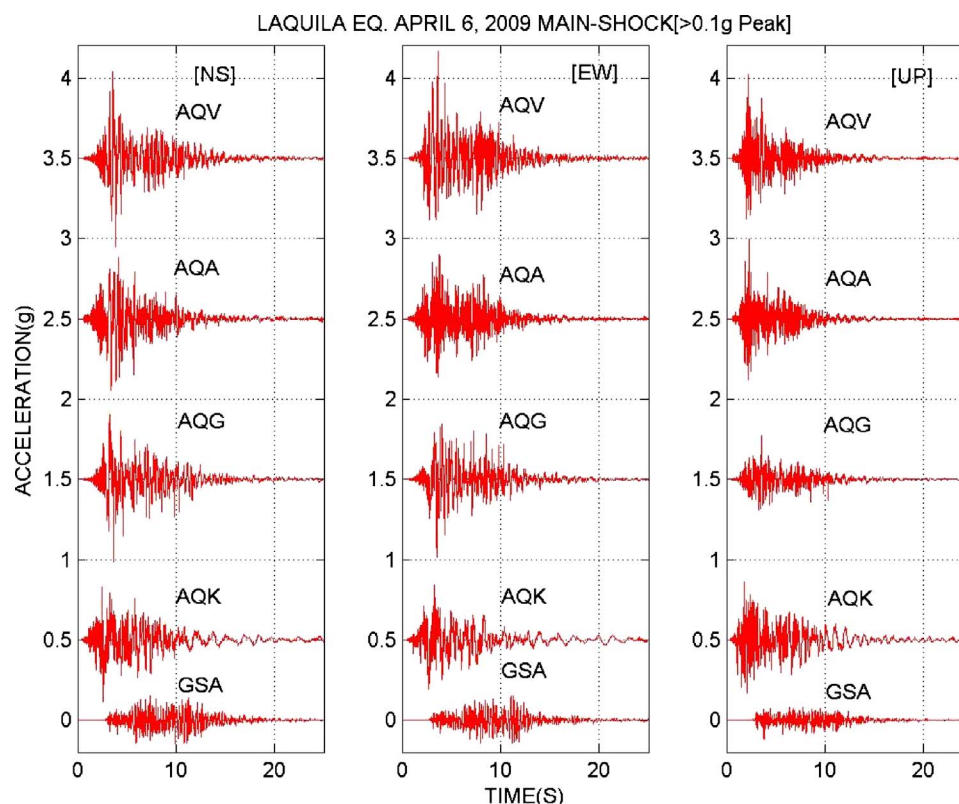
Figure 12. Time-history plots of five stations that recorded >0.1 g. The records are not time synchronized.

Figure 12 shows acceleration plots of the five stations (AQA, AQG, AQK, AQV, and GSA). Their 5%-damped elastic response spectra (for horizontal components) are plotted in Figure 13. Also shown in this figure is the 2008 Italian code design spectrum for rock site with a return period of 475 years (10% probability of exceedence in 50 years; NTC 2008). It is apparent that the response spectra of the records exceeded the most recent

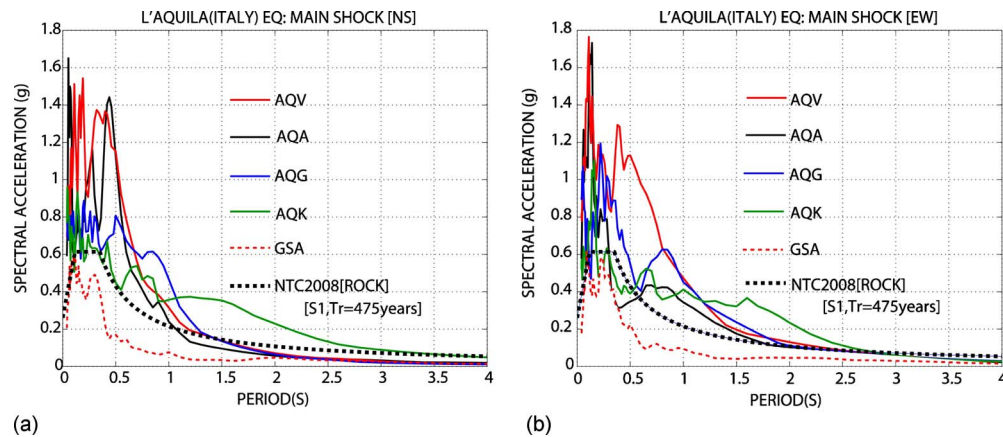
Figure 13. Response spectra for 5% damping for the five stations that recorded >0.1 g and comparison with the 2008 Italian Code Spectrum (for 475 years return period and rock site).

up-to-date code design response spectrum. More research should be devoted to this aspect, because some stations could have also experienced significant site amplification effects. Hence, none of the damaged structures in L'Aquila were likely designed (or constructed) with capacity compatible with the demands of the 2008 code design spectrum in Figure 13.

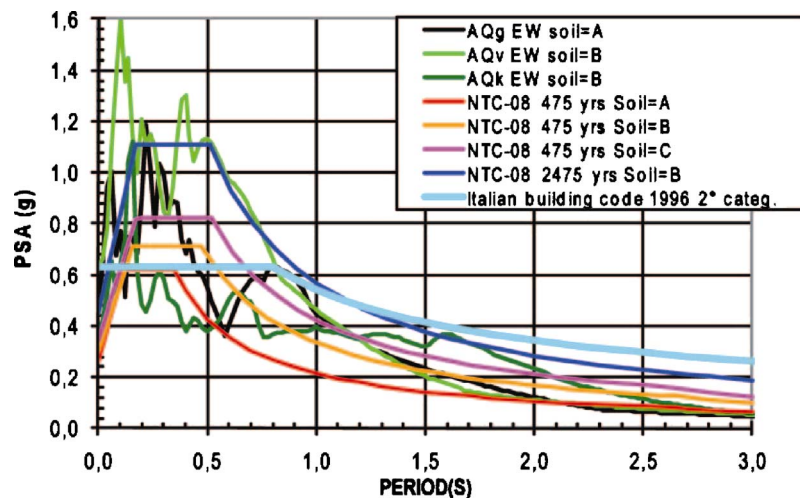
Figure 14. Response spectra for 5% damping for the three highest PGA recording stations (excluding AQM) and comparison with the 1996 and 2008 Italian Code Spectrum (for 475 years return period and different soil classes). Assumptions in construction of the 1996 Code Spectrum are: structure factor 4 for regular frames variable in type and material and a reduction factor of resistance of 1.5 (variable between the materials). For reinforced concrete, 1.5 is adopted, but it may vary between 1.35 and 1.5, which is an intermediate value between that of concrete and steel.

minating (Figure 14). Most modern buildings in the area likely used the 1996 code and not the recent 2008 code. In constructing the 1996 design response spectrum, we assume a structure factor about 4 for regular frames (but very variable in type and material) and

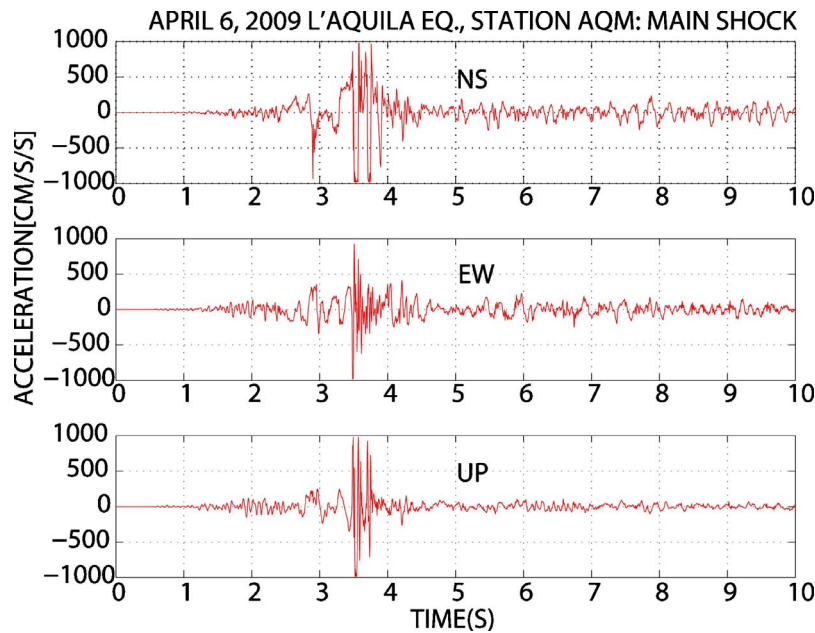
Figure 15. Acceleration time-history of the AQM record shows clipping at 1 g. High frequency pulses dominate the record 3.5 s after arrival. The clipping is attributed to loose anchorage of recorder to the mat of the station (Nicoletti 2009). Data is not used in further deliberations of this paper.

³ Subsequent to the initial submittal of this manuscript, staff from DPC have verified that there was partial loss of anchorage of the recorder to the station mat (Nicoletti 2009).

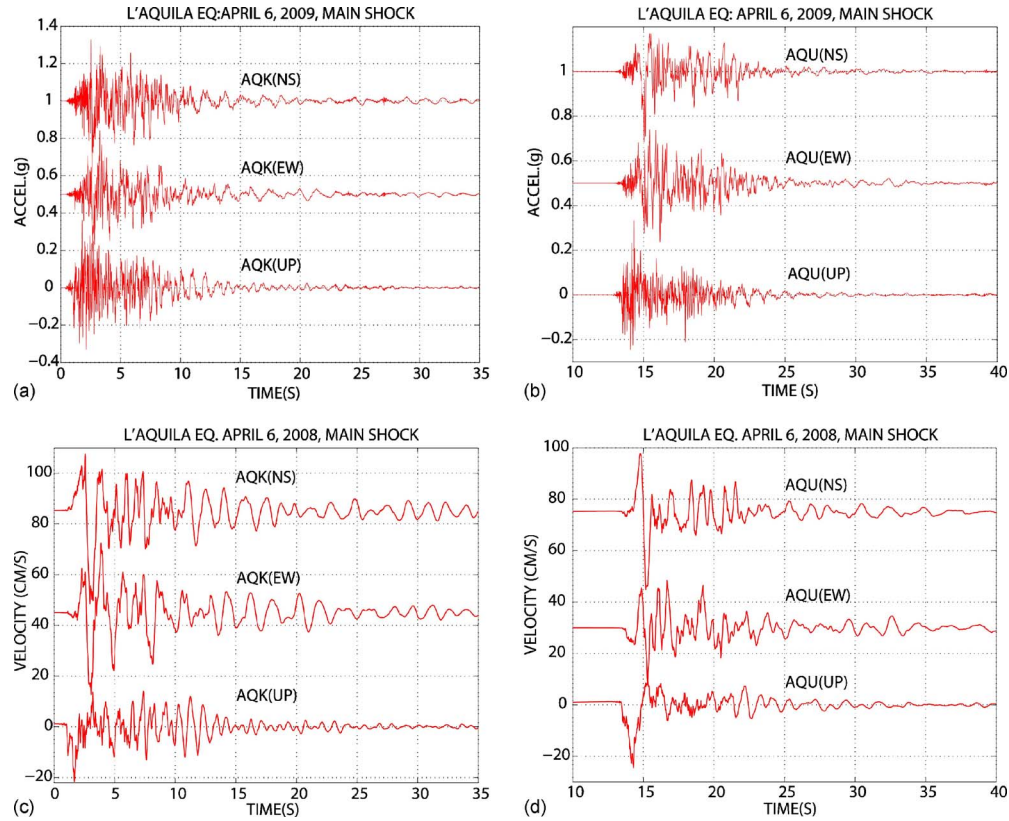
Figure 16. (a) Recorded accelerations and (b) velocities at stations AQK and AQU. There is no time synchronization between the records at AQK and AQU.

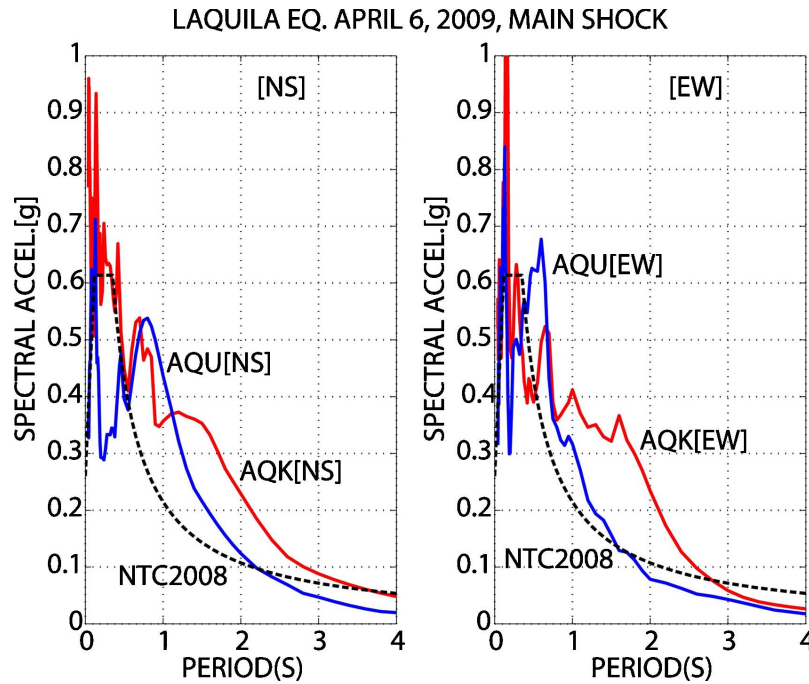
Figure 17. Comparative 5%-damped elastic acceleration response spectra of NS and EW components of accelerations and that of the 2008 code only.

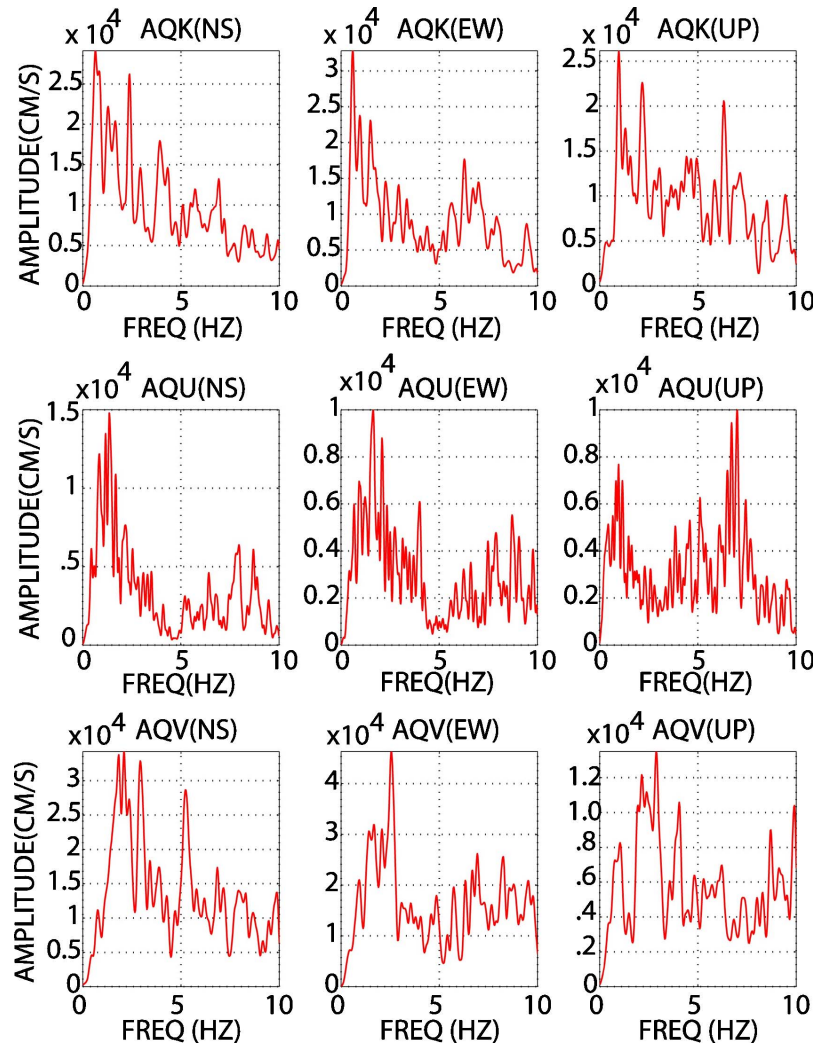
Figure 18. Comparison of amplitude spectra computed from accelerations recorded at AQQ, AQU, and Aqv.

Both the response spectra and amplitude spectra indicate similarities in frequency content of the motions recorded at AQK and AQU and definitely expose the fact that the shaking (in the free-field) is rich in frequencies in the ranges 1–4 Hz (0.25–1 s) and 5–8 Hz (0.12–0.2 s), which are similar to the fundamental frequencies of vibration of one-to-eight-story buildings in L'Aquila and in other parts of the region. This would be particularly true for less-stiff, strength-deficient, low-rise buildings that were damaged during the first shock and, as a result, may have responded with lengthened periods (shorter frequencies) putting them in the range of dominant frequencies of the input motions (as shown in Figure 18).

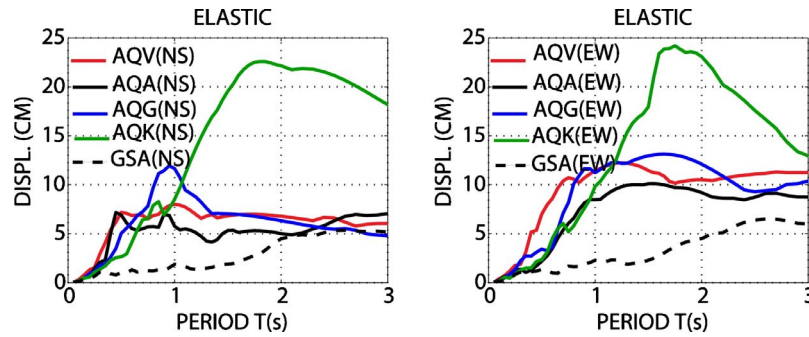
Figure 19. Elastic displacement spectra for five stations.

Analyzing the elastic displacement demand, d , (Figure 19), for the strong motion records not affected by the particular location of the instruments, it is possible to obtain a more realistic description of the seismic demand than the elastic acceleration spectra, compatible with the observed damage (Decanini et al. 2009). In the range between 0–1.0 seconds, the spectral displacements do not exceed 12 cm. Another interesting description of the destructive potential of earthquake ground motions compatible with the damage pattern can be obtained by the inelastic strength demand spectra (Decanini et al. 2009) in

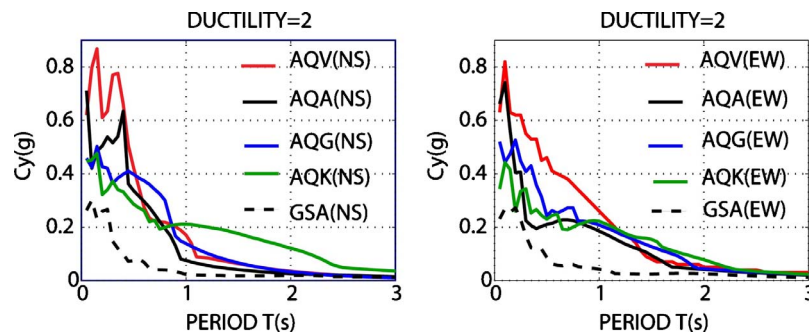
Figure 20. Inelastic strength demand spectra, C_y (g) for displacement ductility=2 (Decanini et al. 2009).

terms of C_y (i.e., the ratio between maximum base shear and conventional weight of the building, which accounts for dead loads and a fraction of the live loads), described in Figure 20 (for a displacement ductility $\mu=2$). The figure clearly demonstrates that, except for GSA, the inelastic demand ($C_y \sim 0.4\text{--}0.8$ g for $T < 0.5$ s in the NS direction and $C_y \sim 0.2\text{--}0.8$ g in the EW direction) on structures were very high, and for structures not well designed according to the seismic code, the demand far exceeded their capacities.

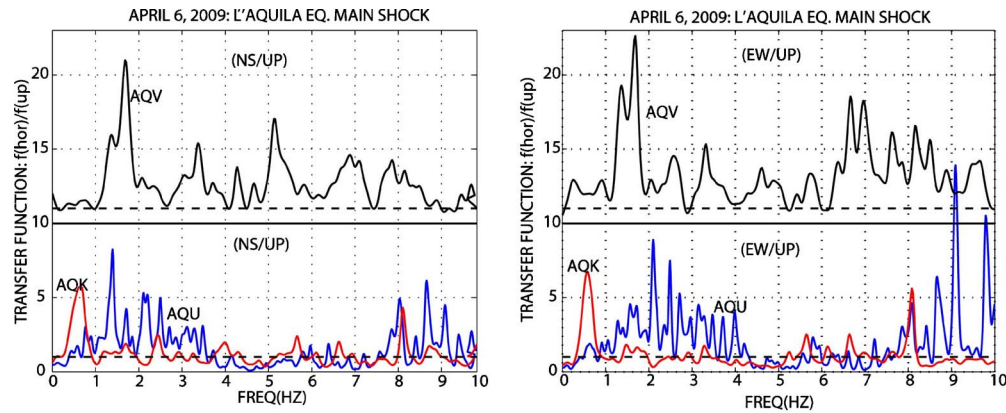
Figure 21. Transfer functions for AQR, AQU, and AQP computed by H/V ratios of amplitude spectra.

Figure 21 shows transfer functions computed from H/V ratios, using Nakamura's (1989) micro-tremor method, of smoothed amplitude spectra for AQK, AQU, and AQV. Clearly, the bands of amplified frequencies are different for the valley (AQV) as compared to AQK and AQU located at the perimeter of L'Aquila. For AQK, a clear amplification band is identified between $\sim 0.4\text{--}0.6$ Hz and at ~ 8 Hz. This is consistent with findings of De Luca et al. (2005). For AQU, it is apparent that there are resonances between 1–4 Hz and between 7.5–10 Hz—clearly in the range of frequencies for typical one-to-

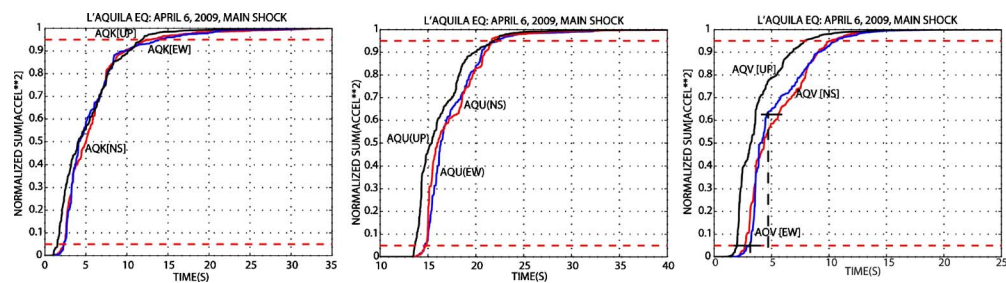
Figure 22. Cumulative sum of squared acceleration at AQR, AQU, and AQP indicate the strong shaking duration (90% of the energy) to be between 3–10 seconds and that 60% of strong shaking occurs within about 3–5 seconds.

As demonstrated by the comparative normalized cumulative sum of squared acceleration (which can also be described as Arias Intensity, or comparative energy) plots in Figure 22 for stations AQR, AQU, and AQP, the duration of strong shaking, as indicated by the records is short. Hence, the strong shaking damaged the majority of deficient structures within a couple of cycles rather than sustained/prolonged displacement excursions. If the effective duration had been longer at higher level of accelerations, displacement demands would have been higher. Certainly, the region is capable of generating

larger events (e.g., the $M_w=7.0$ event in 1915). Furthermore, Figure 22 shows that approximately 90% of the energy affected the structures within 3–10 seconds, and in the case of AQV, 60% of the energy affected the structures within a duration of about 2 seconds or less. Longer-duration shaking would certainly exhibit different statistics on collapsed buildings.

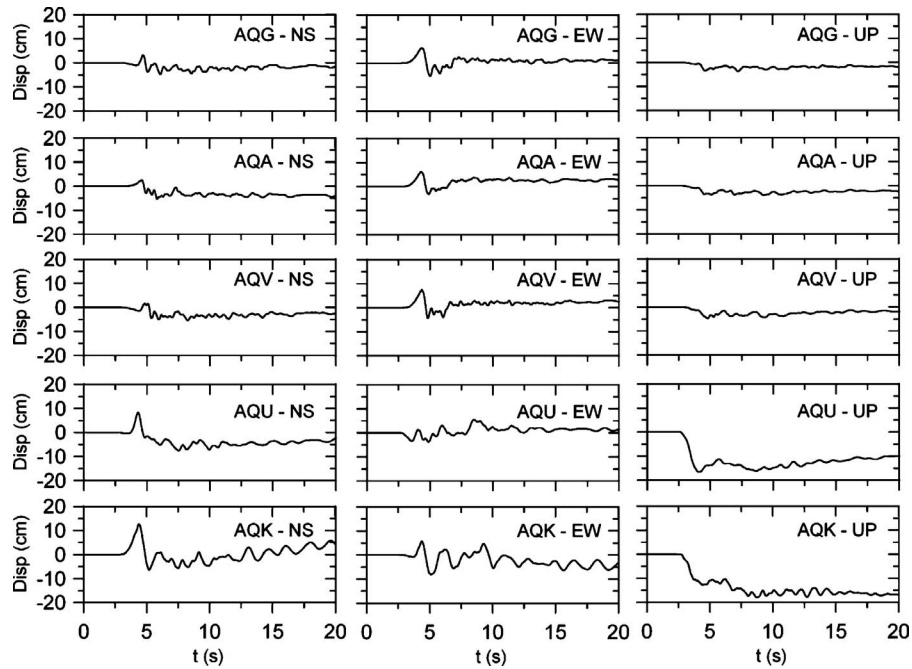
Figure 23. Coherent displacement time series at the Aterno Valley stations (AQG, AQA, AQV) and at L'Aquila stations (AQU, AQK): (a) NS, (b) EW, and (c) UP components. To obtain displacements, acceleration records were processed by a baseline correction technique, consisting of least-squares fitting the velocity time histories by three consecutive line segments, and removing them from velocity (from [Paolucci and Smerzini 2010](#)).

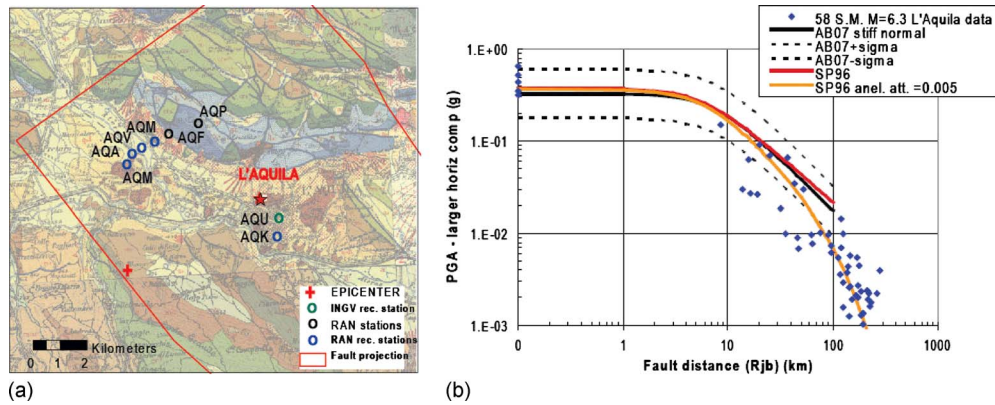
Figure 24. (a) Details of the strong motion stations closest to the epicenter, including the AQU-INGV station, together with the surface projection of the ruptured fault superimposed on the geological map. AQF and AQP only recorded the aftershocks. (b) Comparison of PGA values recorded for the main shock with different attenuations (AB07—Akkar and Bommer 2007, plotted for the case of normal fault and stiff site conditions; SP96—Sabetta and Pugliese 1996) showing as the introduction of an anelastic coefficient=0.005 into Sabetta-Pugliese equation that vastly improves distant data fit (Sabetta et al. 2009)

In the first case, the distance definition, called the Joyner-Boore distance definition (R_{JB}) (Boore et al. 1997) is the closest distance from the recording station to the surface projection of the rupture fault plane. Figure 24 compares the PGA (the larger of the horizontal components) of L'Aquila earthquake with two European GMPEs utilizing R_{JB} definition (Sabetta and Pugliese 1987, 1996 [SP96] and Akkar and Bommer 2007 [AB07]). The latter is a prediction equation based on 532 accelerograms from Europe and the Middle East, recorded from 131 earthquakes with moment magnitudes ranging from 5 to 7.6. As can be expected, because of the rupture plane is physically under many of the recording stations as seen in Figure 24 (left), the data from the closest stations falls on an R_{JB} distance of 0 km right at the axis. The data from stations on the hanging wall of the fault are underpredicted even if they are included in the uncertainty bounds of the Akkar and Bommer (AB07) equation (dashed line = ± 1 standard deviation). Concerning the data at larger distances, it is interesting to point out that the simple inclusion of an anelastic coefficient ($0.005 \times \text{distance}$) in SP96 (orange curve) fits the data very well. In fact, it is only recently that the availability of high sensitivity digital instruments has made accessible very low ground accelerations recorded at large distances that show the effect of the anelastic attenuation generally not considered in common GMPEs using strong motion data up to distances of 100–200 km.

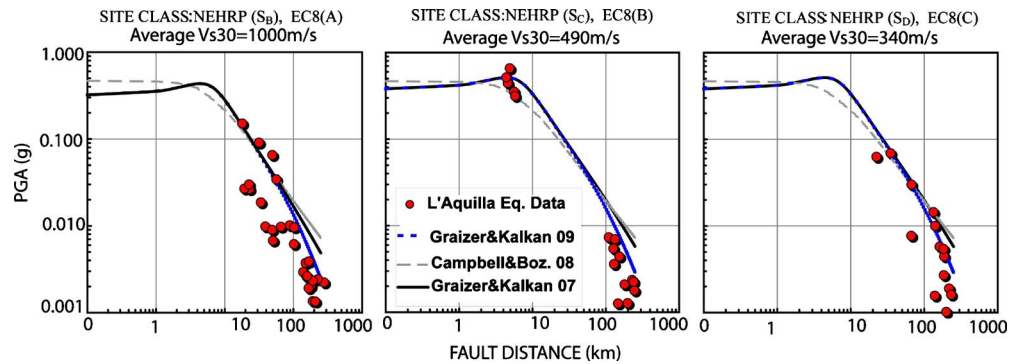
Figure 25. Comparison of maximum peak horizontal ground acceleration of L'Aquila earthquake with predictions from four GMPEs for EC8 site categories A, B, and C.

(<10 km) becomes important and shows some of the recorded PGAs above the GMPEs, particularly for the first case. For distances up to 100 km, the recent GMPEs (Sabetta et al. 2009, Graizer and Kalkan 2007) better predict the recorded data.
