BEHAVIOR OF REINFORCED WALL SYSTEM DURING THE 1999 KOCAELI (IZMIT), TURKEY, EARTHQUAKE

A four-span bridge together with a 10 m-high and 100 m-long bridge approach fill was one of the highway facilities damaged due to surface faulting along the Trans-European Motorway during 1999 Kocaeli Earthquake (Mw 7.4). The fault rupture crossed beneath an overpass bridge within a few meters away from the bridge abutment while damaging the approach fill which was reinforced with a double-faced mechanically stabilized earth wall (MSEW) system. The faulting-induced excessive tectonic ground deformations including near-field seismic shakings were the main sources of damage in the walls. Such effects, along with the others, caused cracks and panel separations in wall faces as a result of a liquefaction-induced differential settlement in the cross section. The performance of the reinforced walls was satisfactory that there was no significant structural damage despite the total collapse of the bridge decks. The wall system provided a unique case history under extreme loading conditions, while proving that they are flexible and can withstand large ground deformations. This paper discusses how the wal

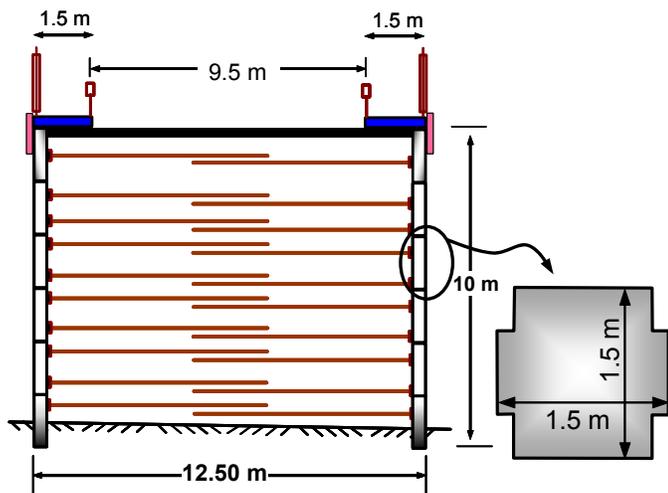
Fig 3. Schematics of double-faced gravity-type MSEW system with reinforced concrete facing panels in Arifiye.

found to be costly as it also required a pile-cap system for each pier. Thereafter, a gravity-type retaining wall system (i.e., Reinforced Earth®) was directly constructed on the ground. This reinforced wall system was selected not only as an economical construction method but also because it could be an effective method for withstanding large consolidation deformations from the compressible poor quality foundation soil (Smith and Unal, 1992). A 100 m-long MSEW system was built as a “double-faced” or “back-to-back” type wall, having parallel reinforced concrete facings with ripped metallic reinforcing inclusions to accommodate a two-way divided roadway as shown in Fig. 3.

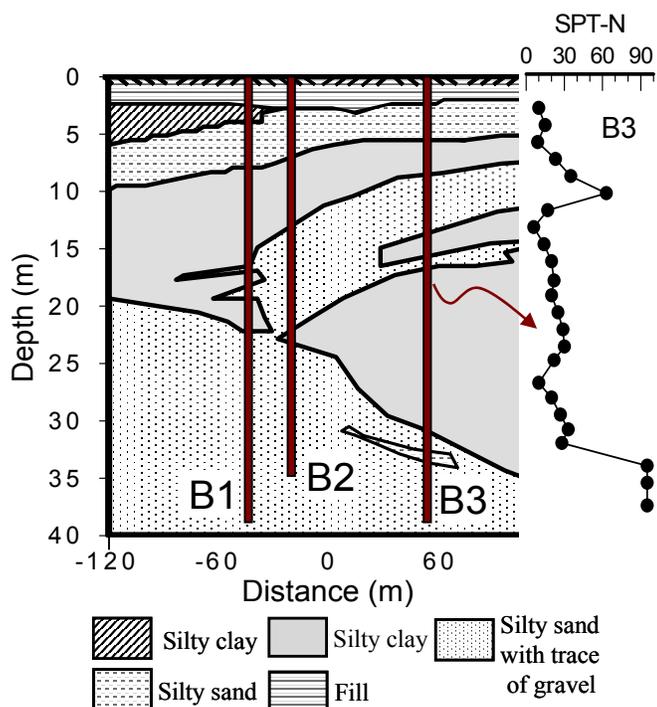
Fig 4. An approximate visualization of subsoil geology along the axis of Arifiye Overpass (modified based on ITU, 1999).

Standard penetration tests (SPT) were conducted by the Turkish General Directorate of Highways (GDH) to gain sufficient subsurface information between both ends of the bridge overpass soon after the earthquake. Three subsurface borings to a depth of 38 m were drilled. Their locations are shown as B1, B2 and B3 in Fig. 2a. A 2-D visualization for the local subsoil conditions along the axis of the bridge overpass is shown in Fig. 4. The ground water table was approximately 5 m below the ground surface.

B1 shows that very soft layers of soil deposits lie under the southern abutment and extend to a depth of 22 m where a dense ($N_{30}=100$) layer of sedimentary deposit (i.e., Pliocene base rock) of silty sand with some gravel was encountered. The loose layers became thicker to the depth of 34 m below the northern abutment as shown in B3, which was the nearest boring to the MSE walls. The soil profile at B3 consisted of a 2.5m-thick fill followed by varying thicknesses of silty sand and silty clay deposits. Loose silty sand and silty clay layers (with $N_{30}< 20$, Fig. 4) below the reinforced walls might have been prone to liquefaction or seismic-induced densification during the seismic
