# Highlights of Worst Devastation in Turkey

- Two back-to-back M7.8 and M7.6 earthquakes occurred in Eastern Turkey within 9 hours
- Affected 15 highly populated provinces
- Over 47,000 people lost their lives
- More than 5,000 buildings collapsed

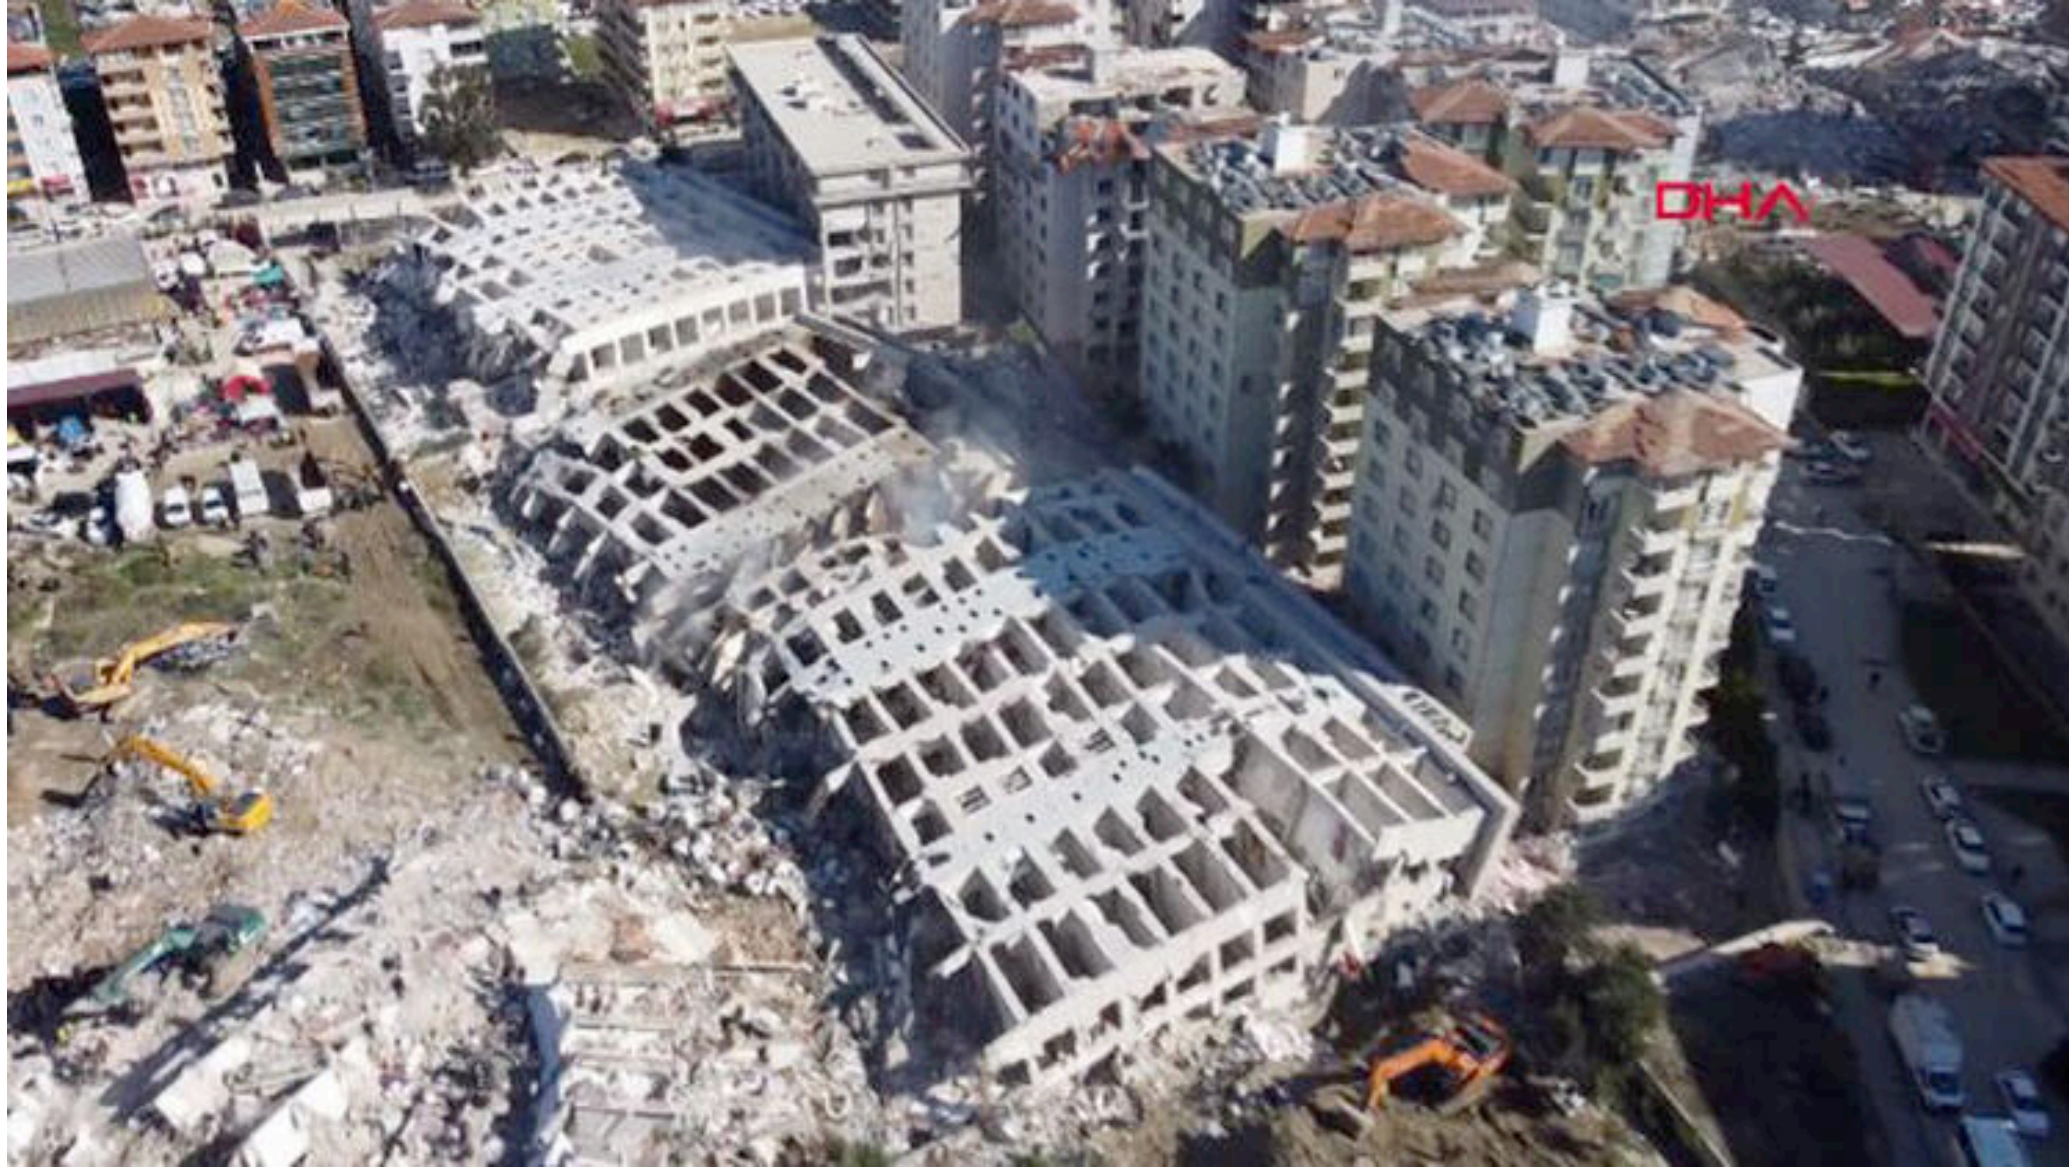
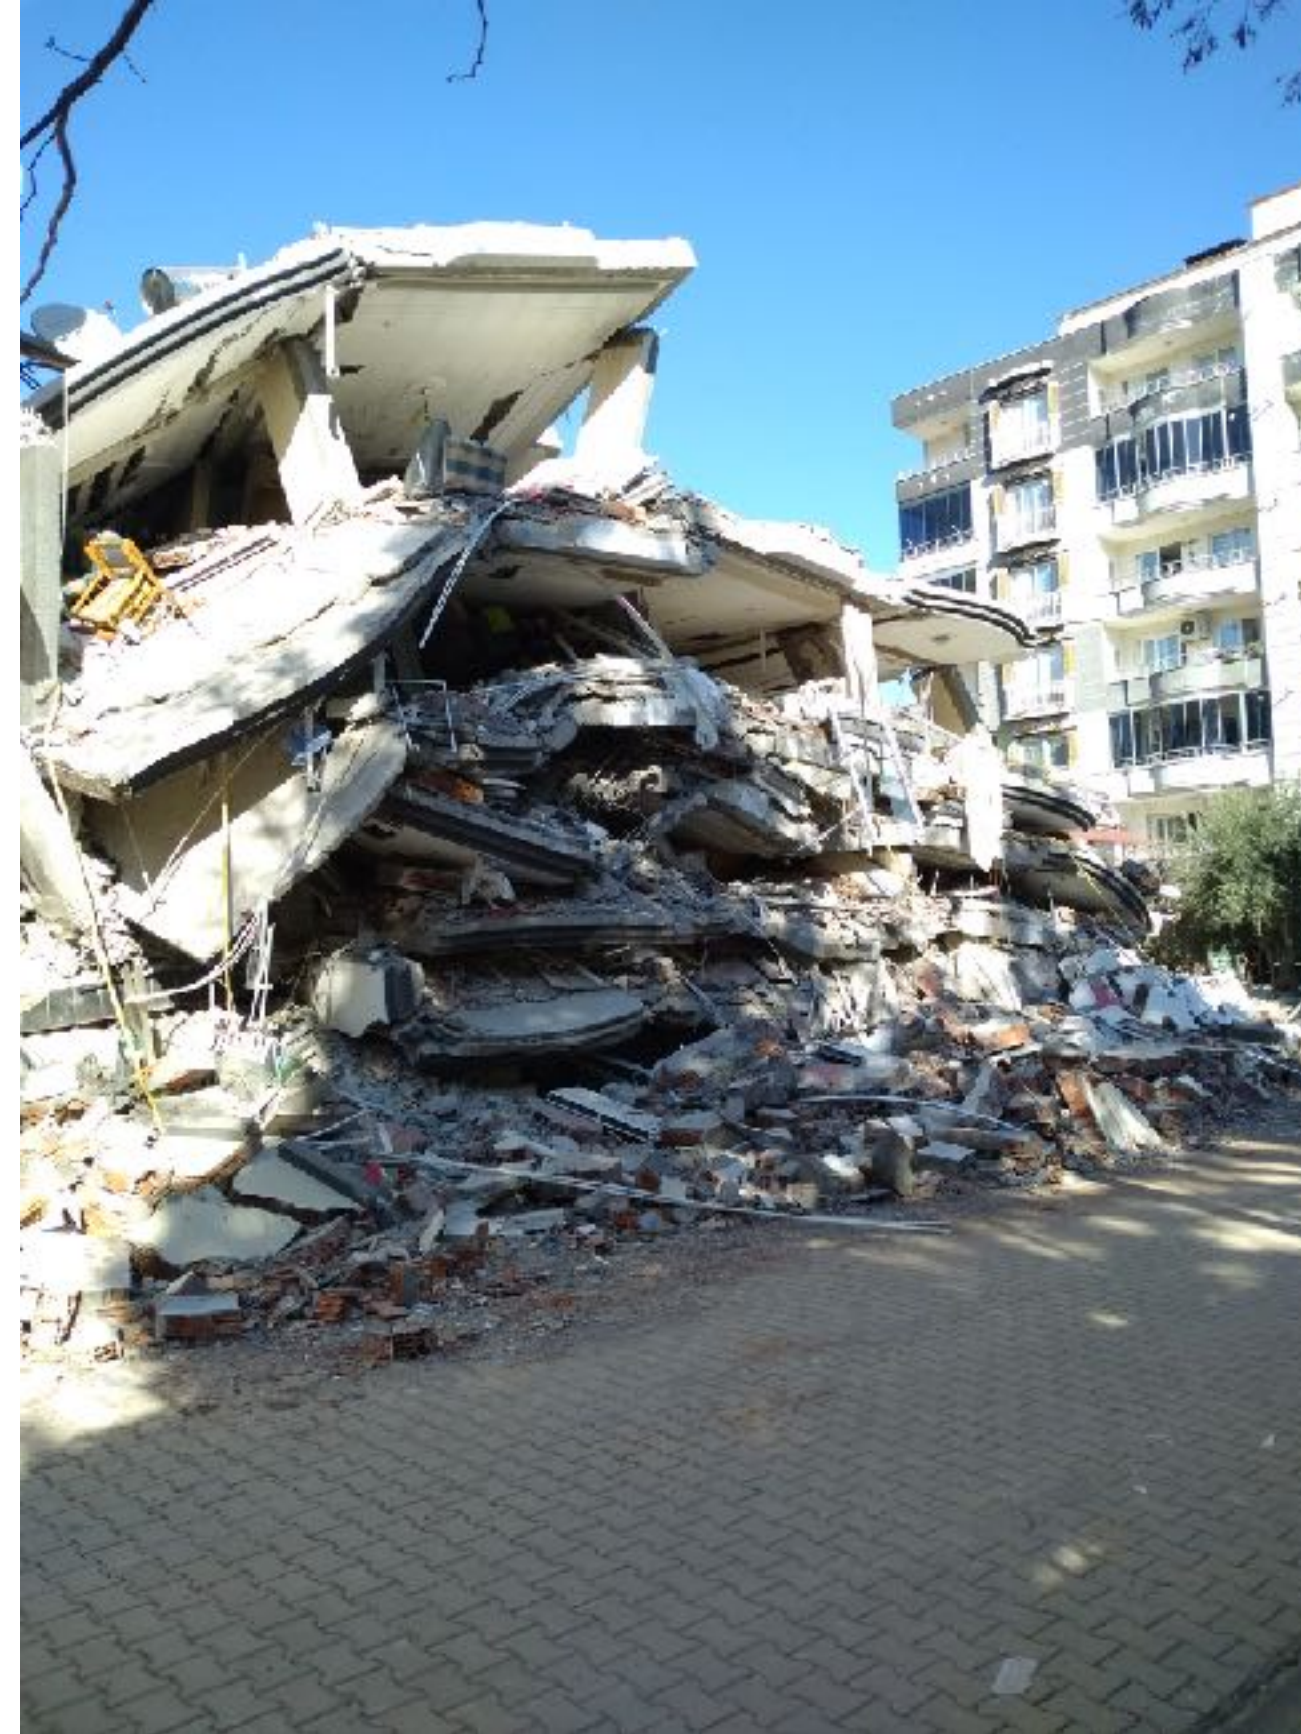
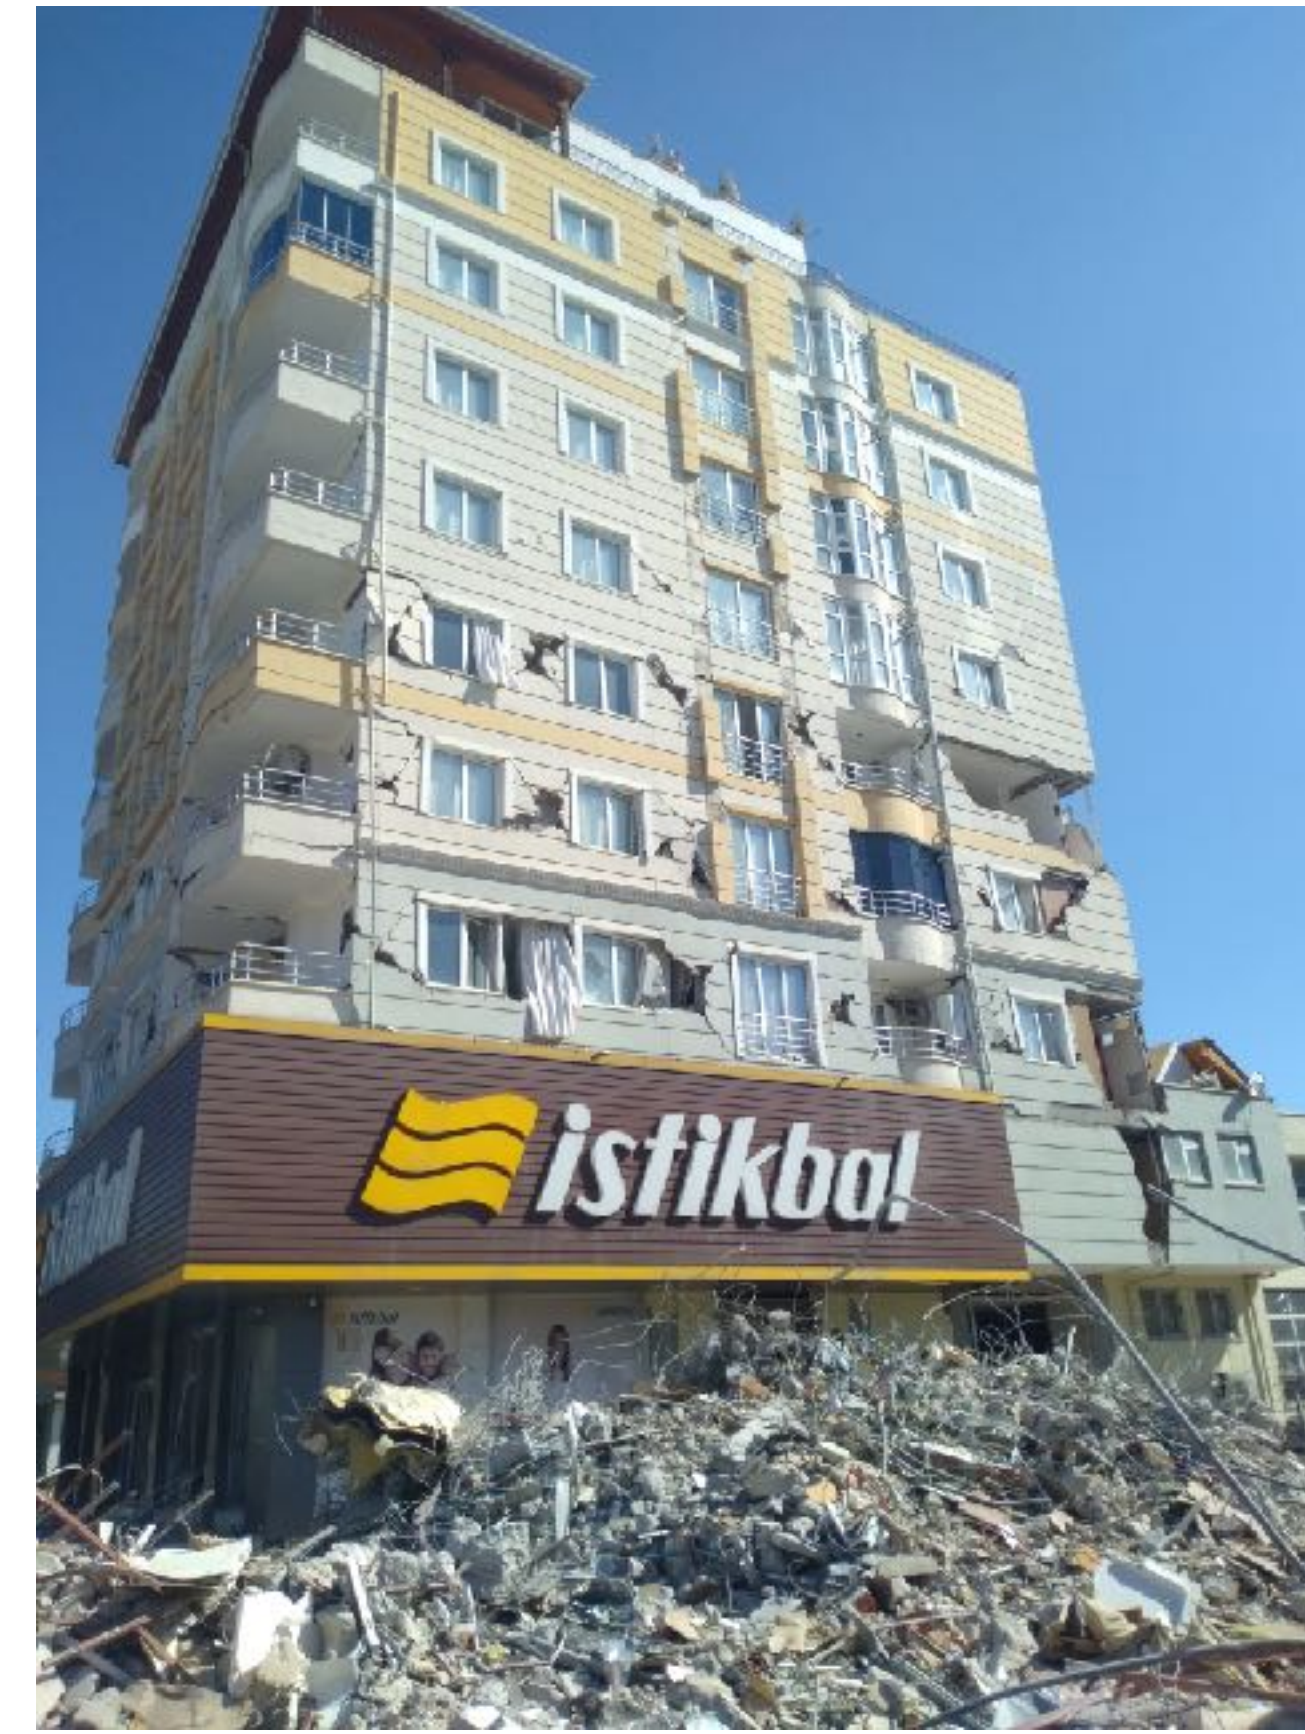
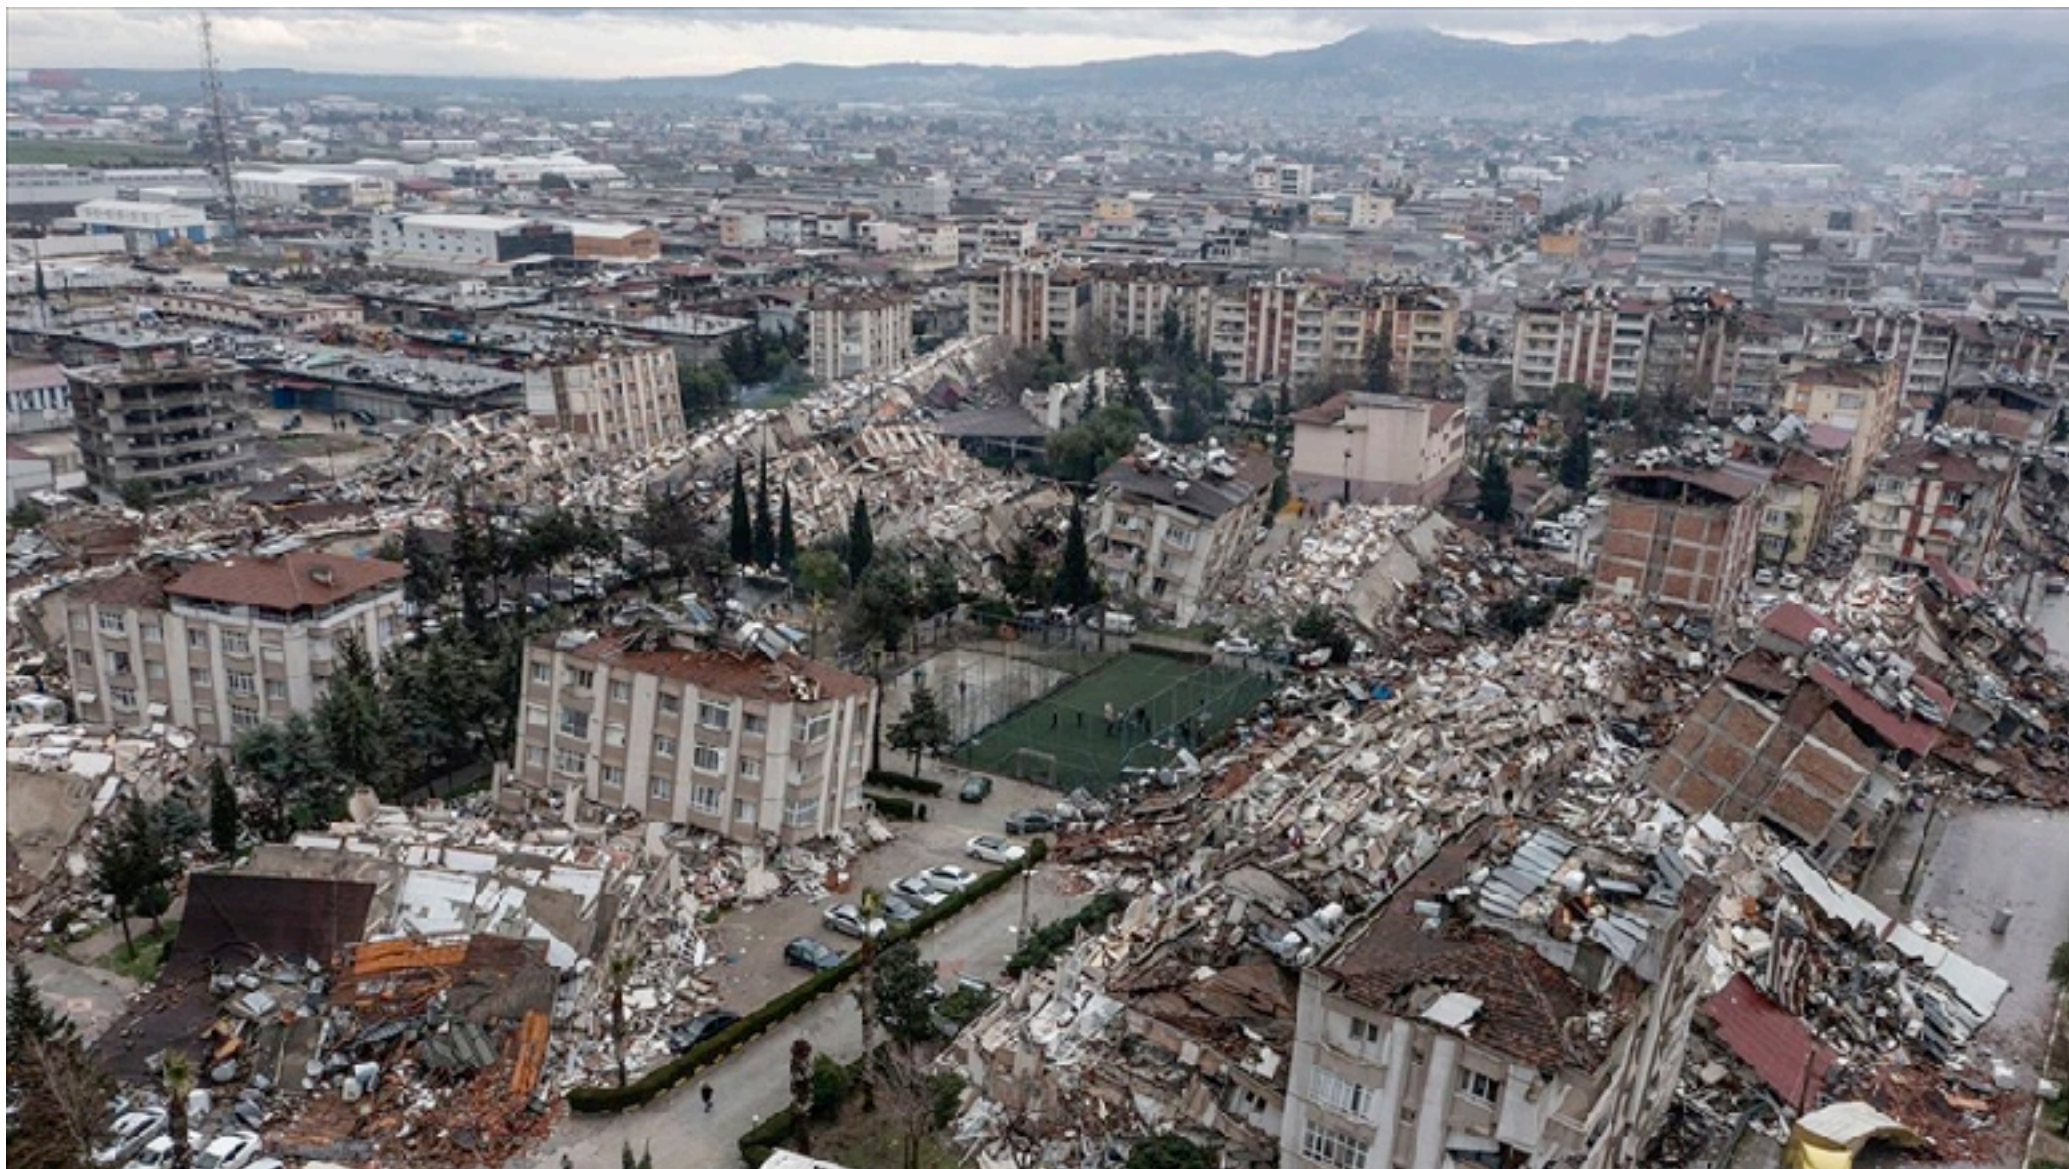
# Earthquake Damage

- The severity of structural damage in the city of Hatay could be due to several factors, including the earthquake's proximity to the city, the local geology and soil conditions, the age and quality of the buildings, and the area's vulnerability to earthquakes.
- One observation from ground motion data is so striking that peak ground velocity (PGV) reached 188 cm/s at the seismic station in Hatay. This is the largest PGV recorded during this earthquake.

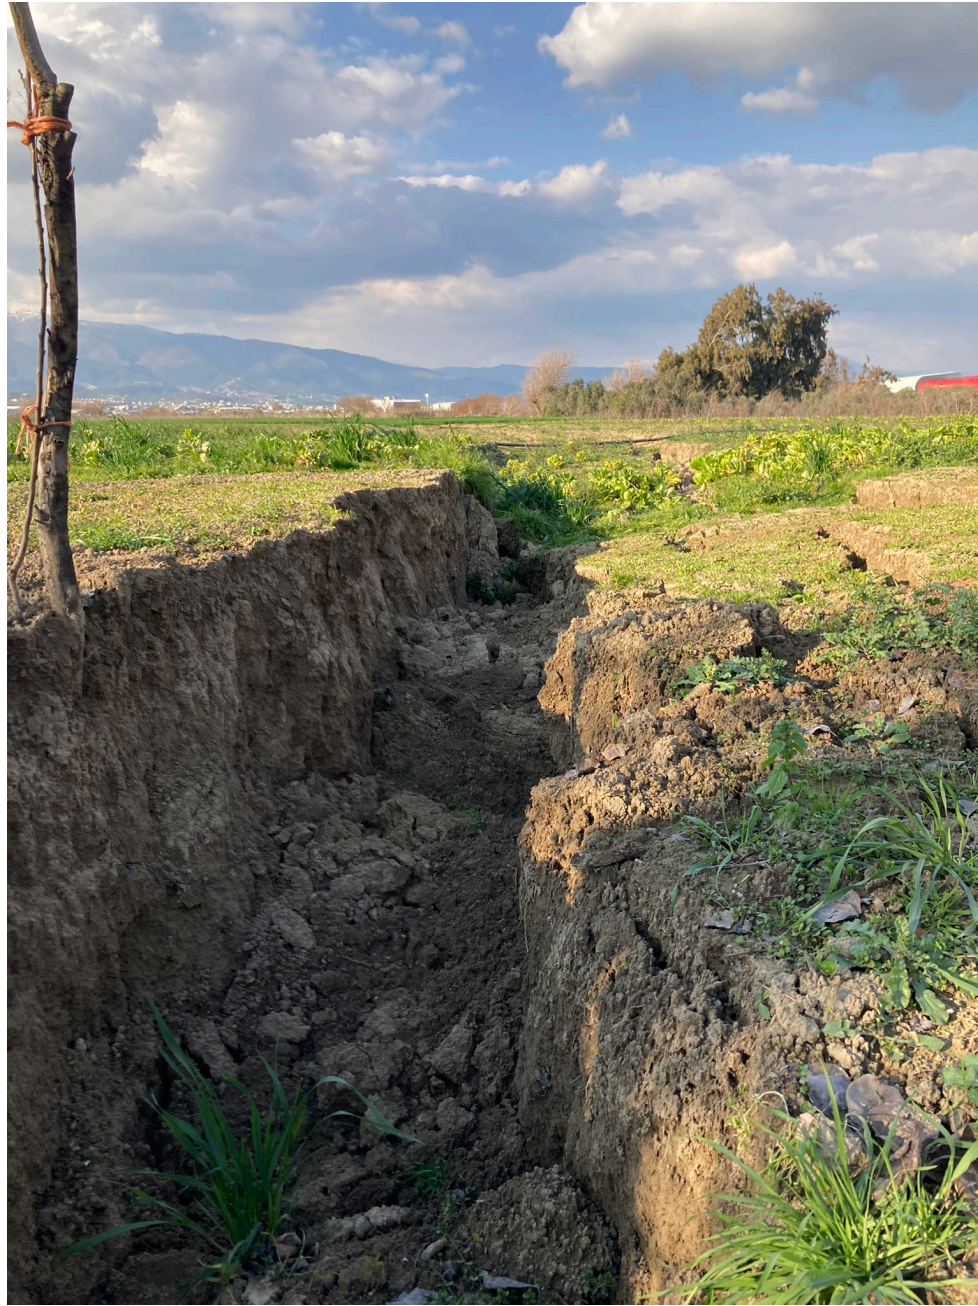
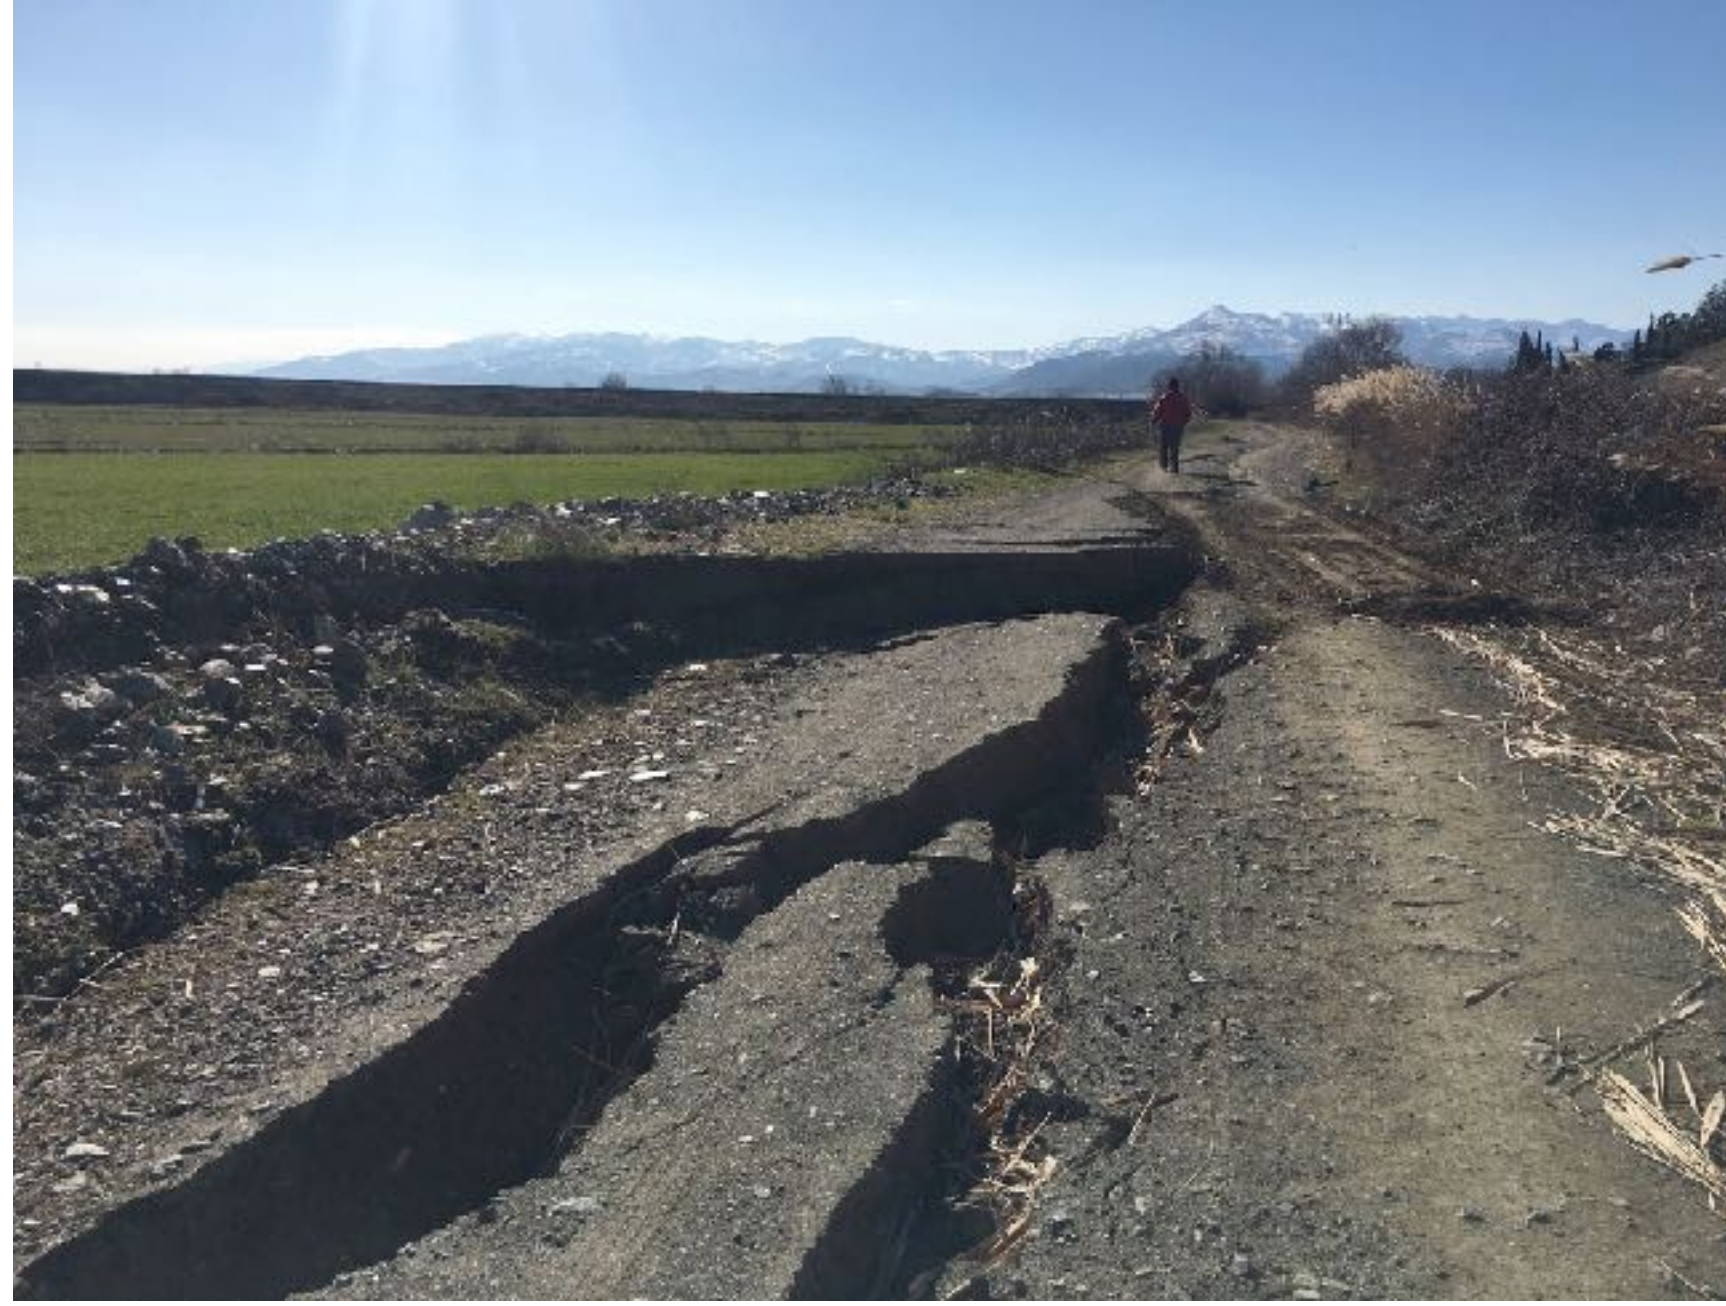
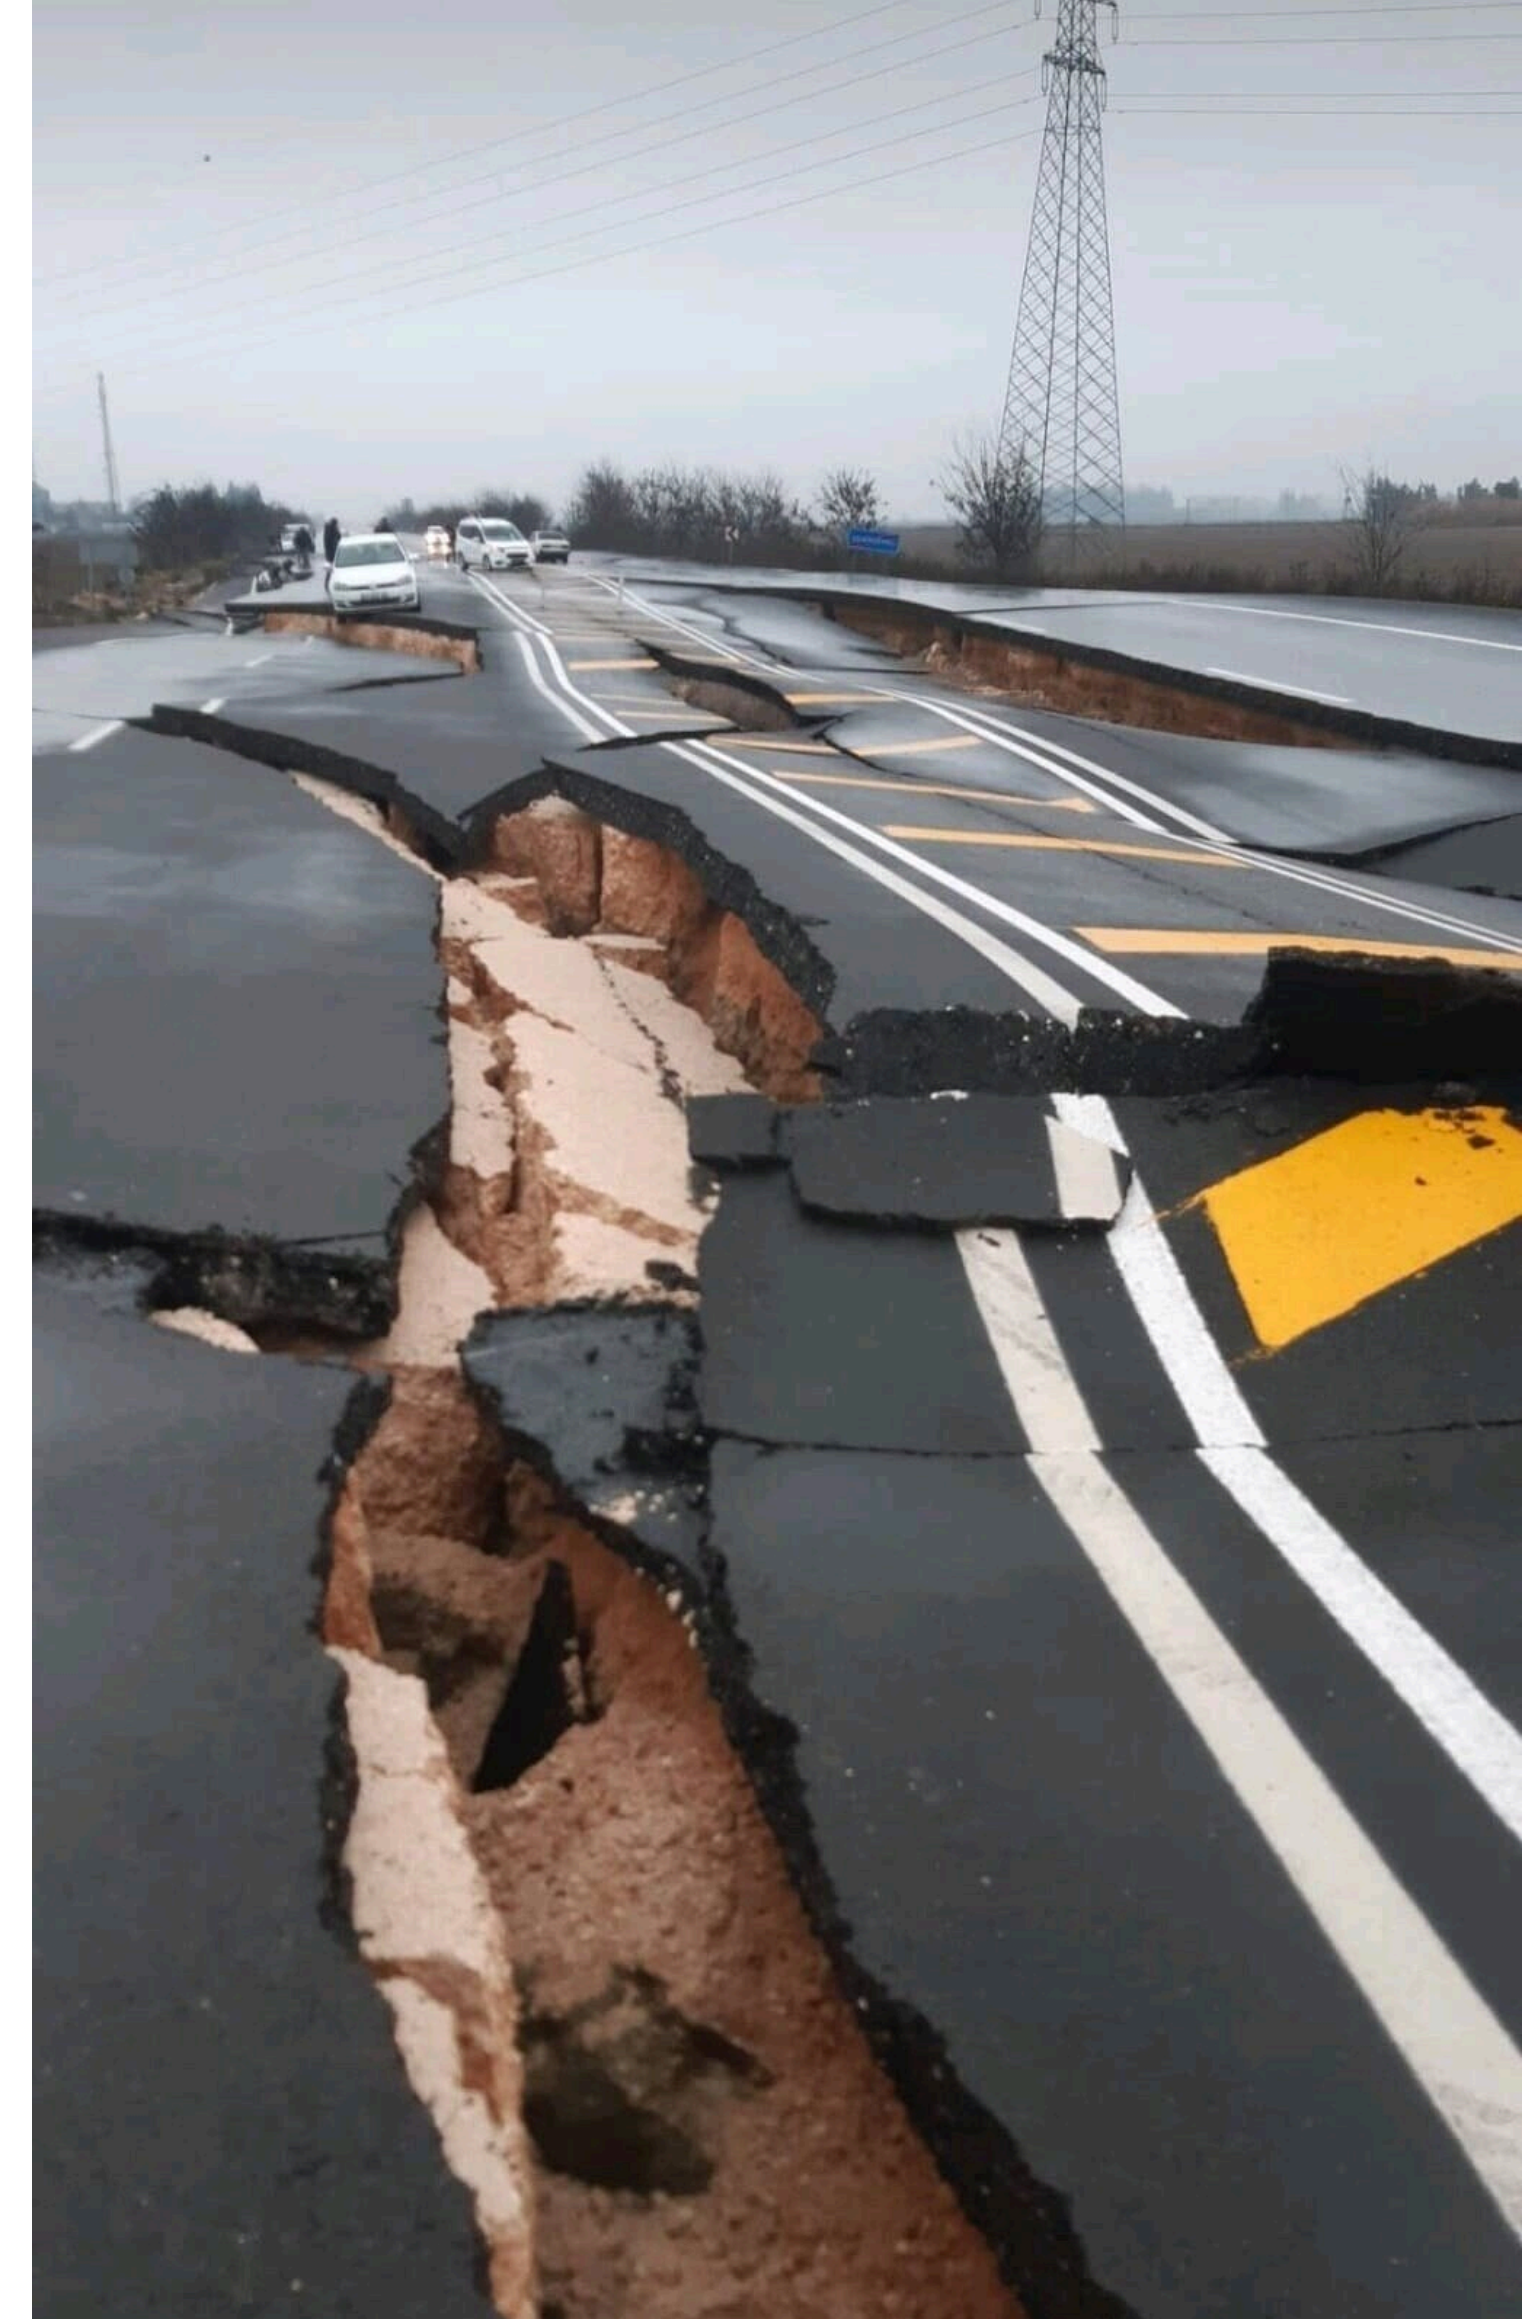
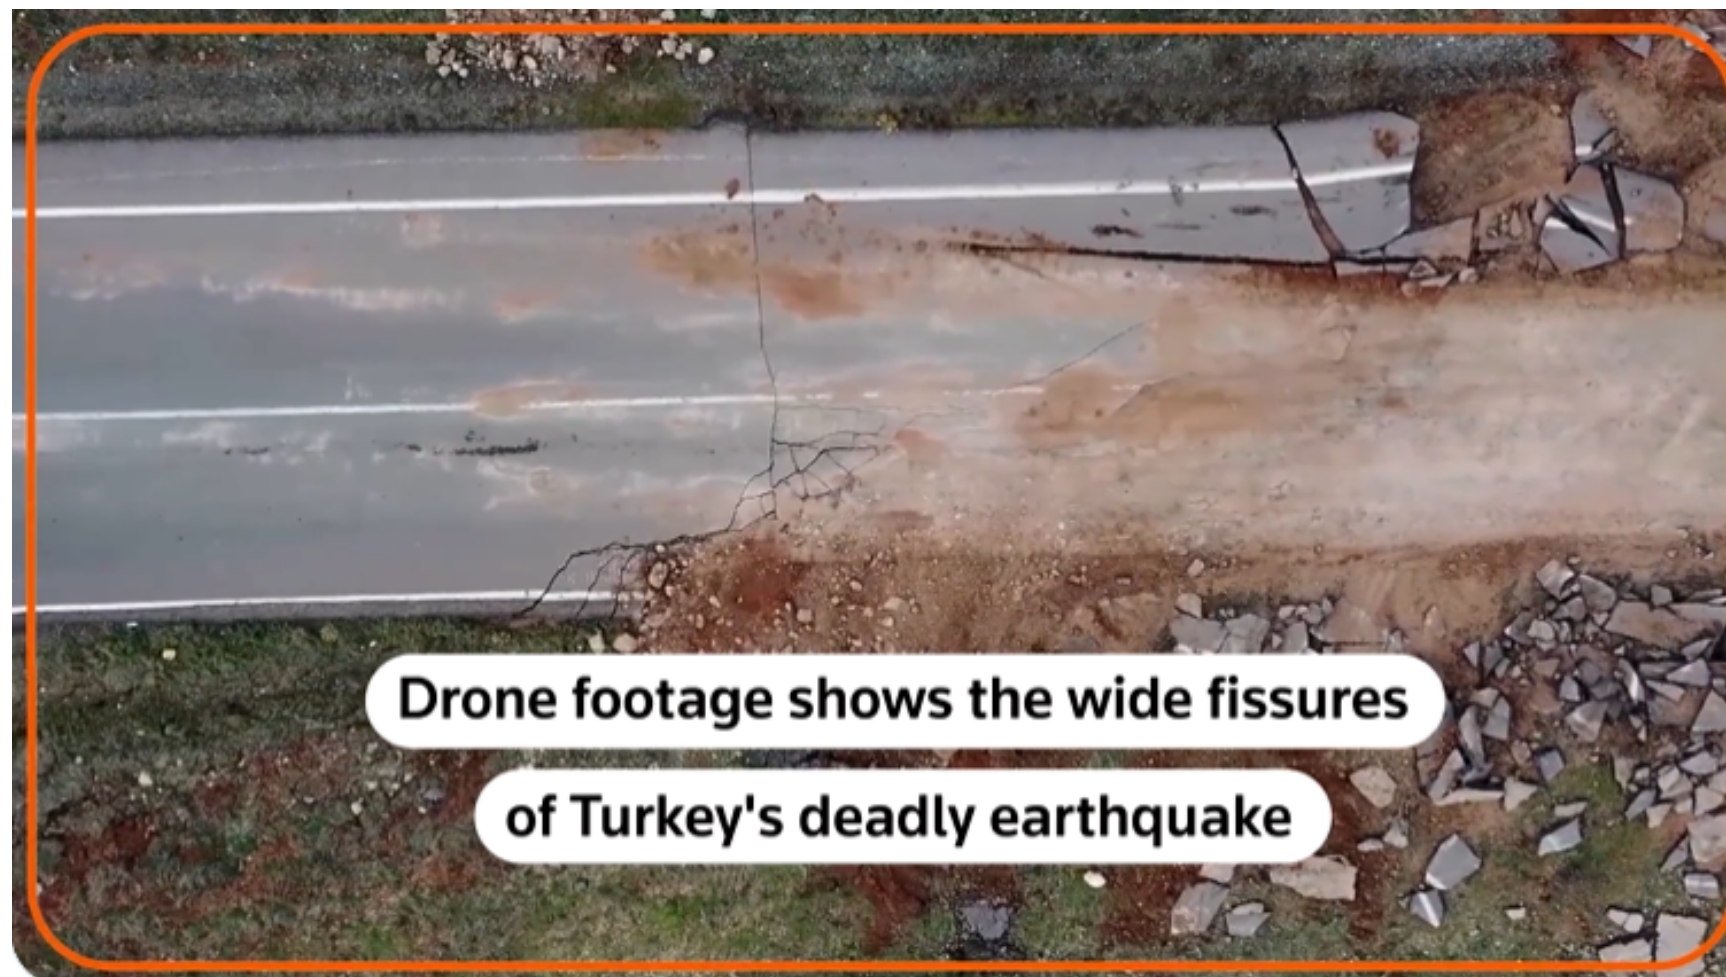
# Ground Failure & Surface Rupture

Drone footage shows the wide fissures  
of Turkey's deadly earthquake
