# Highlights of Worst Devastation in Turkey

- Two back-to-back M7.8 and M7.6 earthquakes occurred in Eastern Turkey within 9 hours
- Affected 15 highly populated provinces
- Over 47,000 people lost their lives
- More than 5,000 buildings collapsed

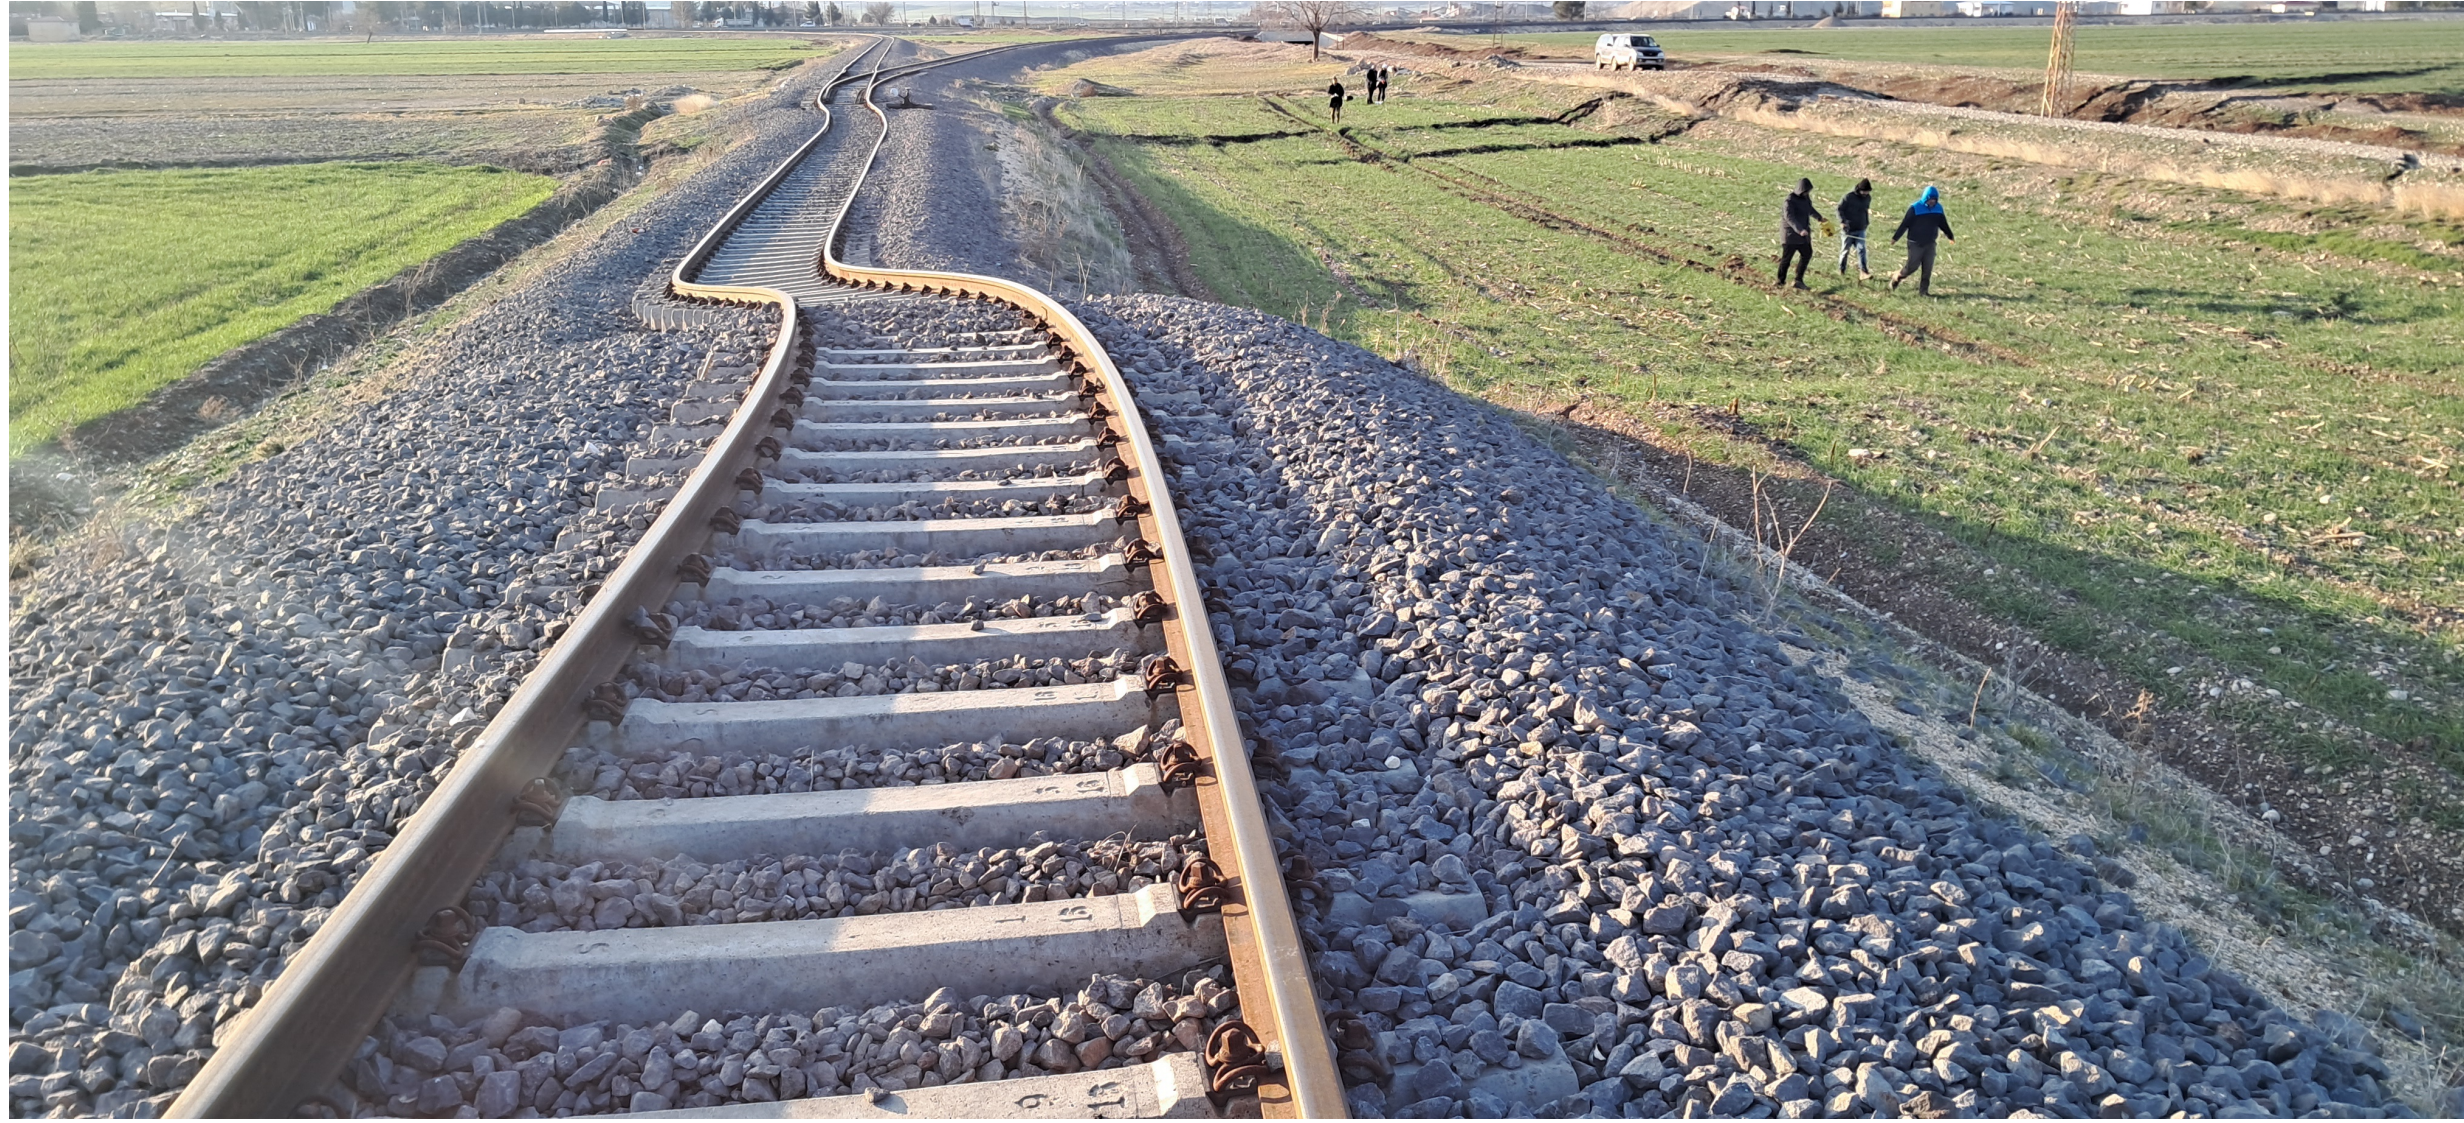
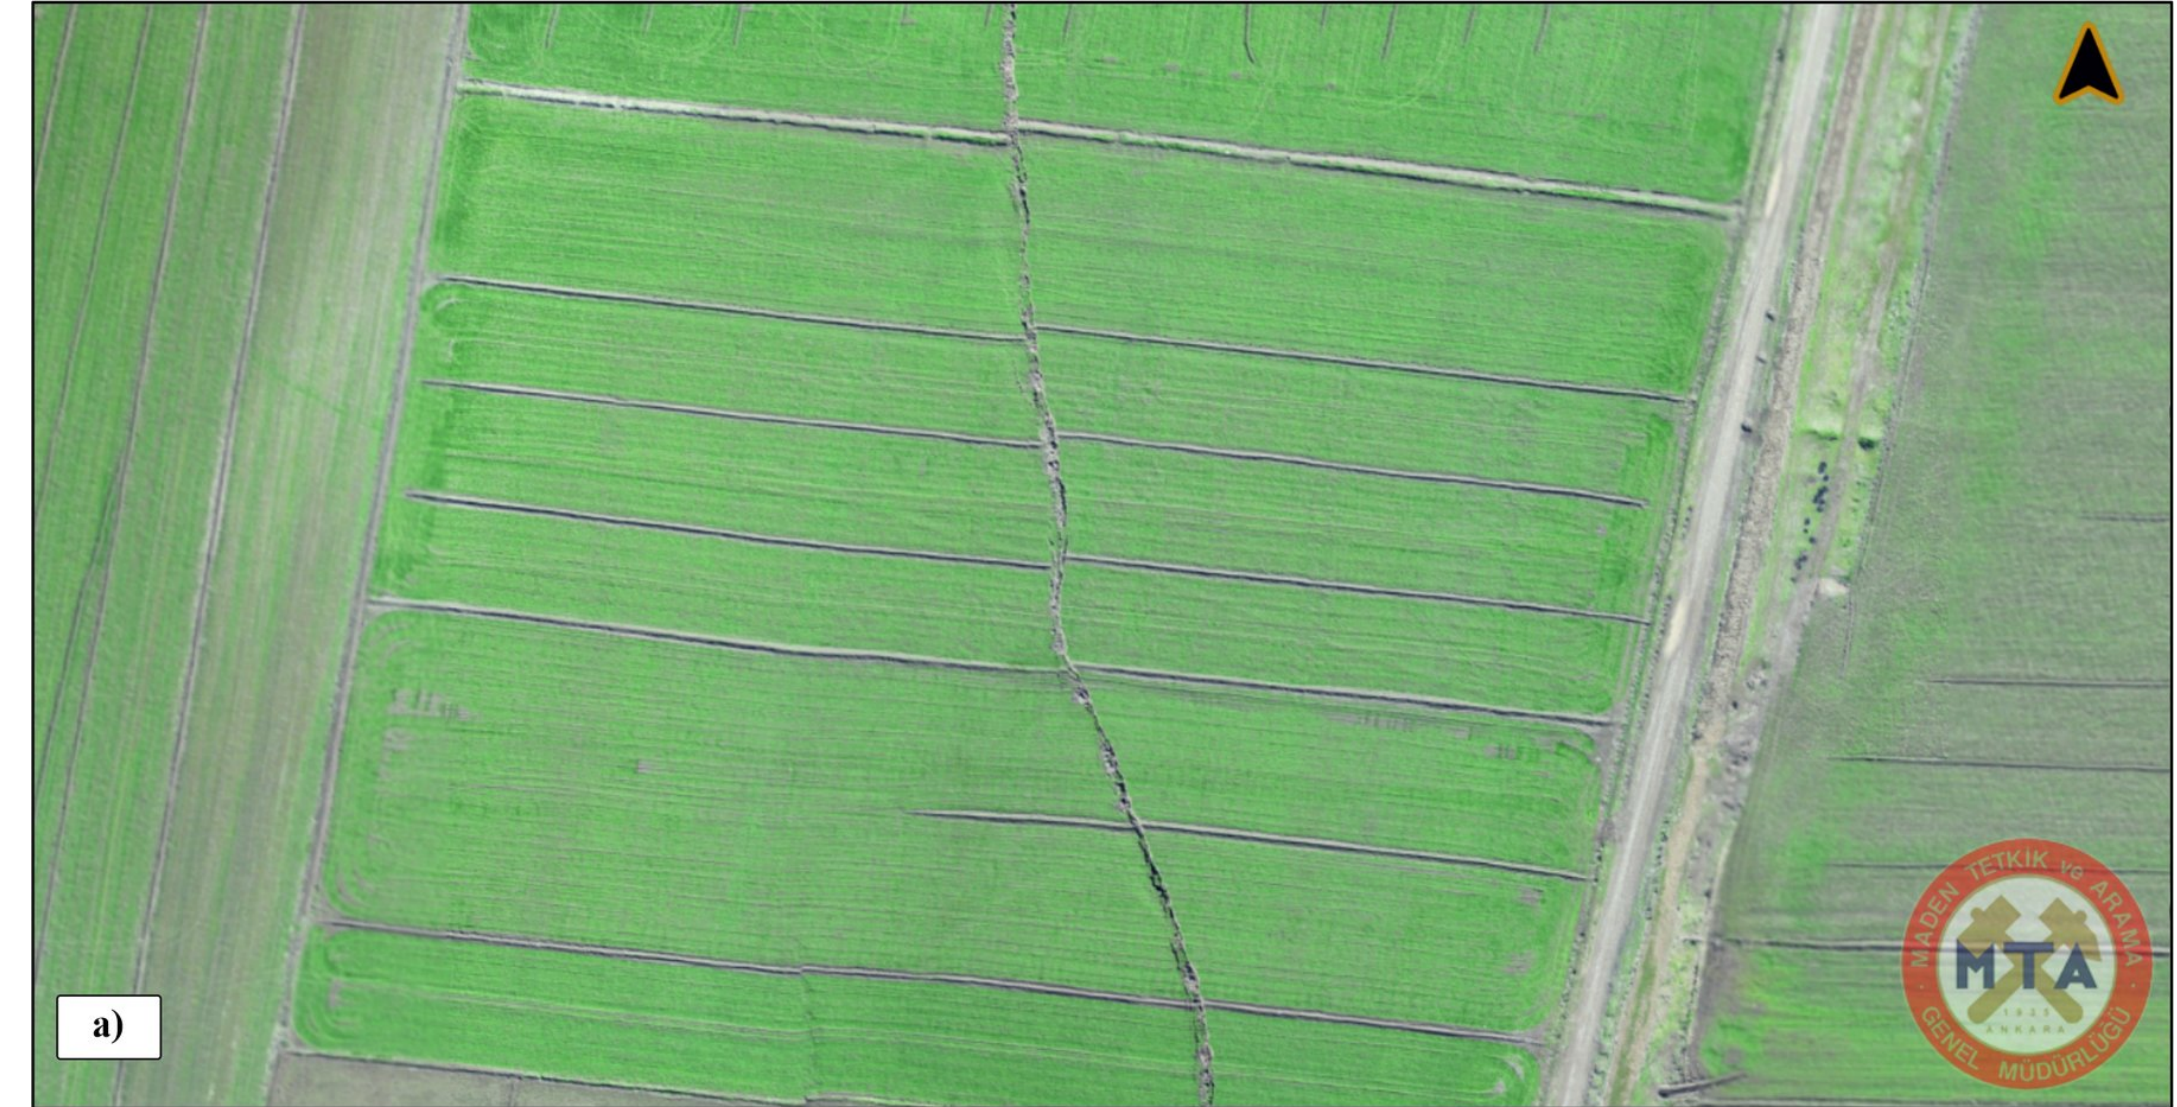
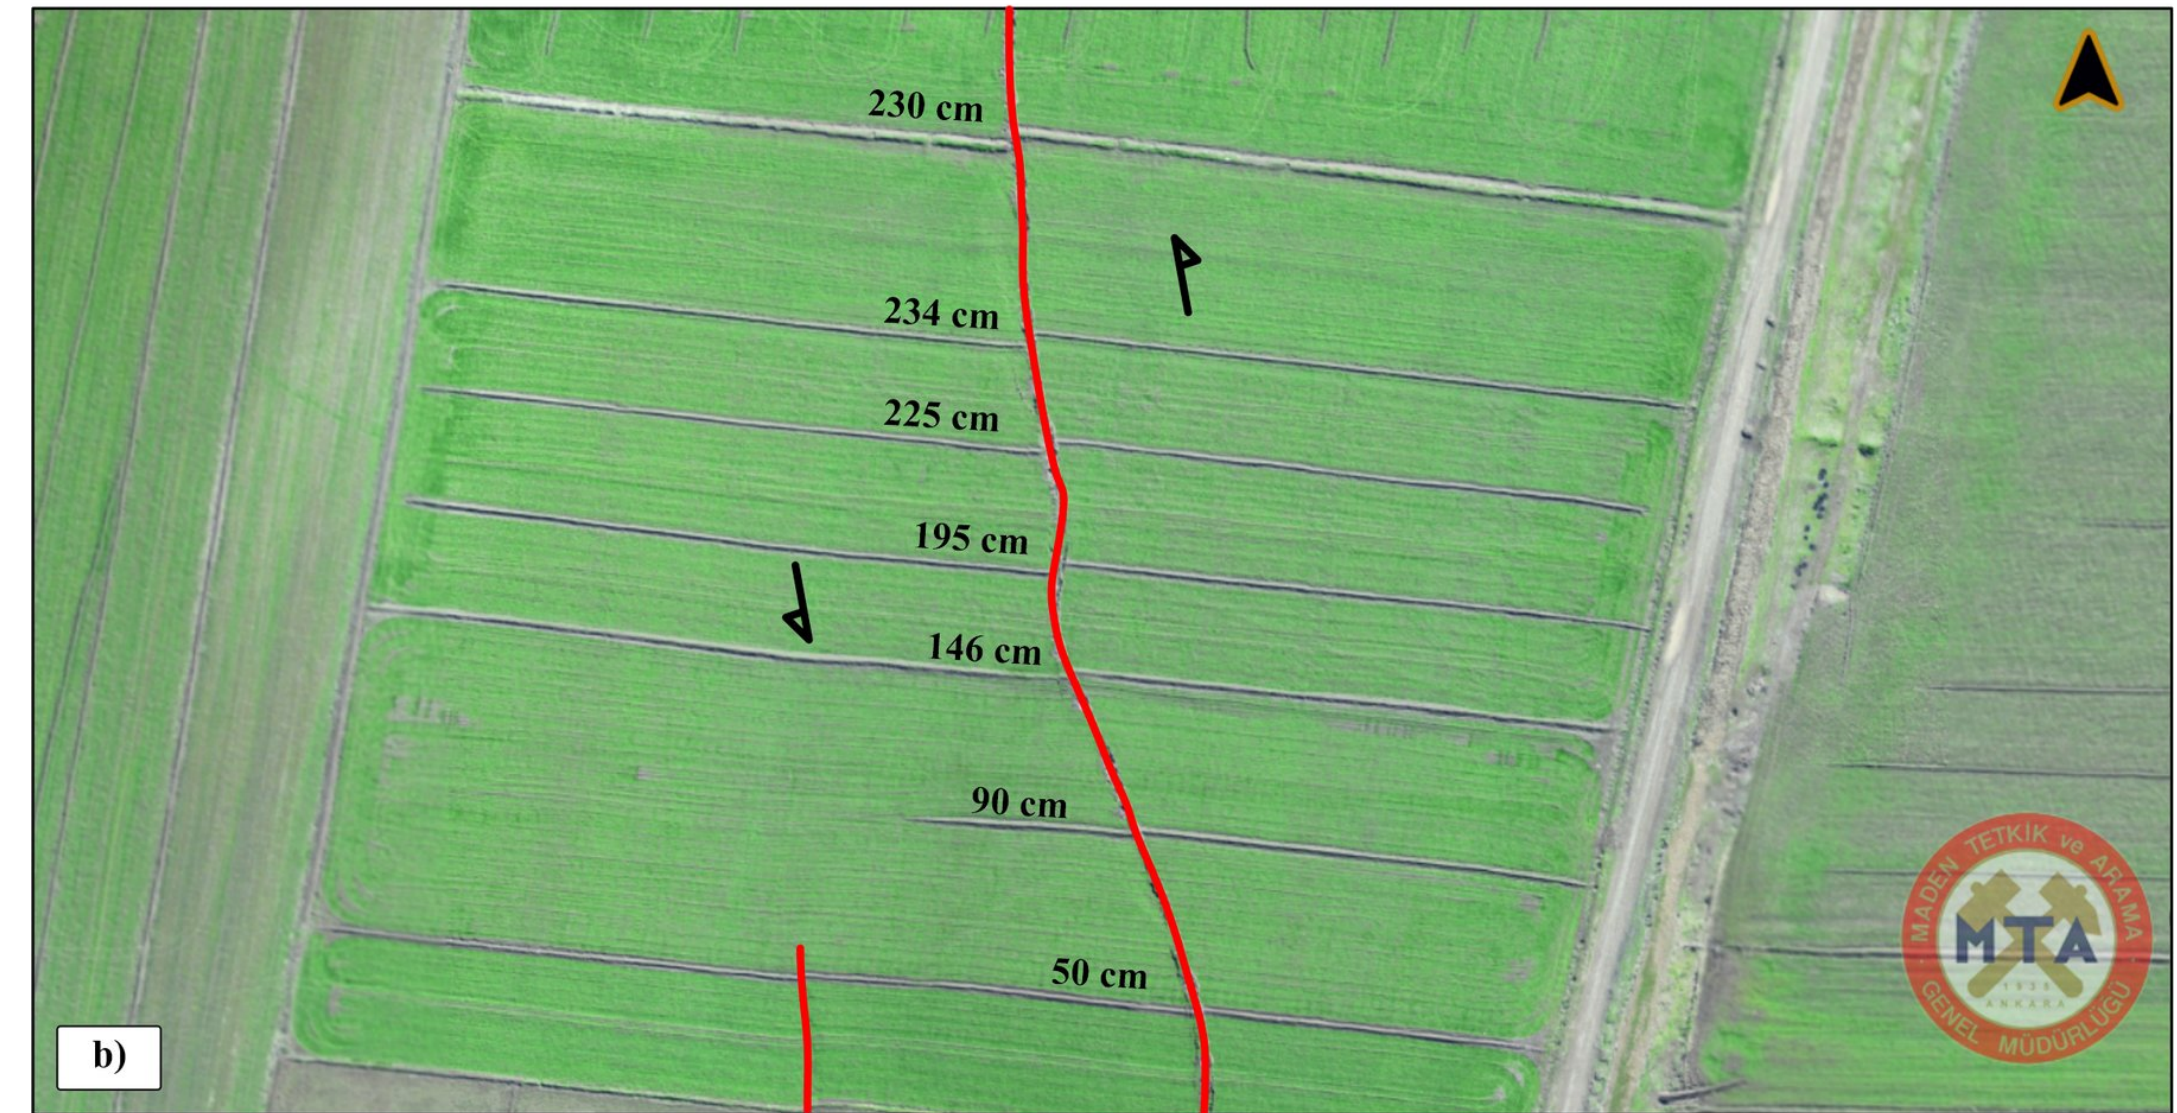
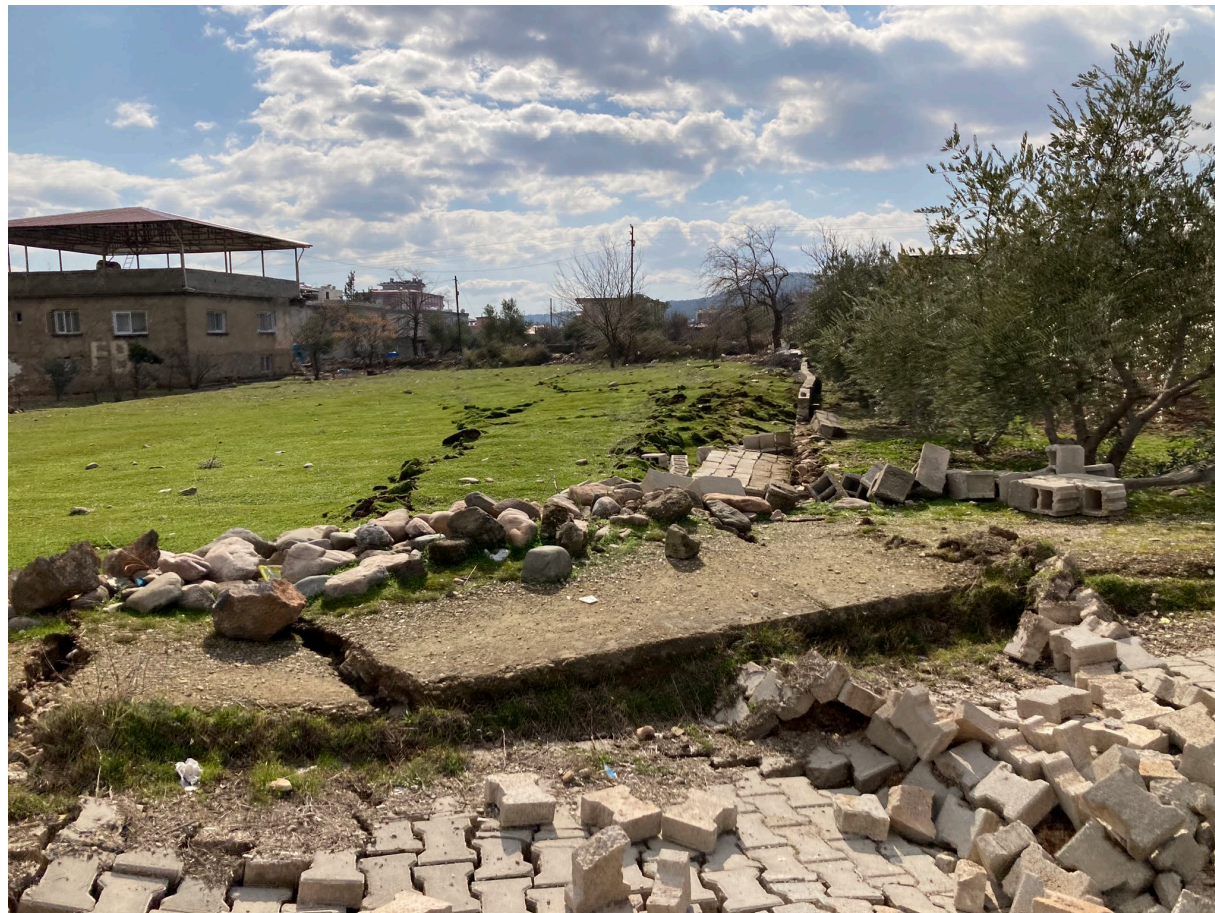
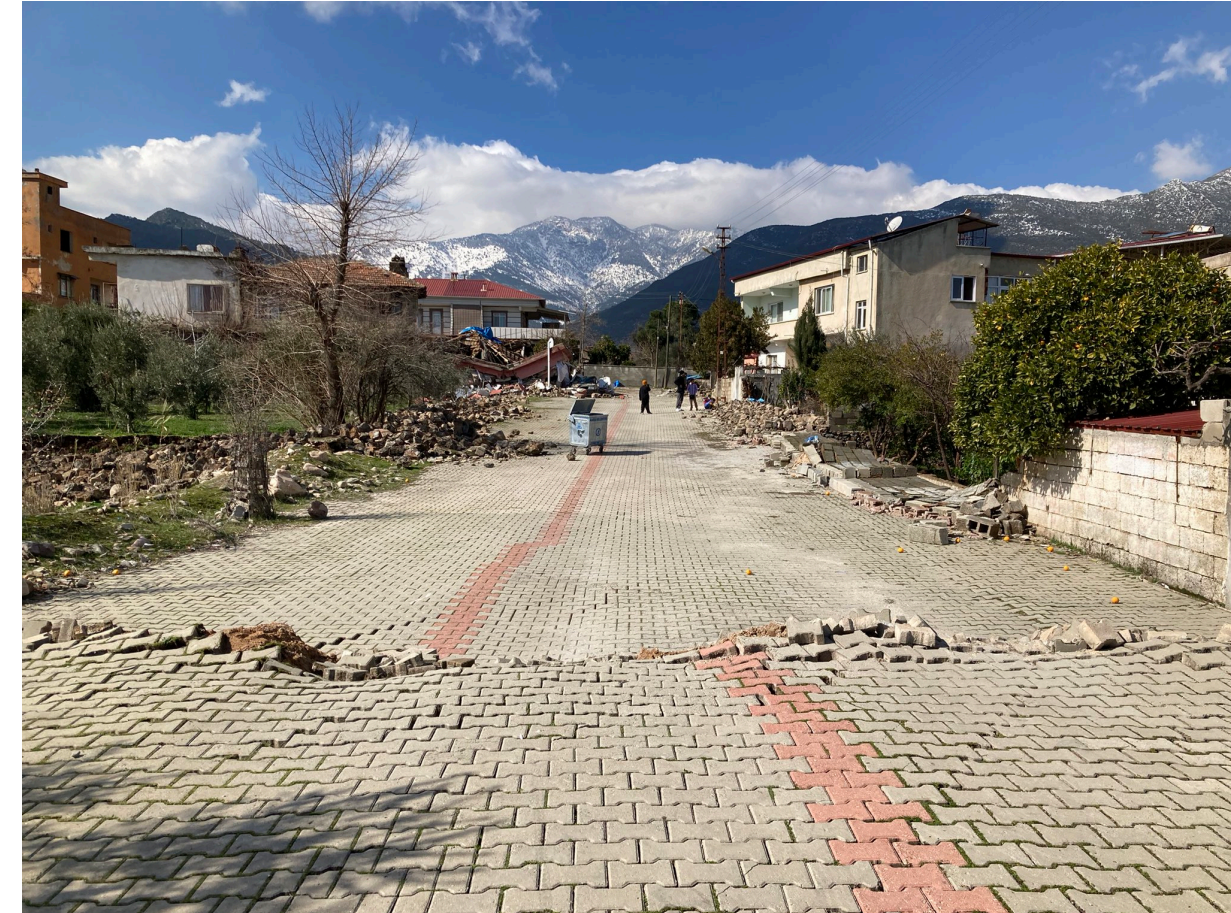
# Surface Offsets

06 Şubat 2023 Pazarcık (Kahramanmaraş) Depremi (Mw 7,7) sırasında Ölü Deniz Fay Zonu'nun Narlı Segmenti üzerinde meydana gelen deprem yüzey kırıkları ve yer değiştirme miktarları, ilk defa Maden Tetkik ve Arama Genel Müdürlüğü (MTA) ekipleri tarafından İnsansız Hava Aracı (İHA) ile kaydedilmiştir.

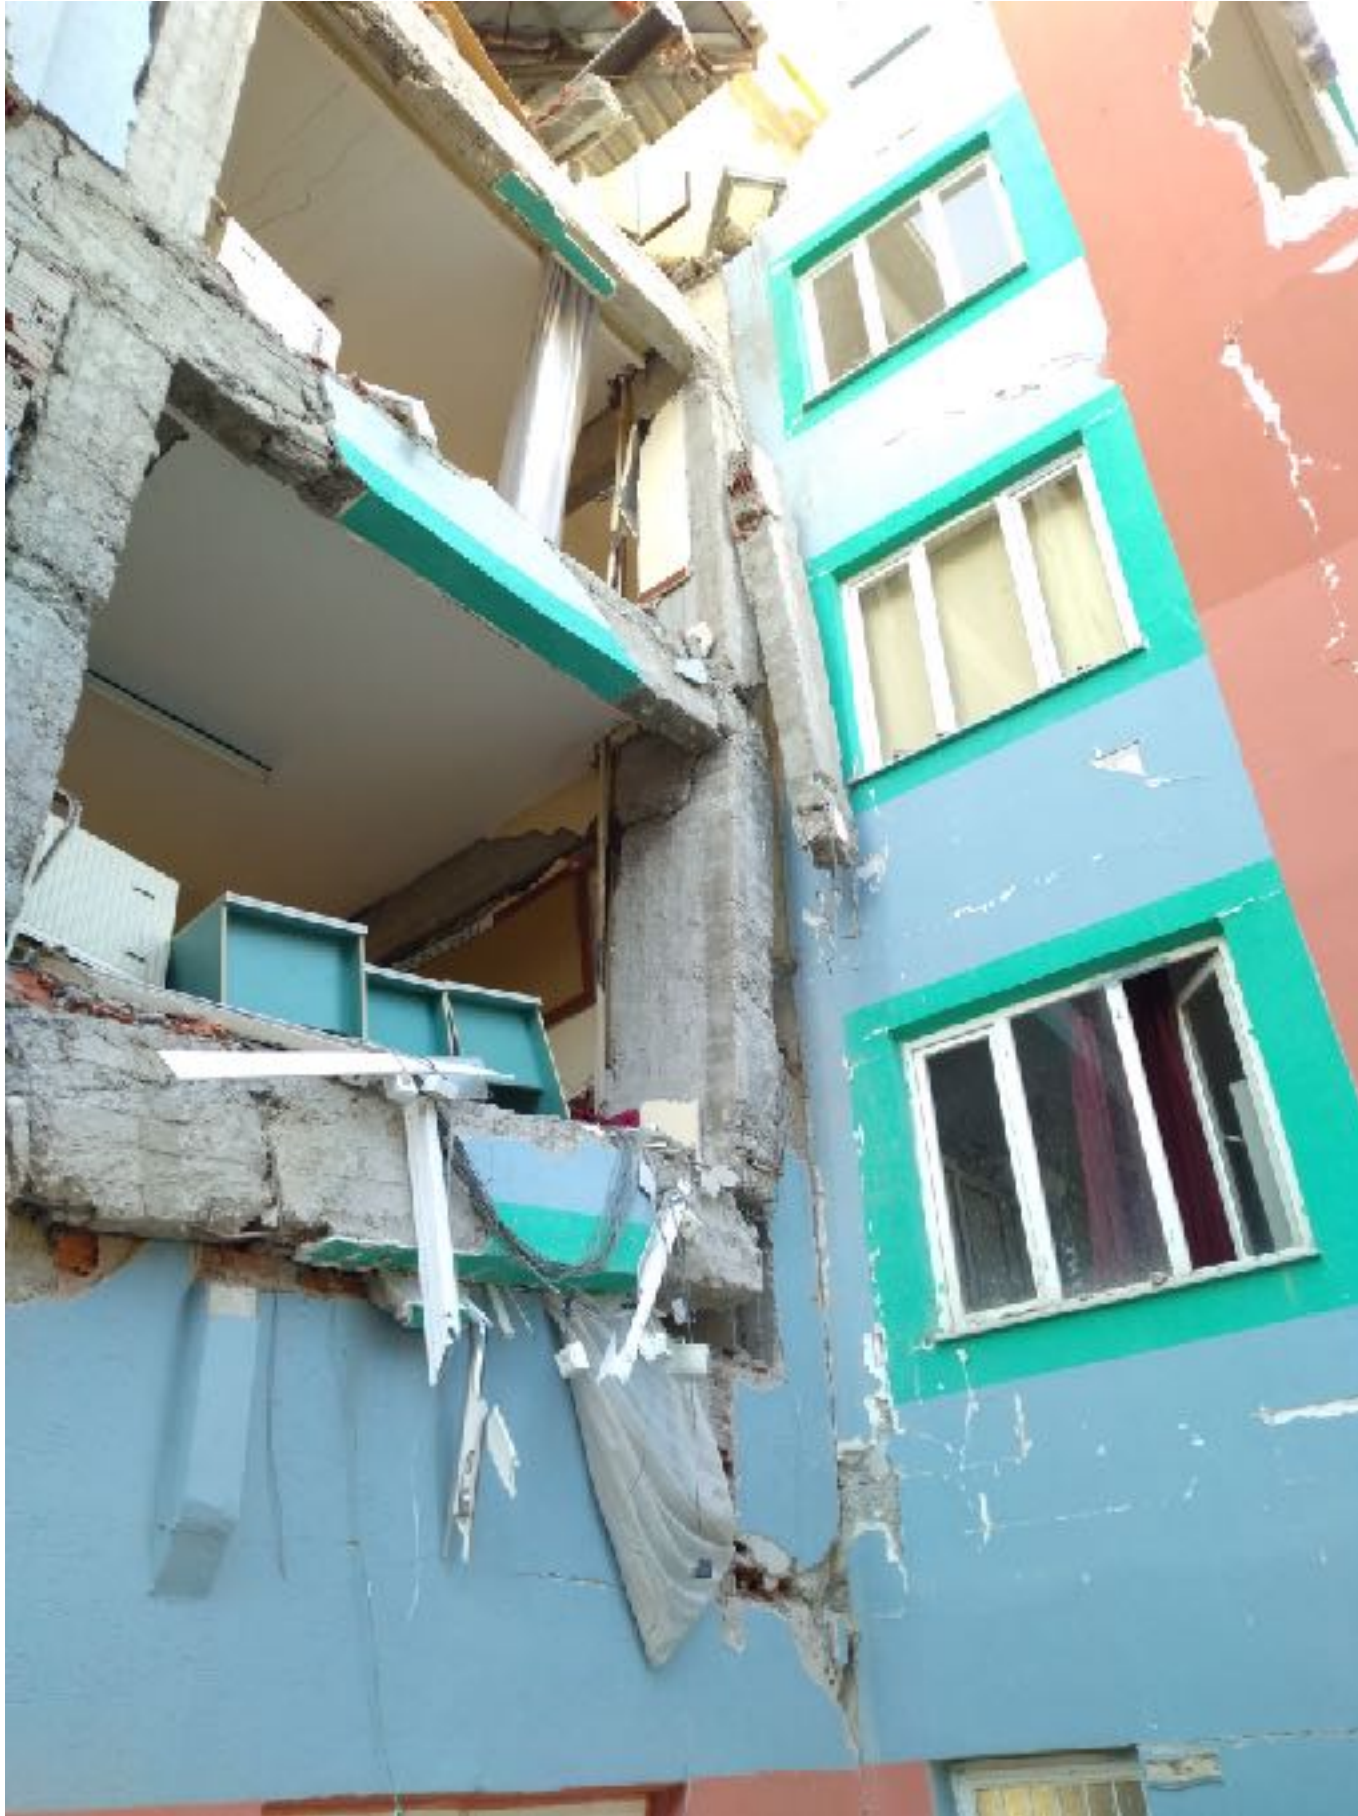
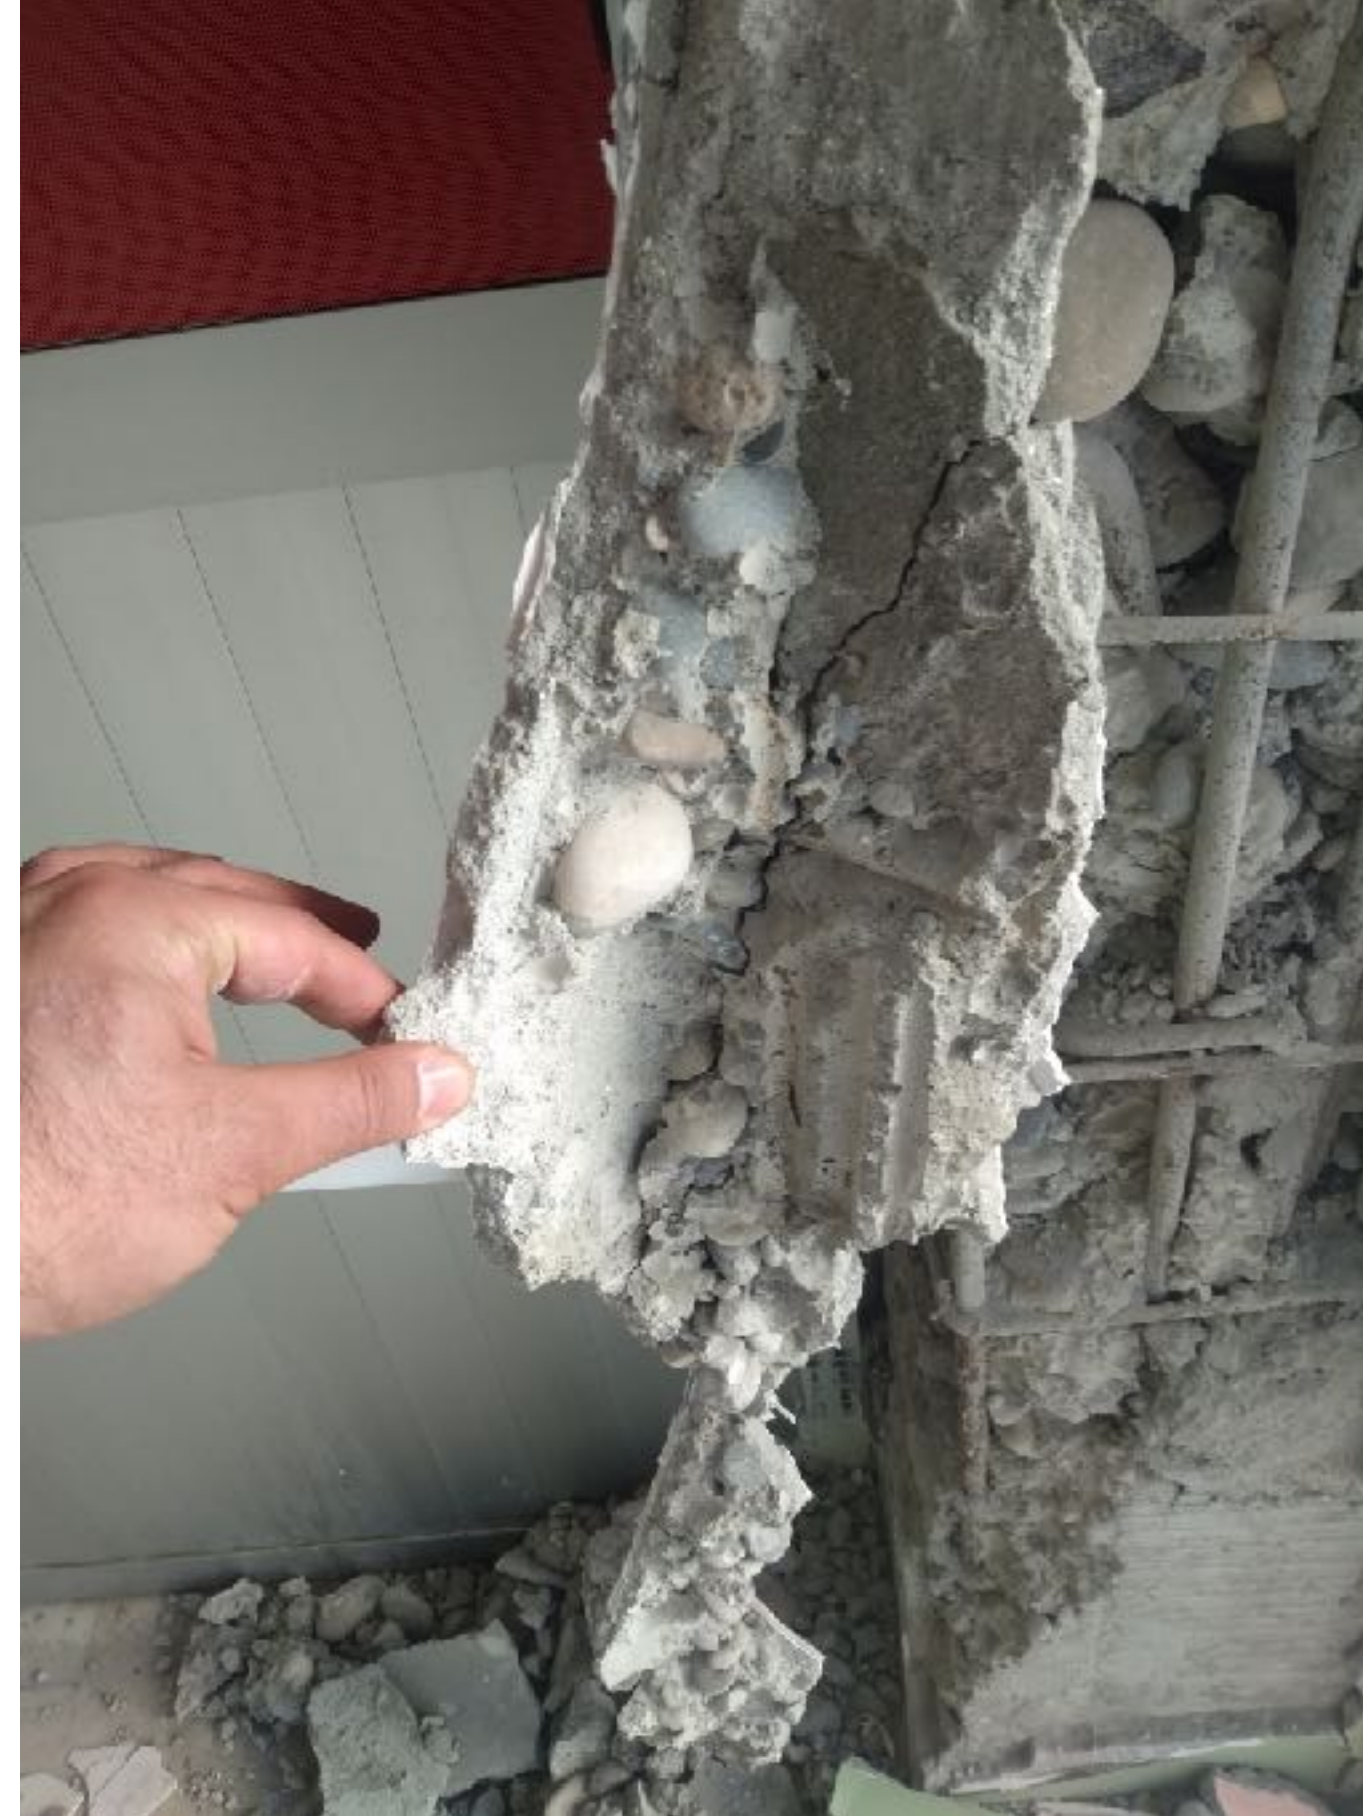
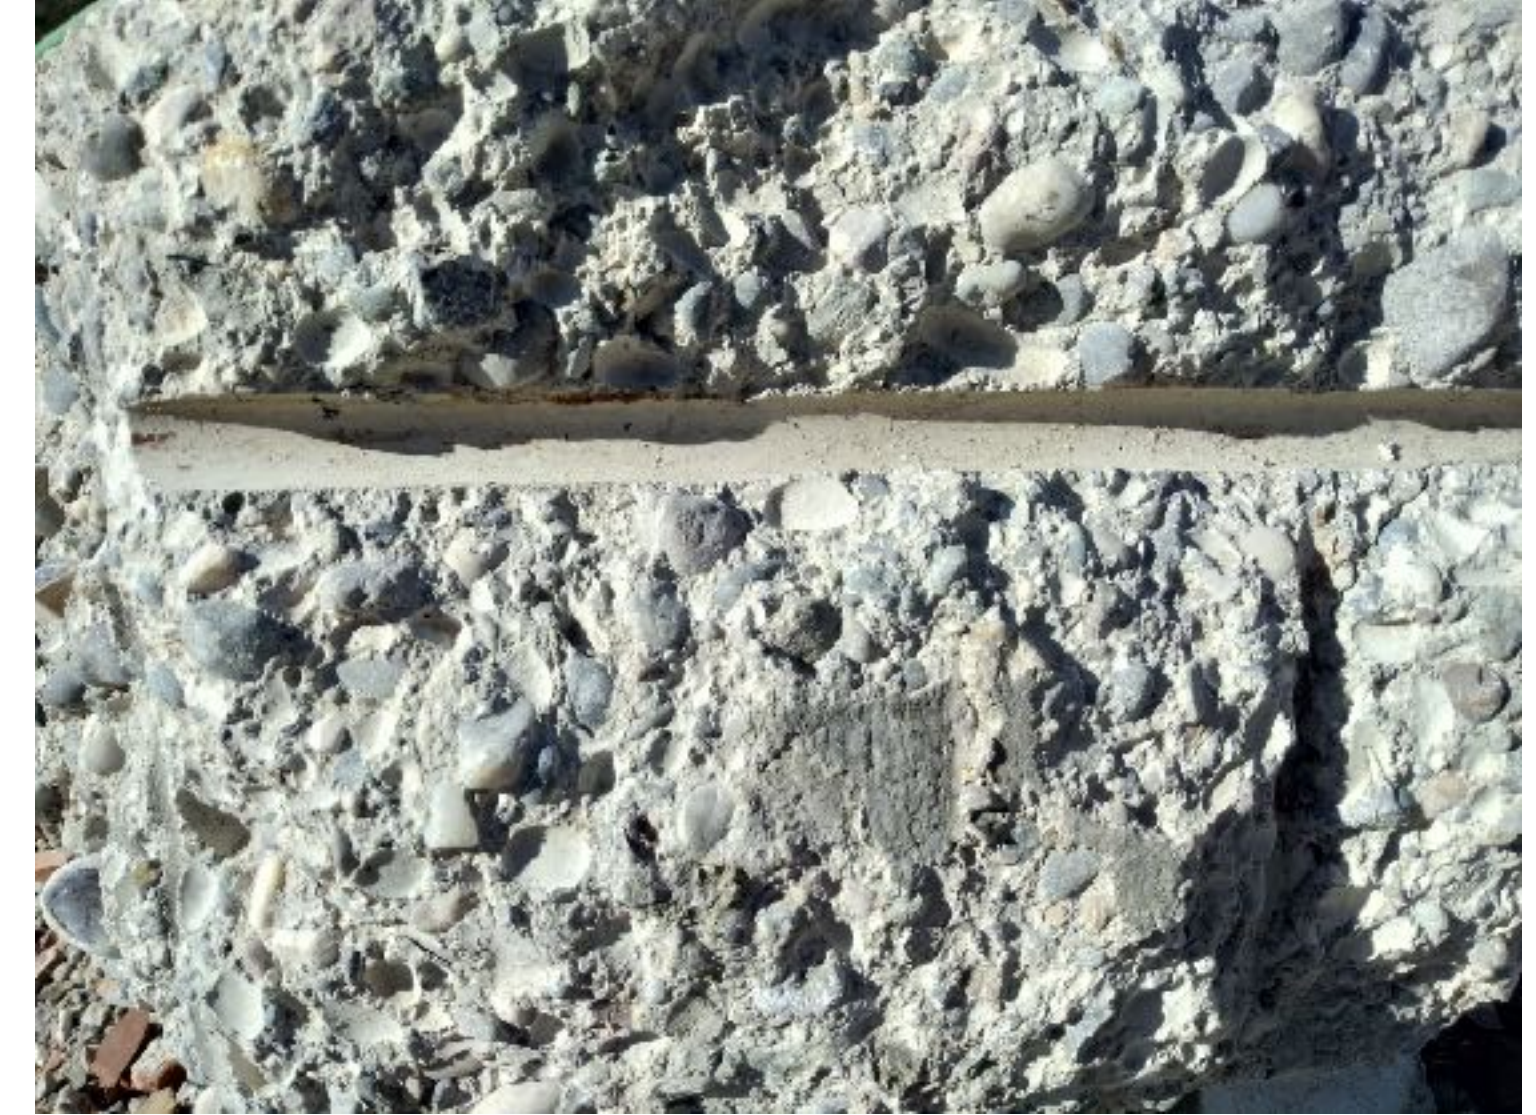
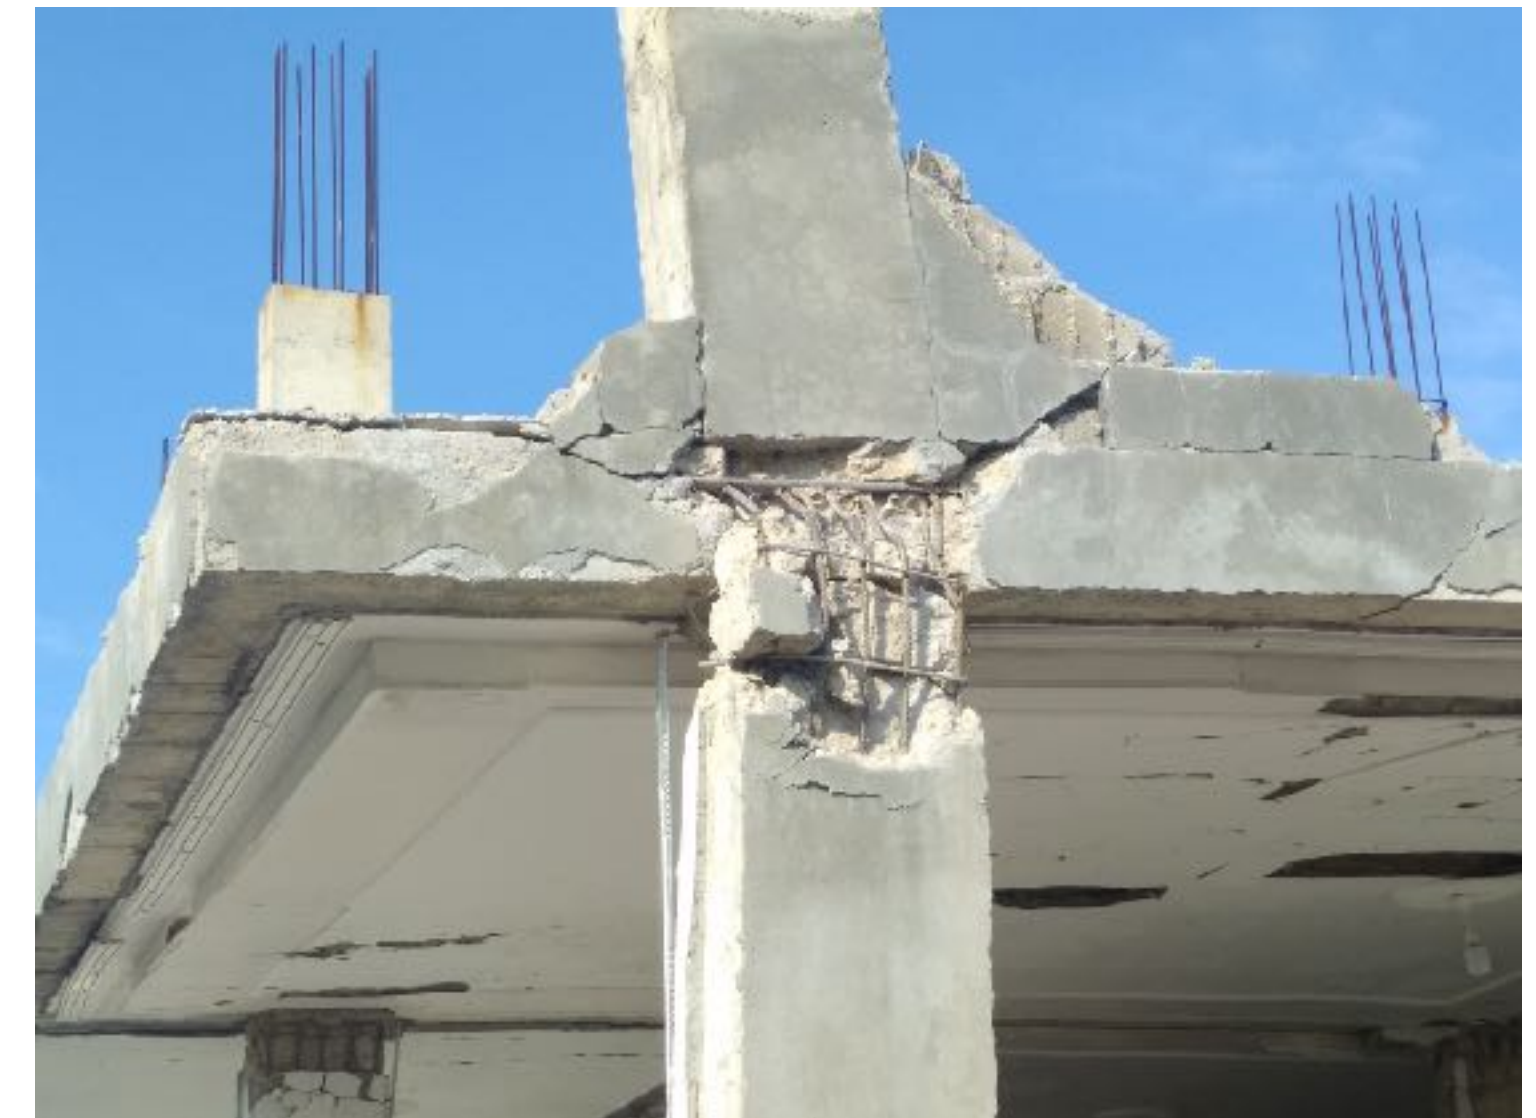
# Insufficient Reinforcement and Detailing

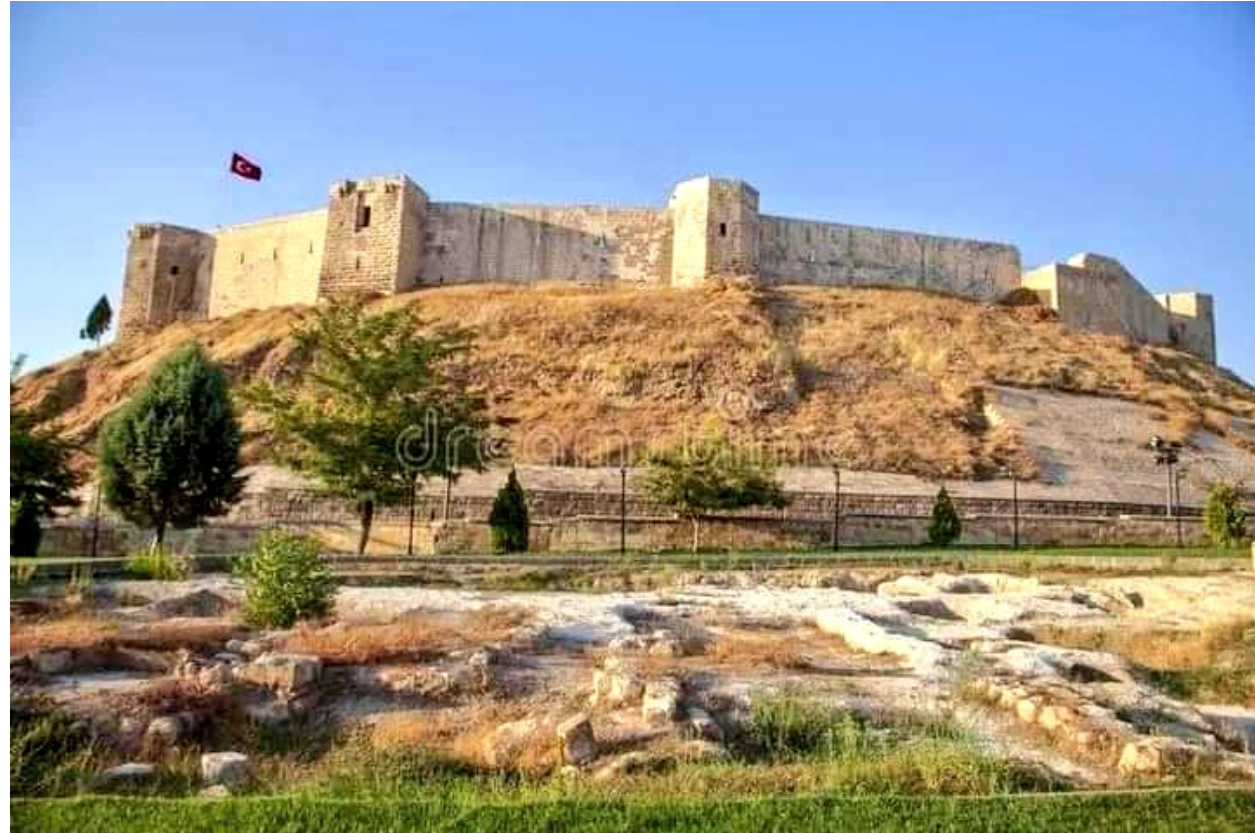
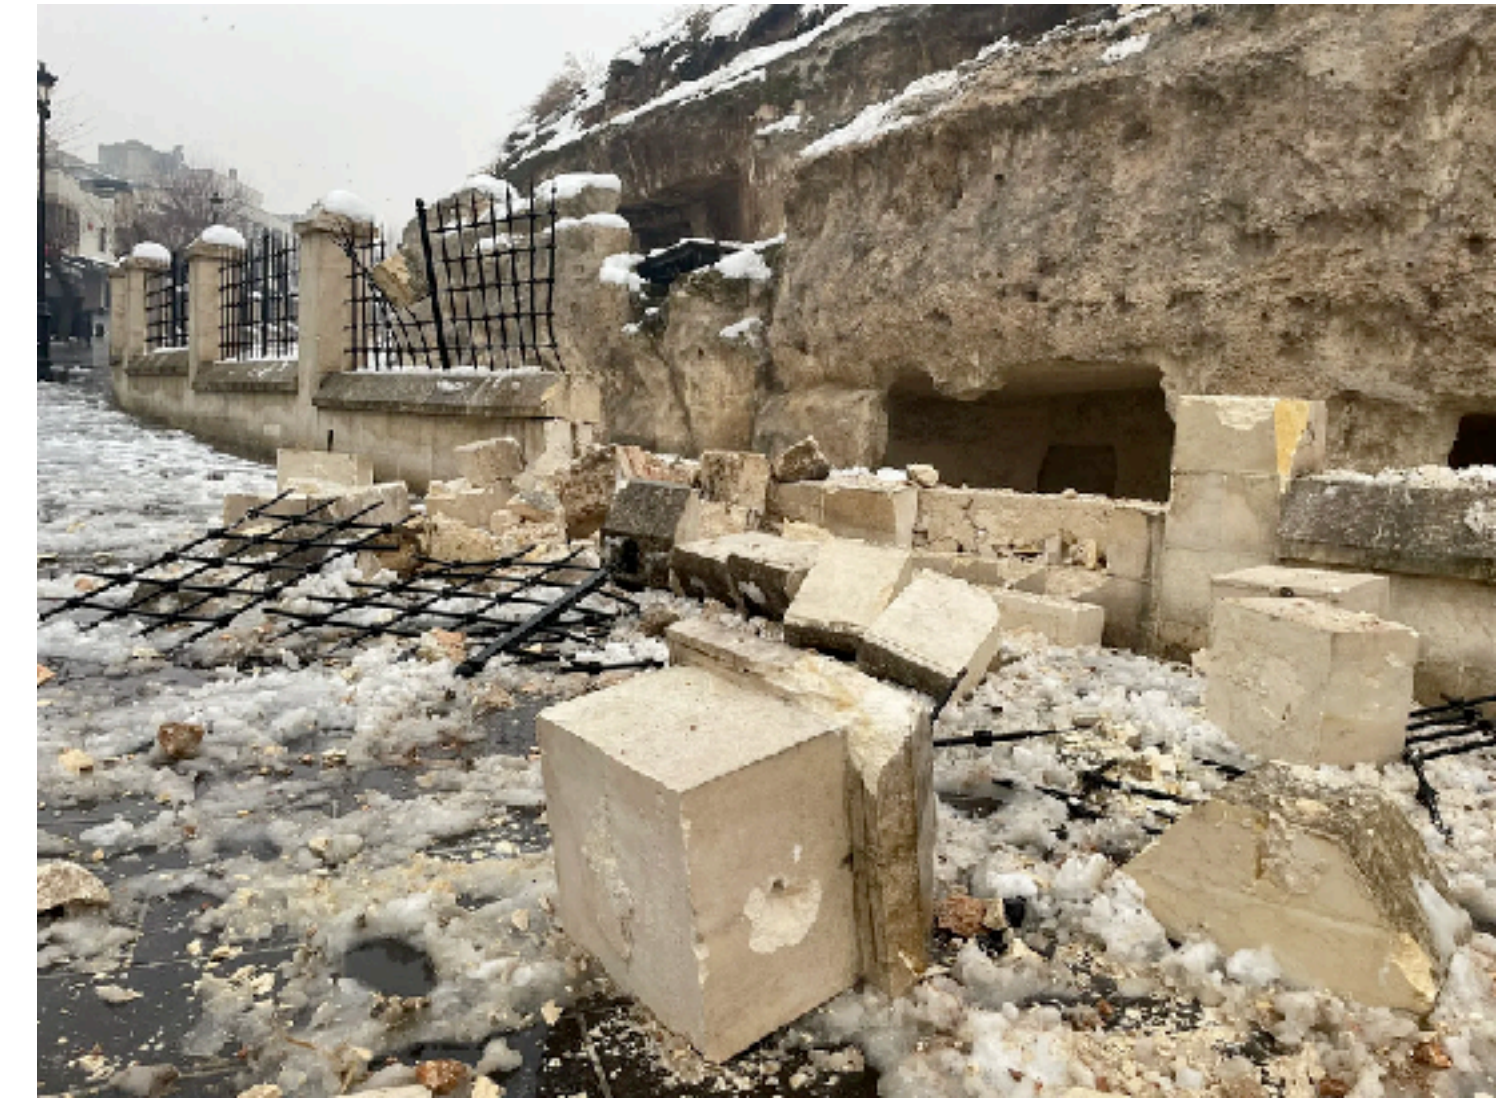
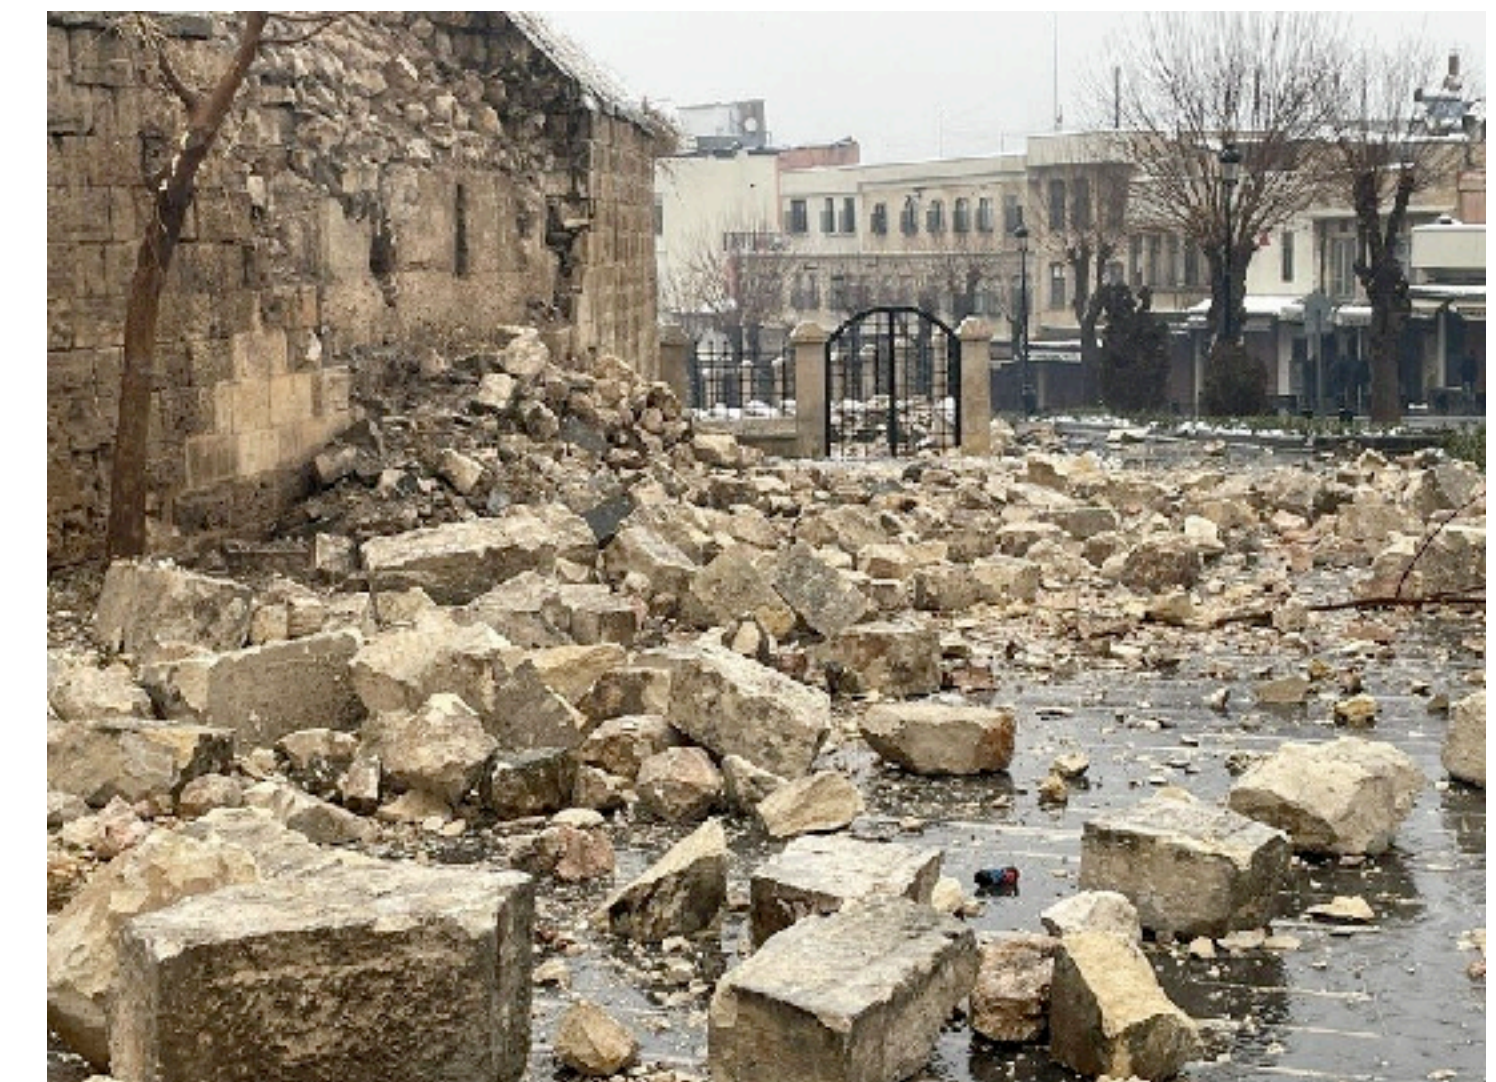
# Collapse of 2,200 Years Old Heritage

- Dating back to the Roman empire, around the second, third, and fourth centuries A.D., the structure was originally built as a lookout.
