# Highlights of Worst Devastation in Turkey

- Two back-to-back M7.8 and M7.6 earthquakes occurred in Eastern Turkey within 9 hours
- Affected 15 highly populated provinces
- Over 47,000 people lost their lives
- More than 5,000 buildings collapsed

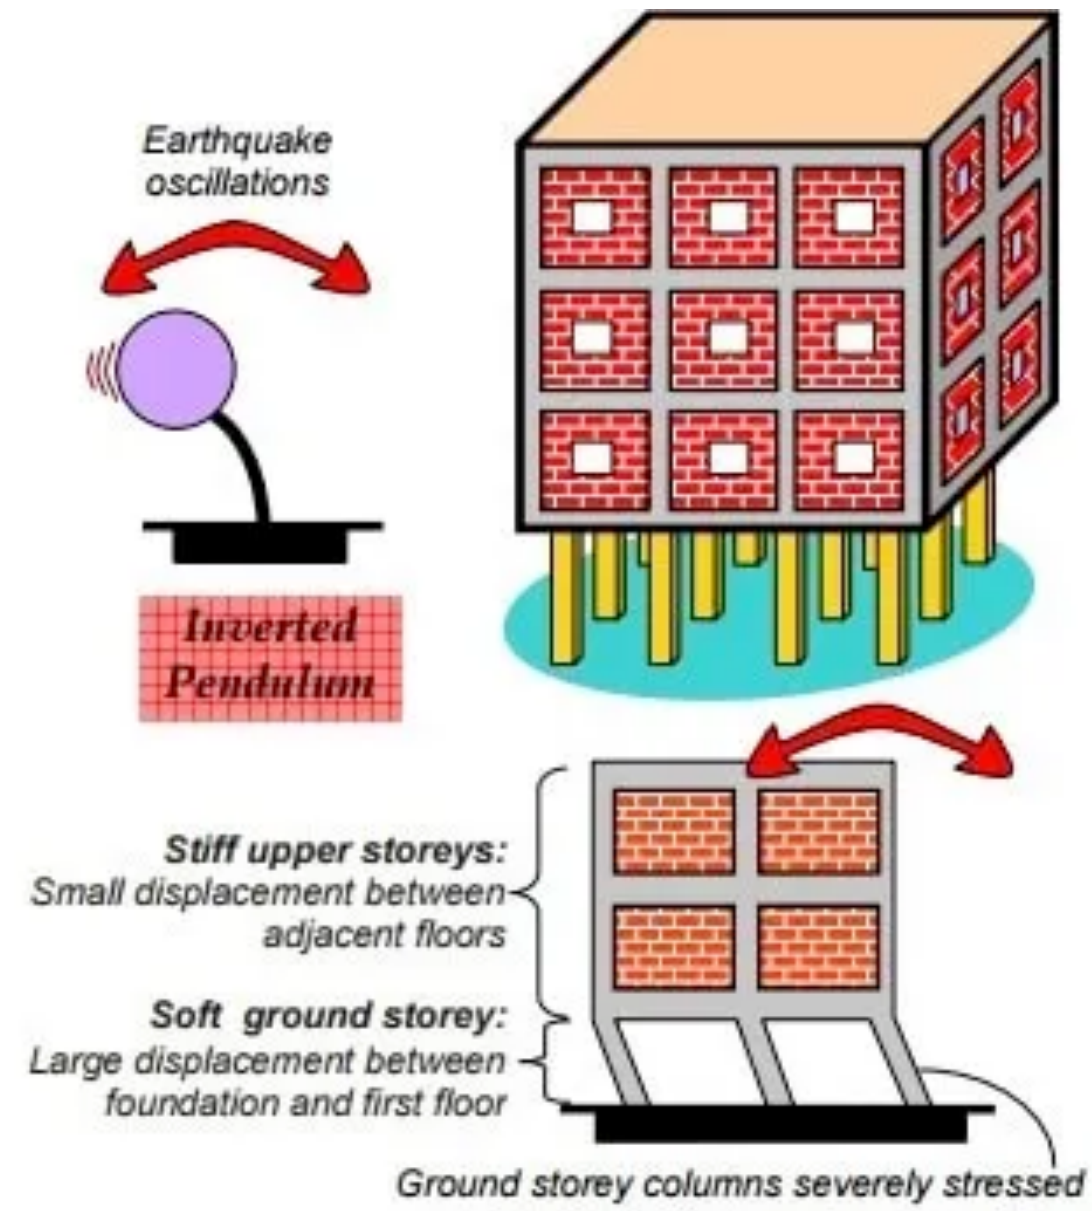
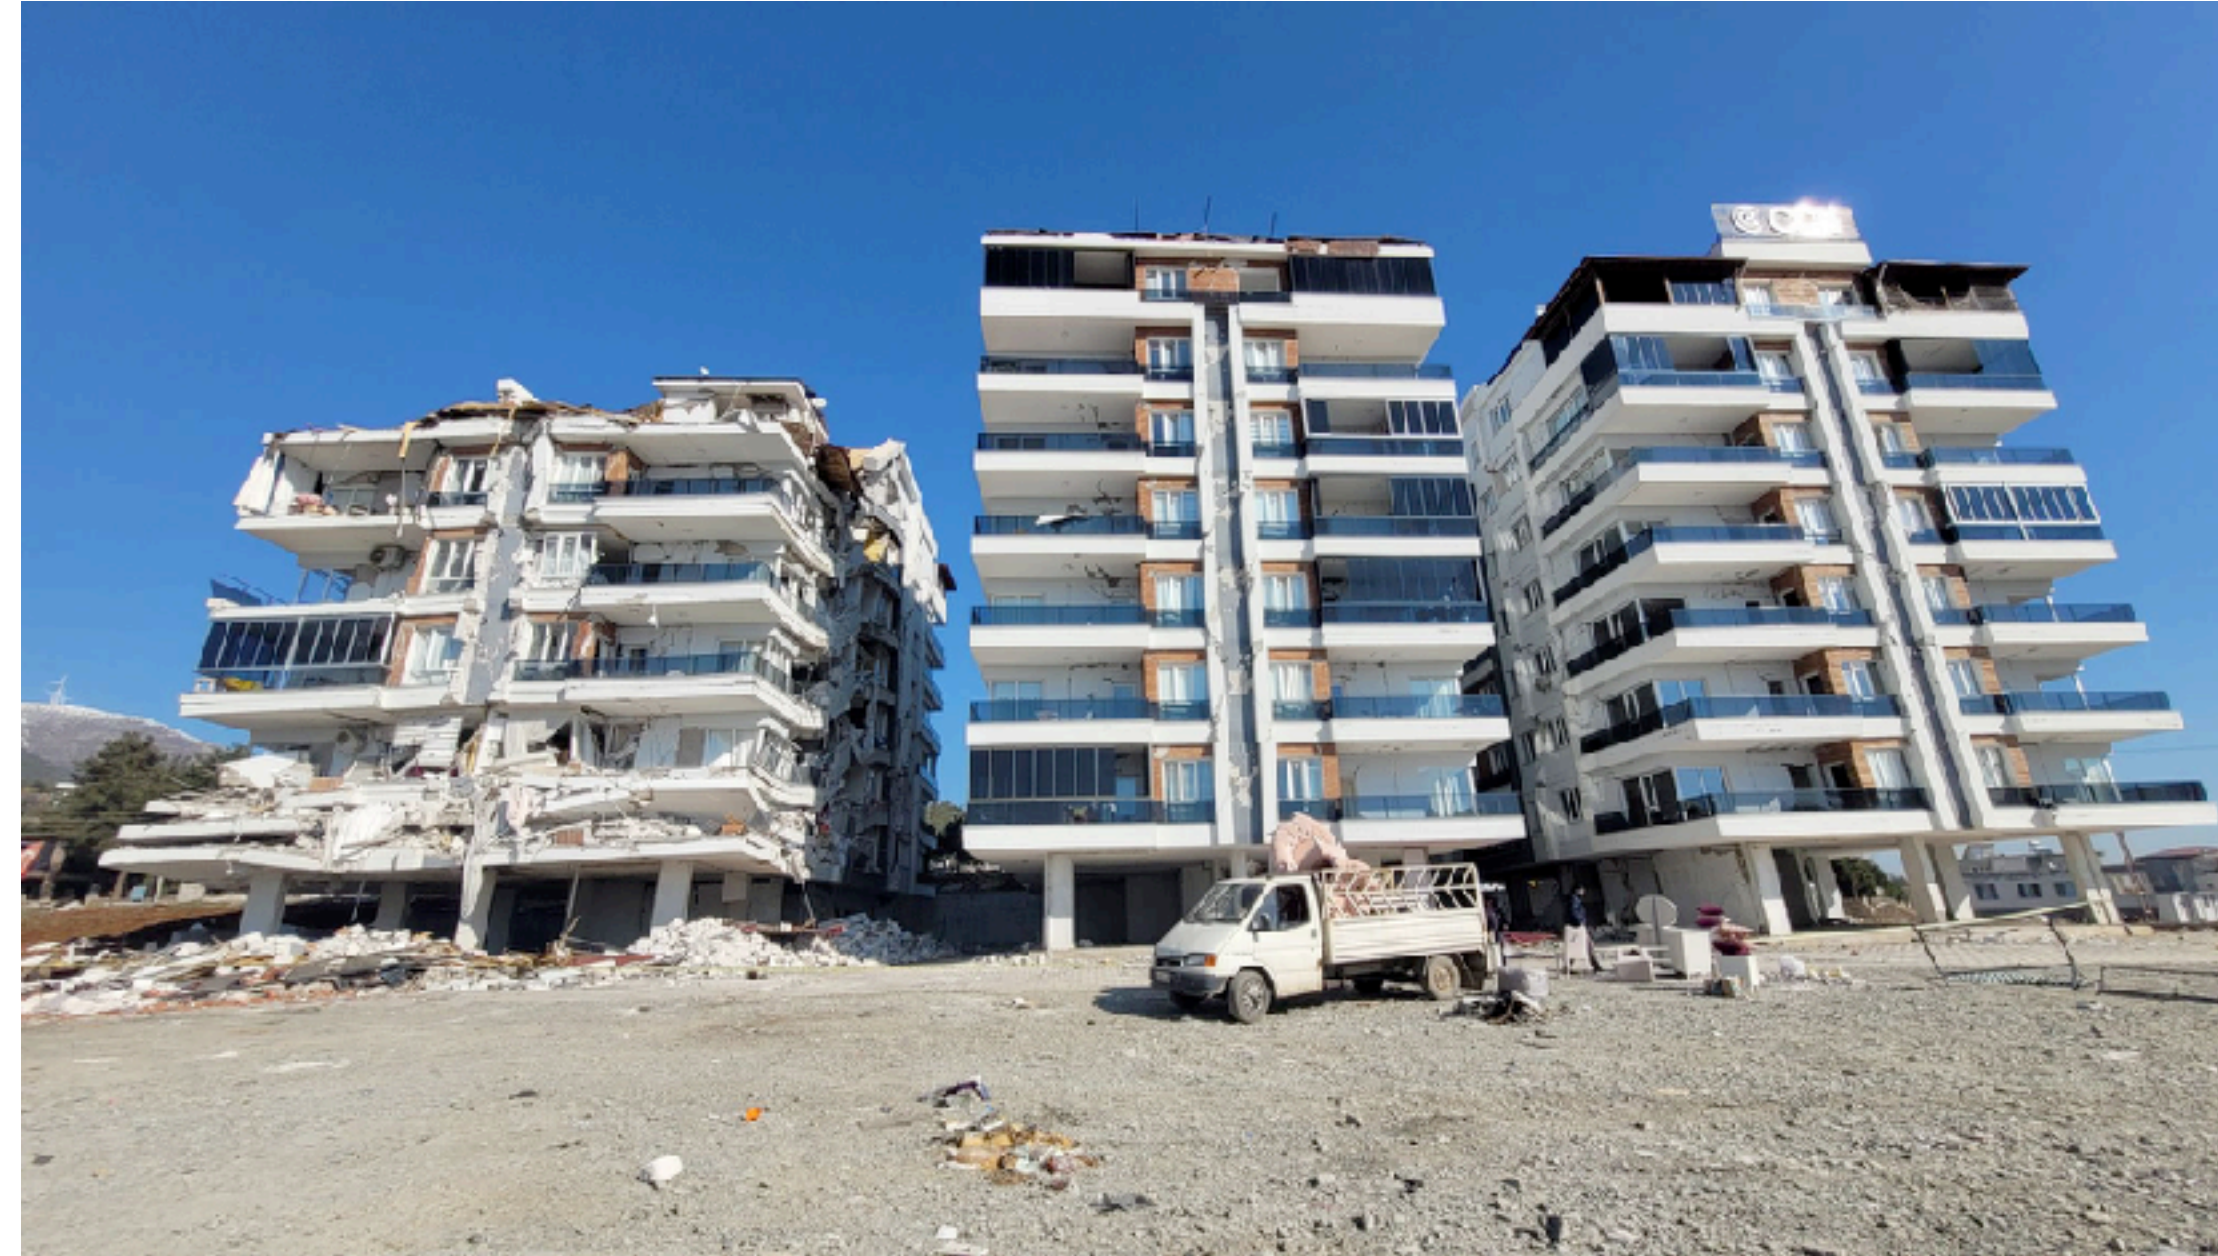
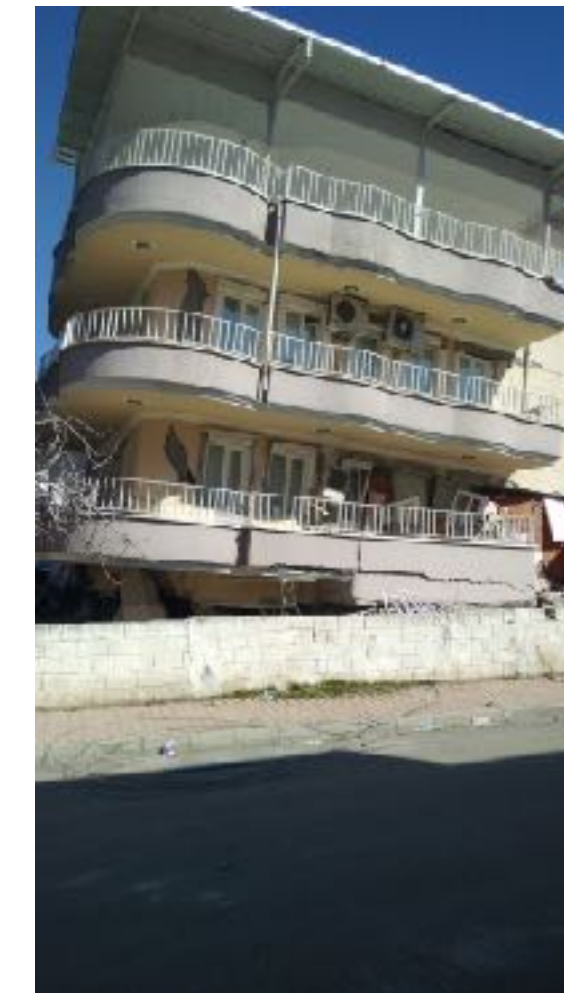
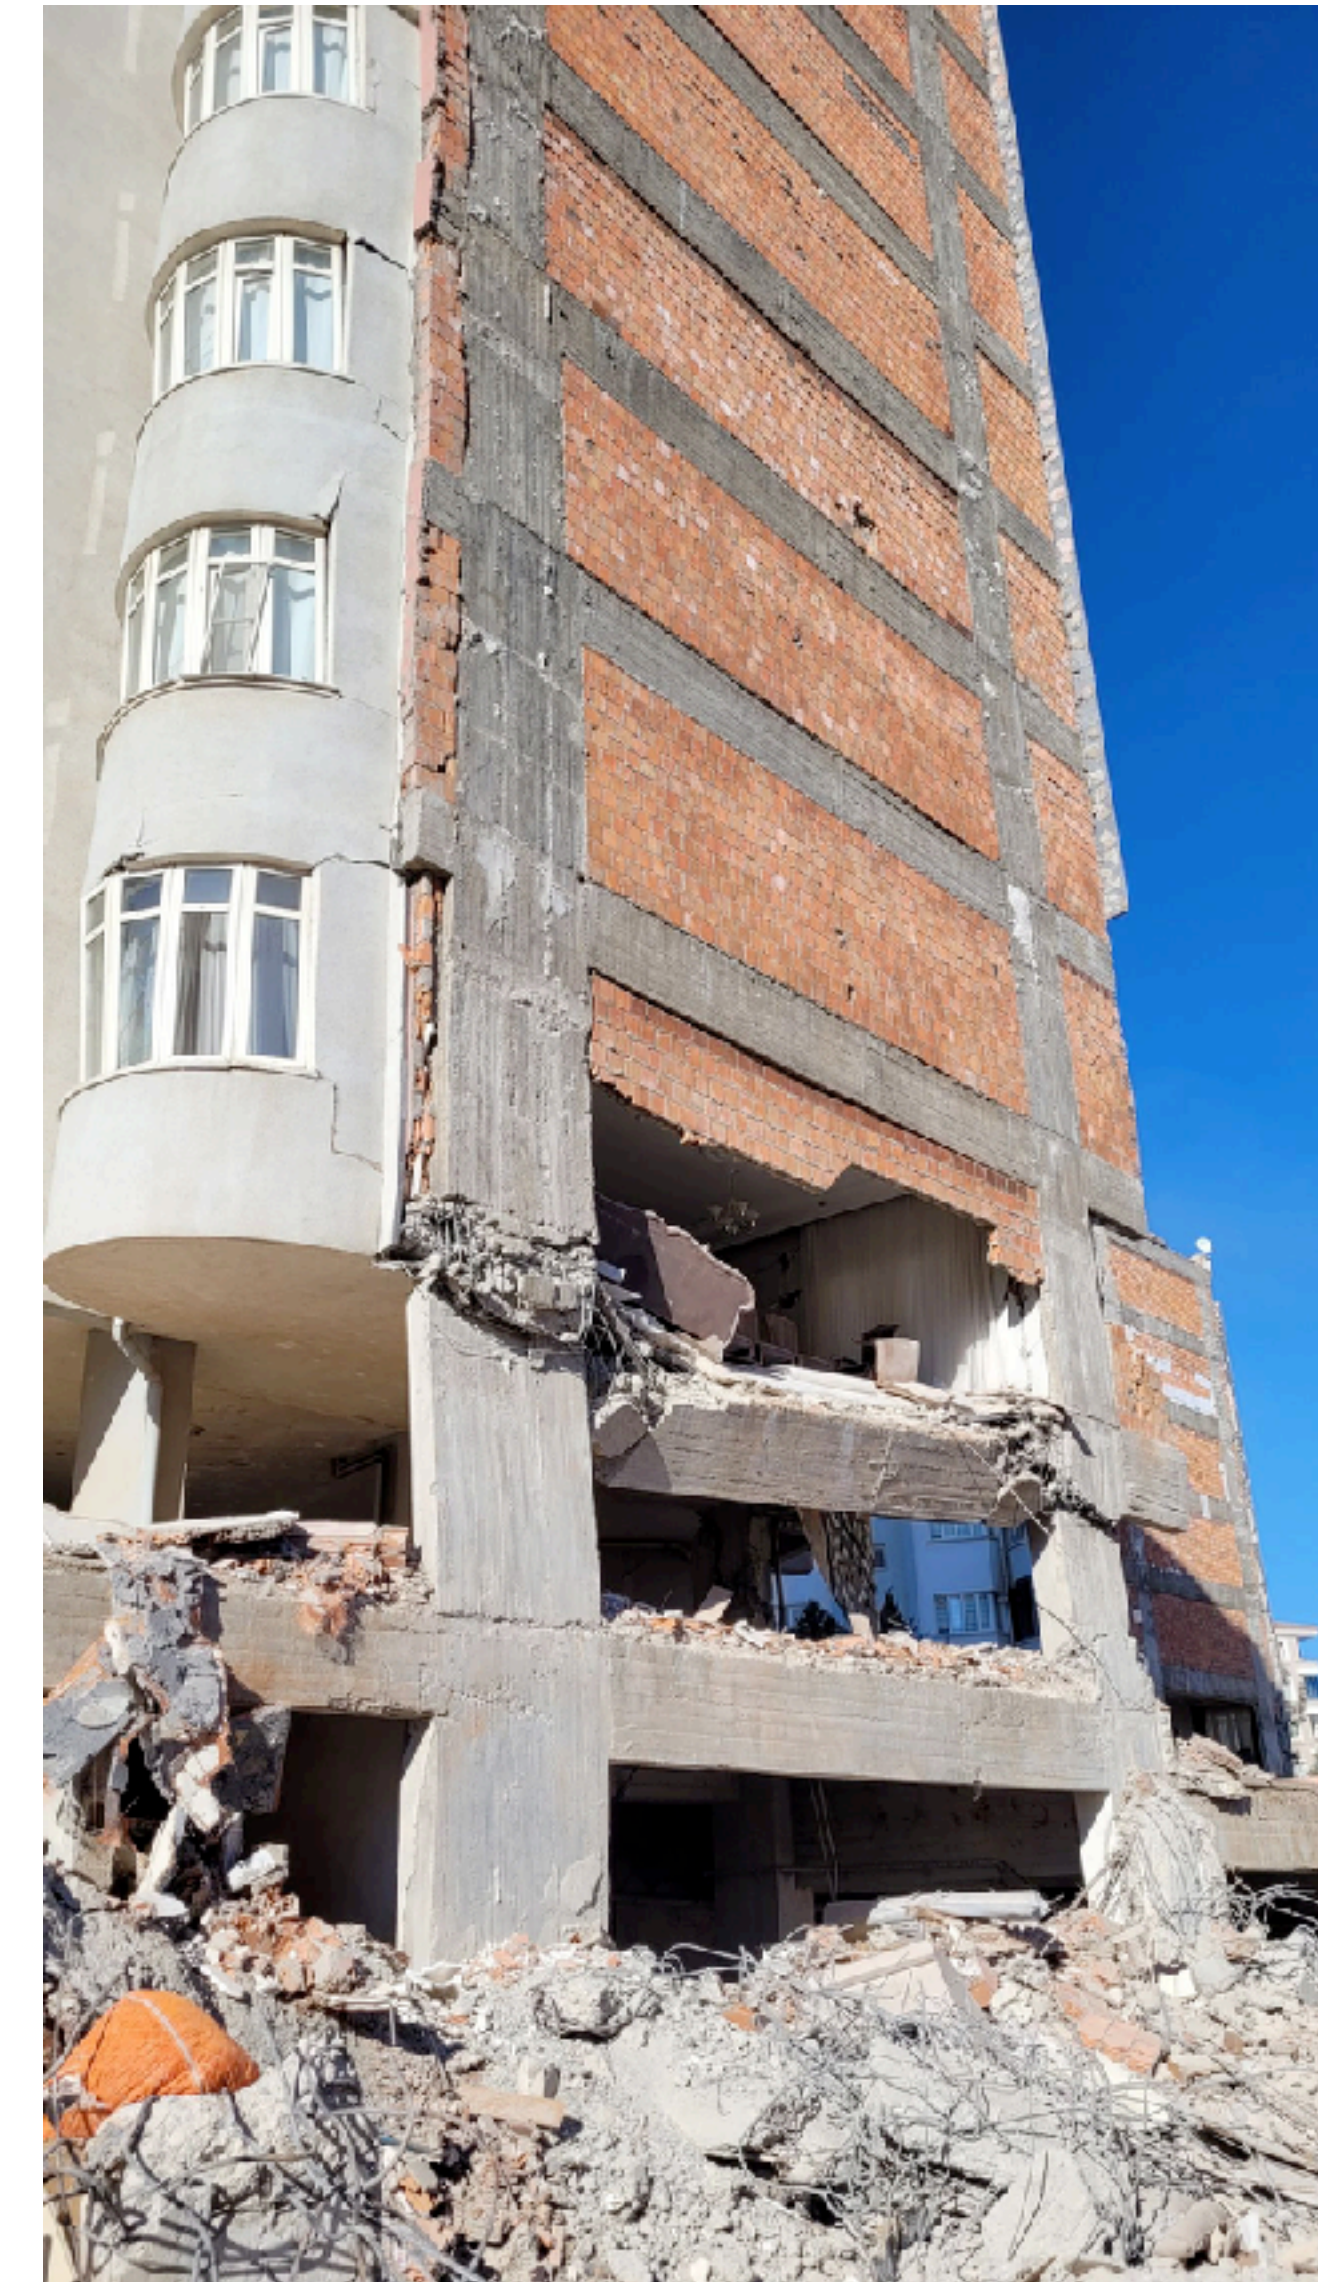
# Soft Story Mechanism

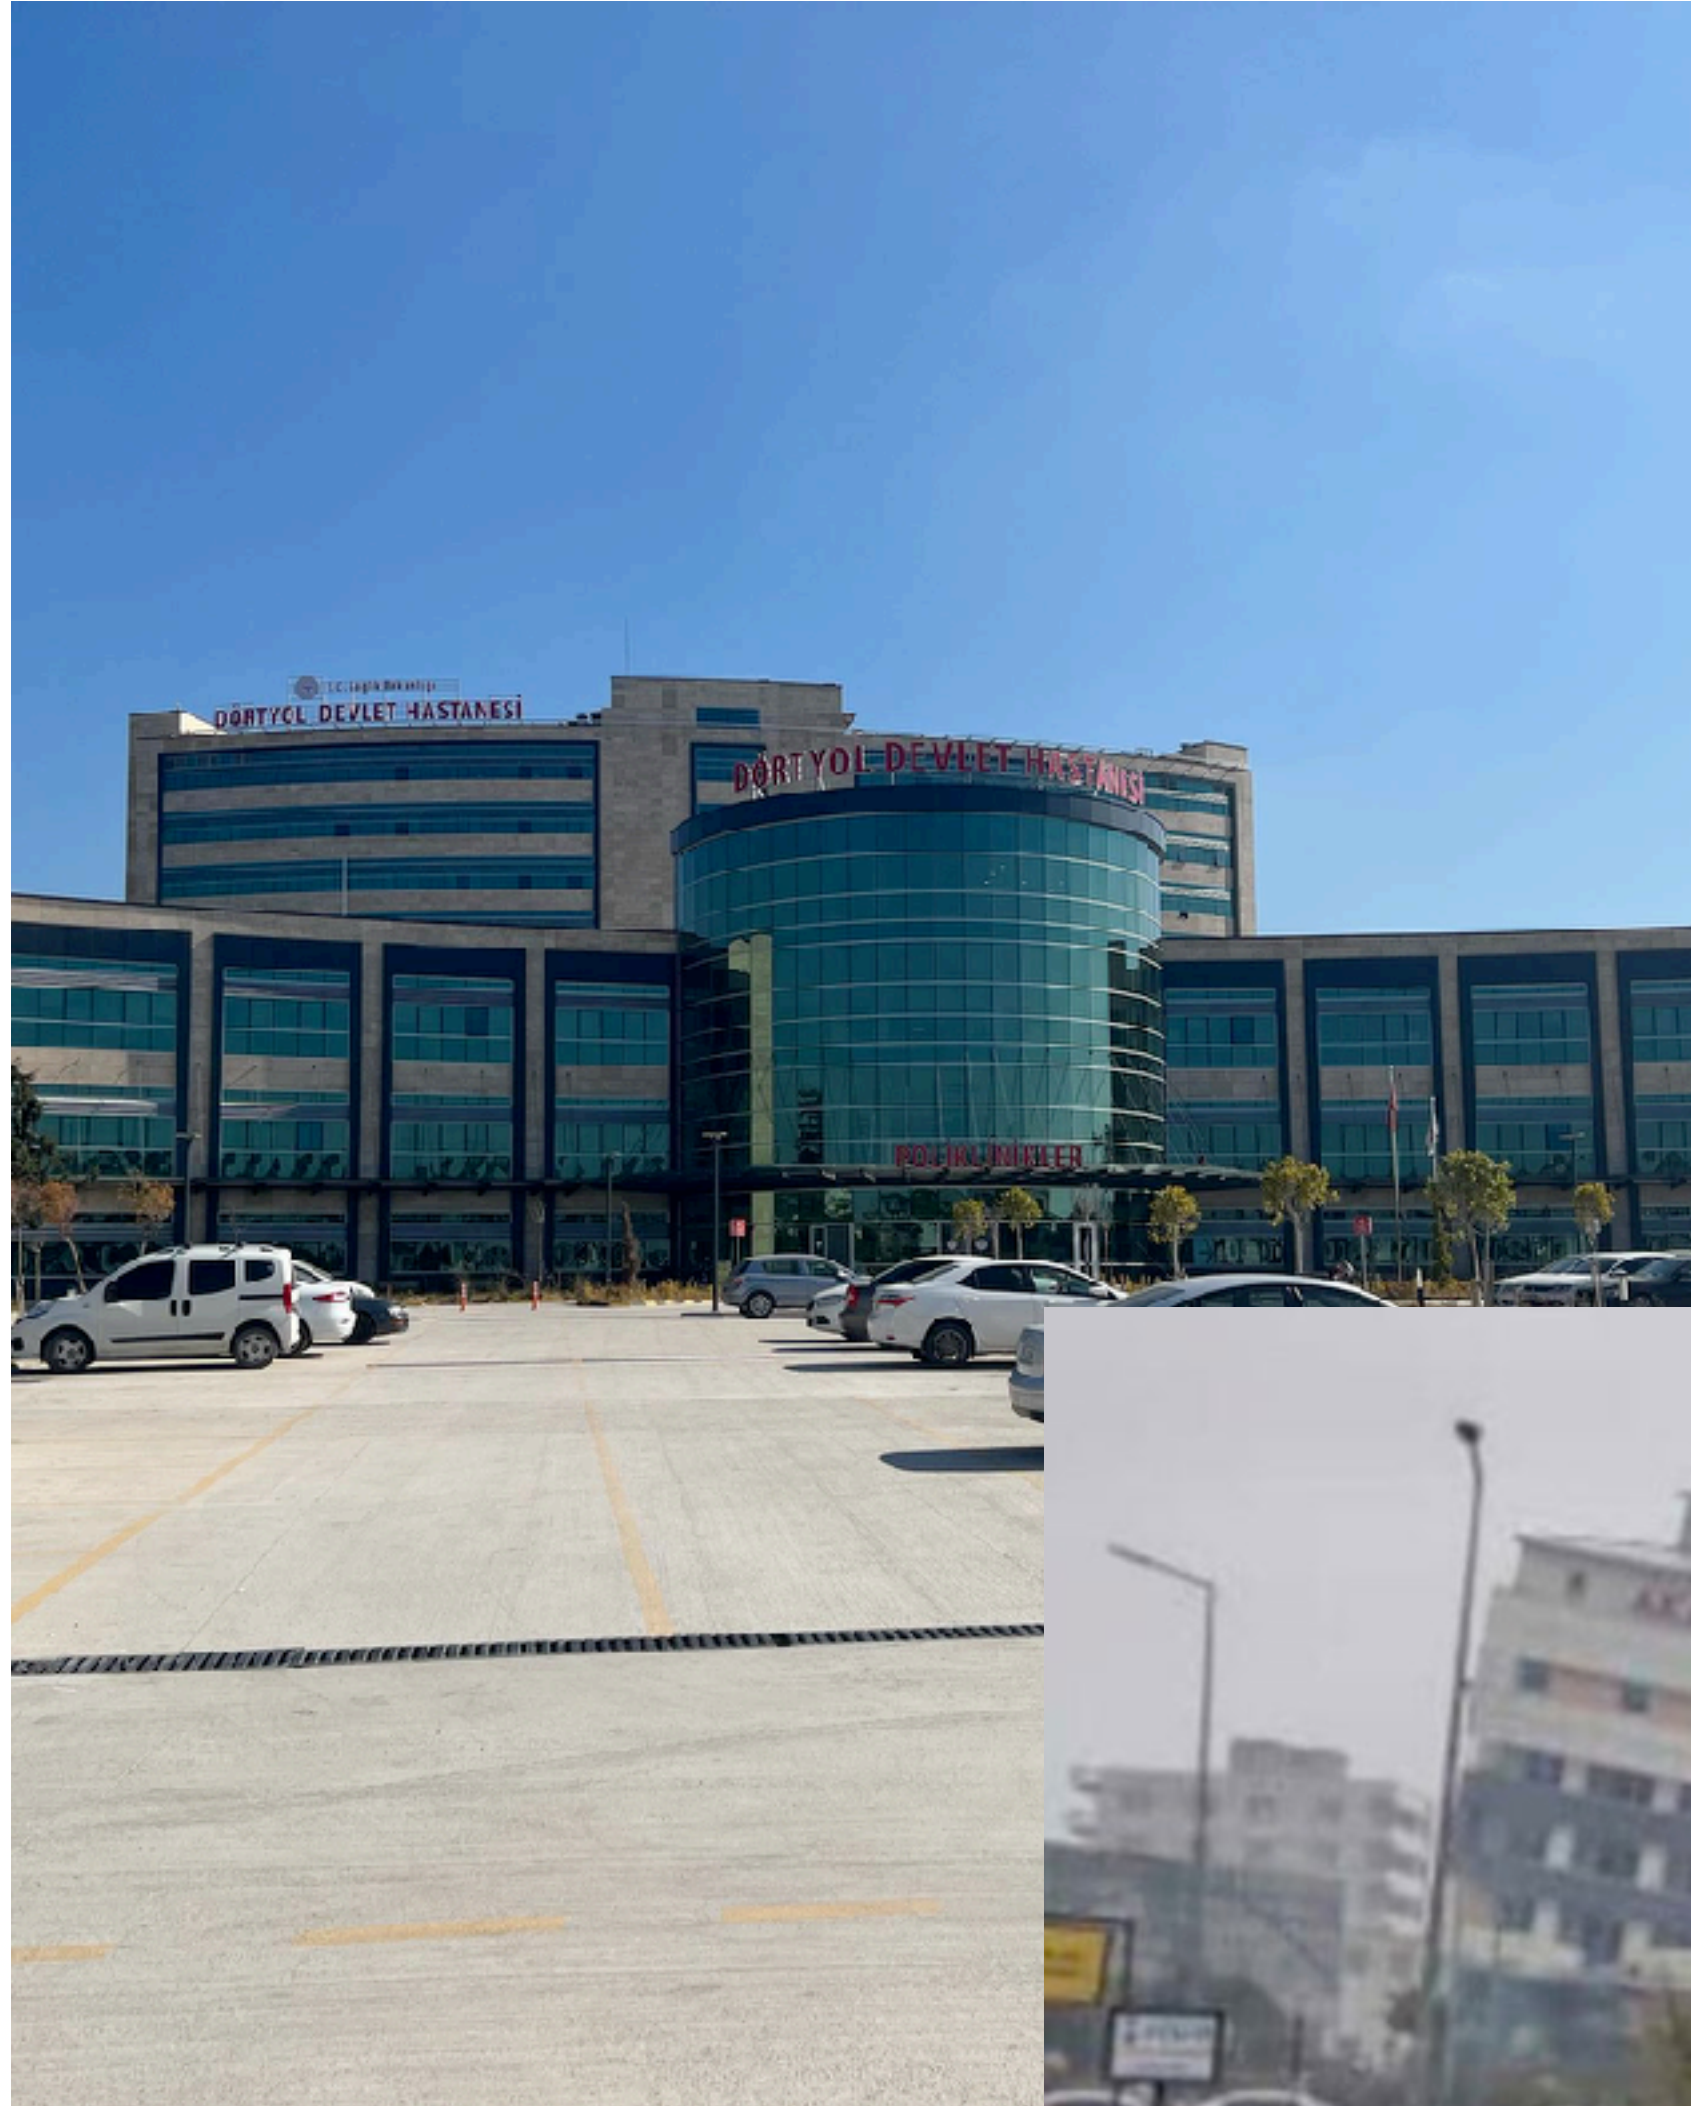
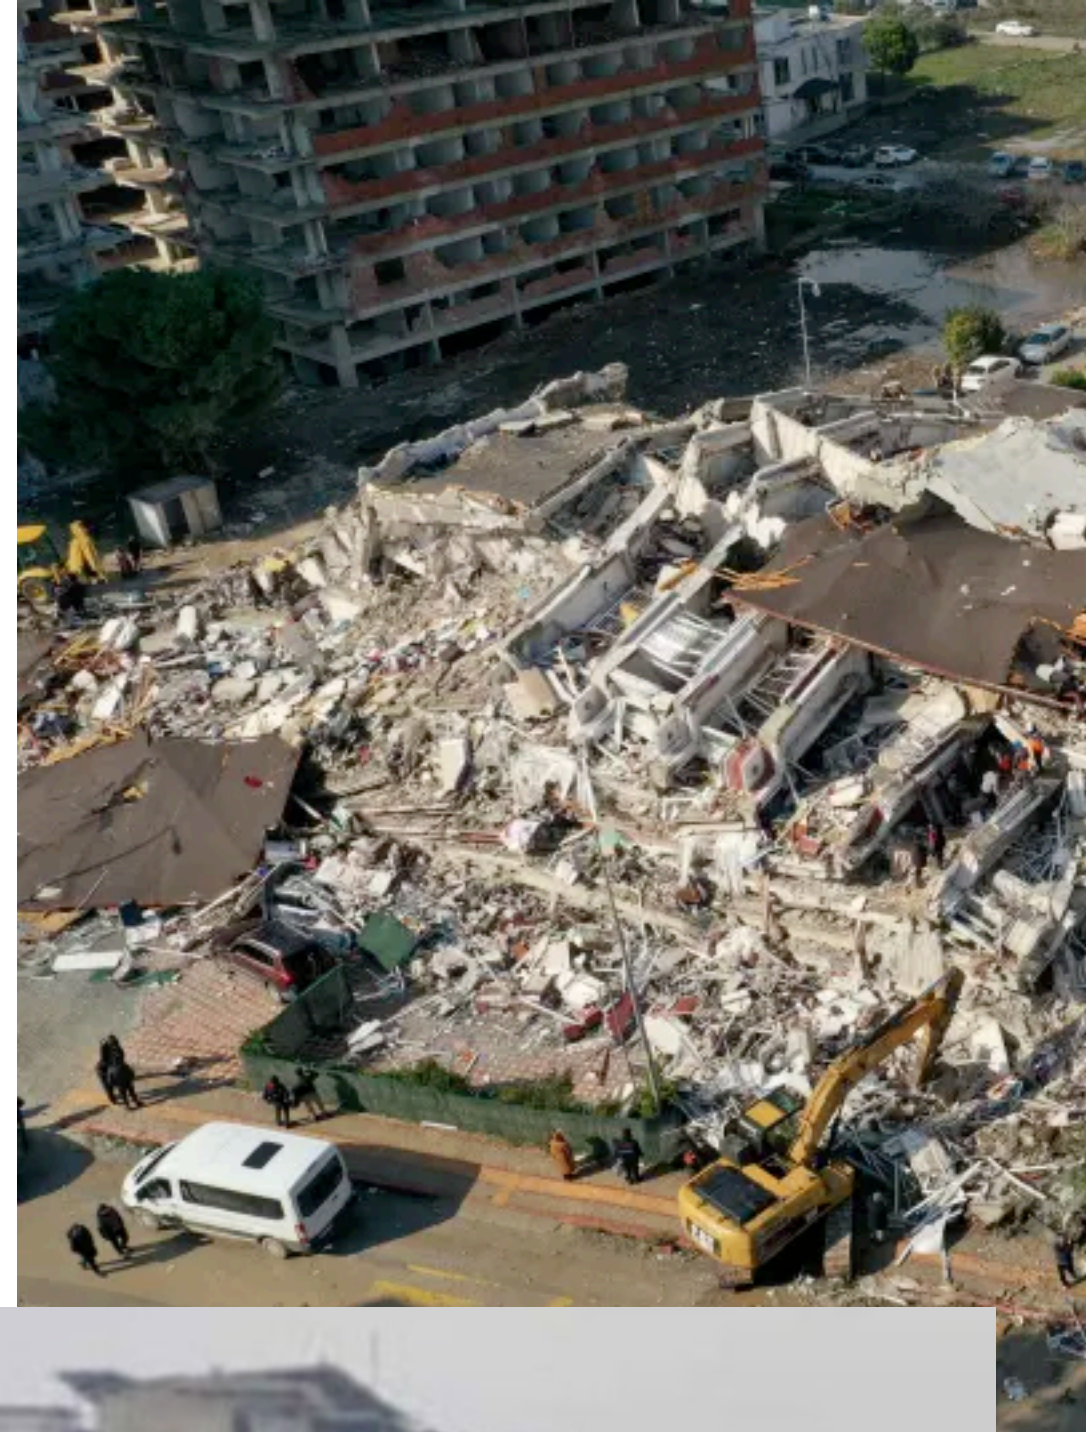
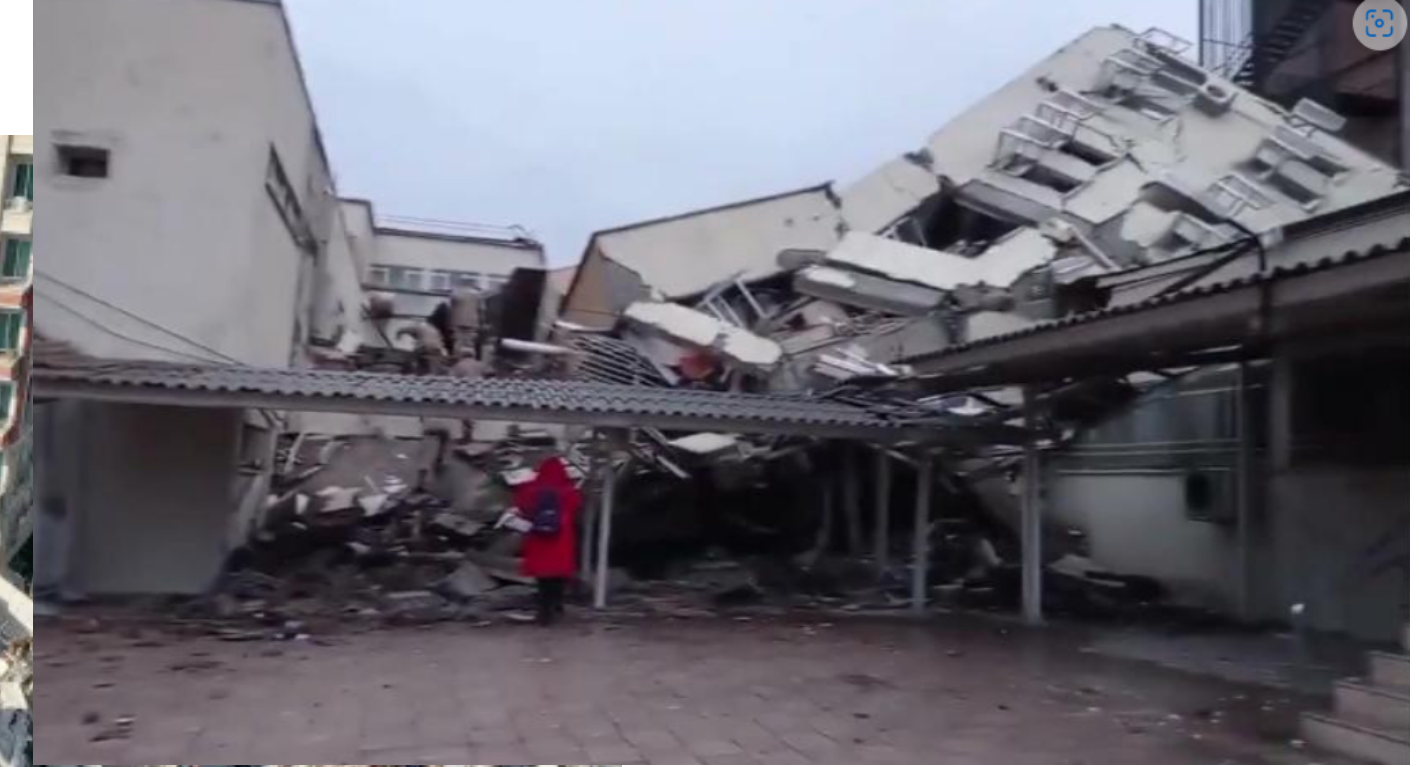
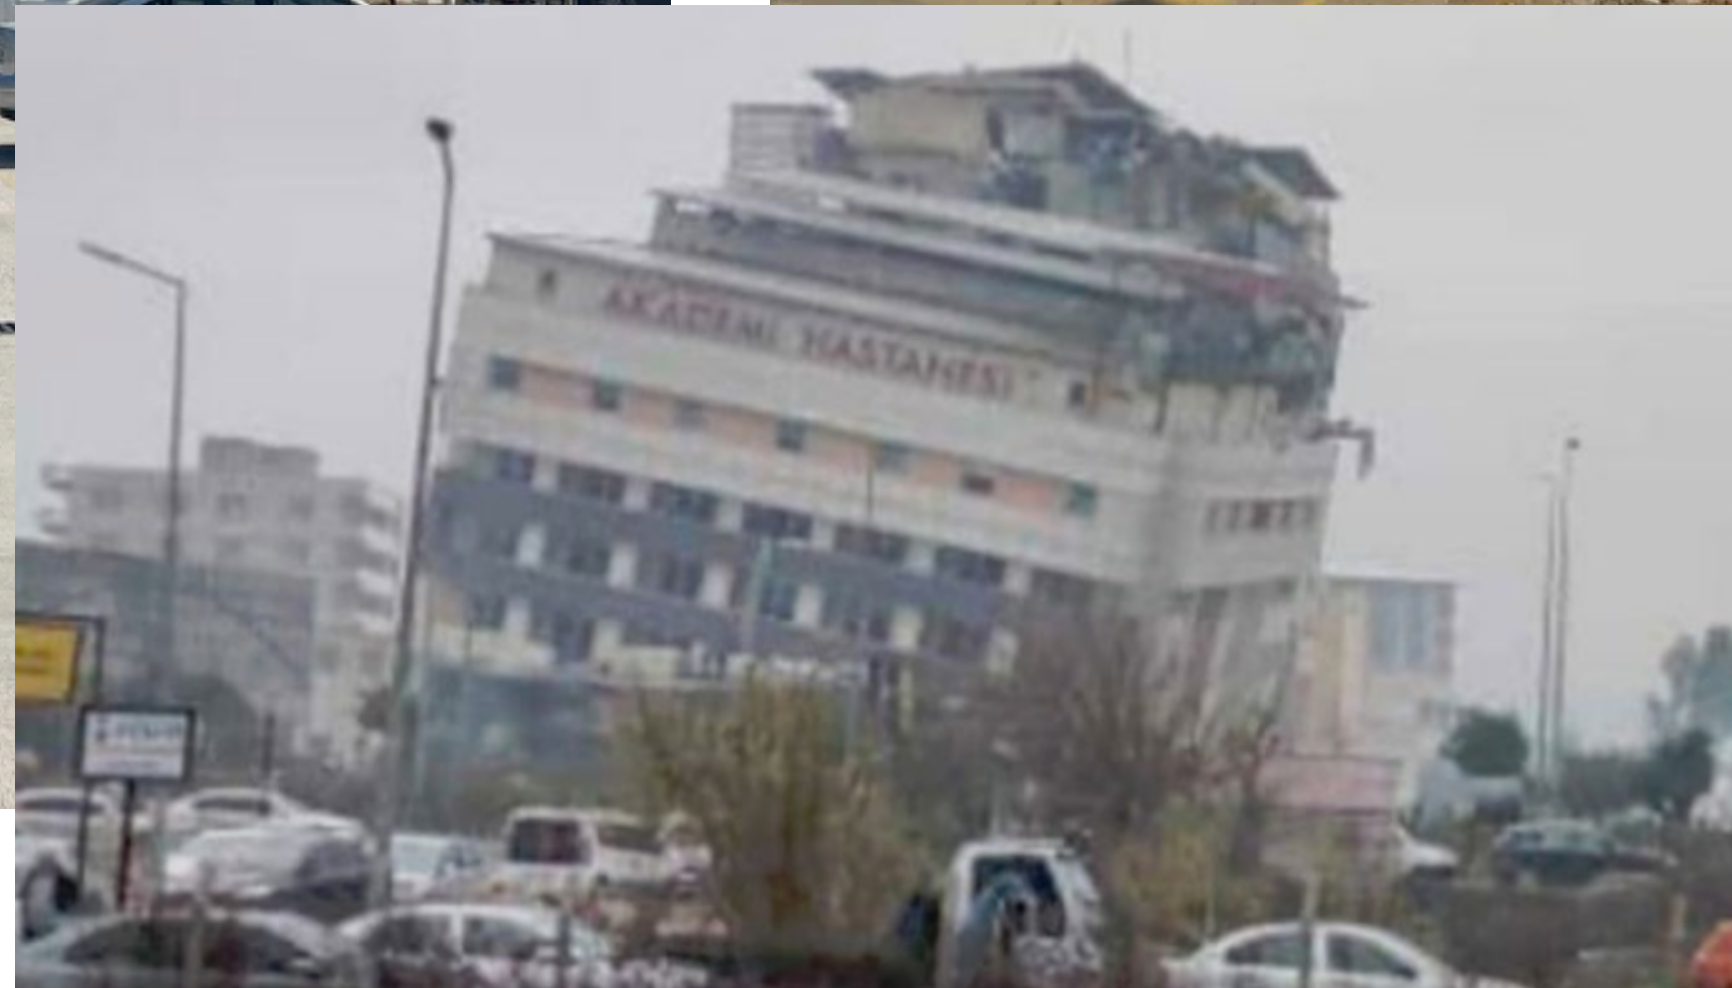
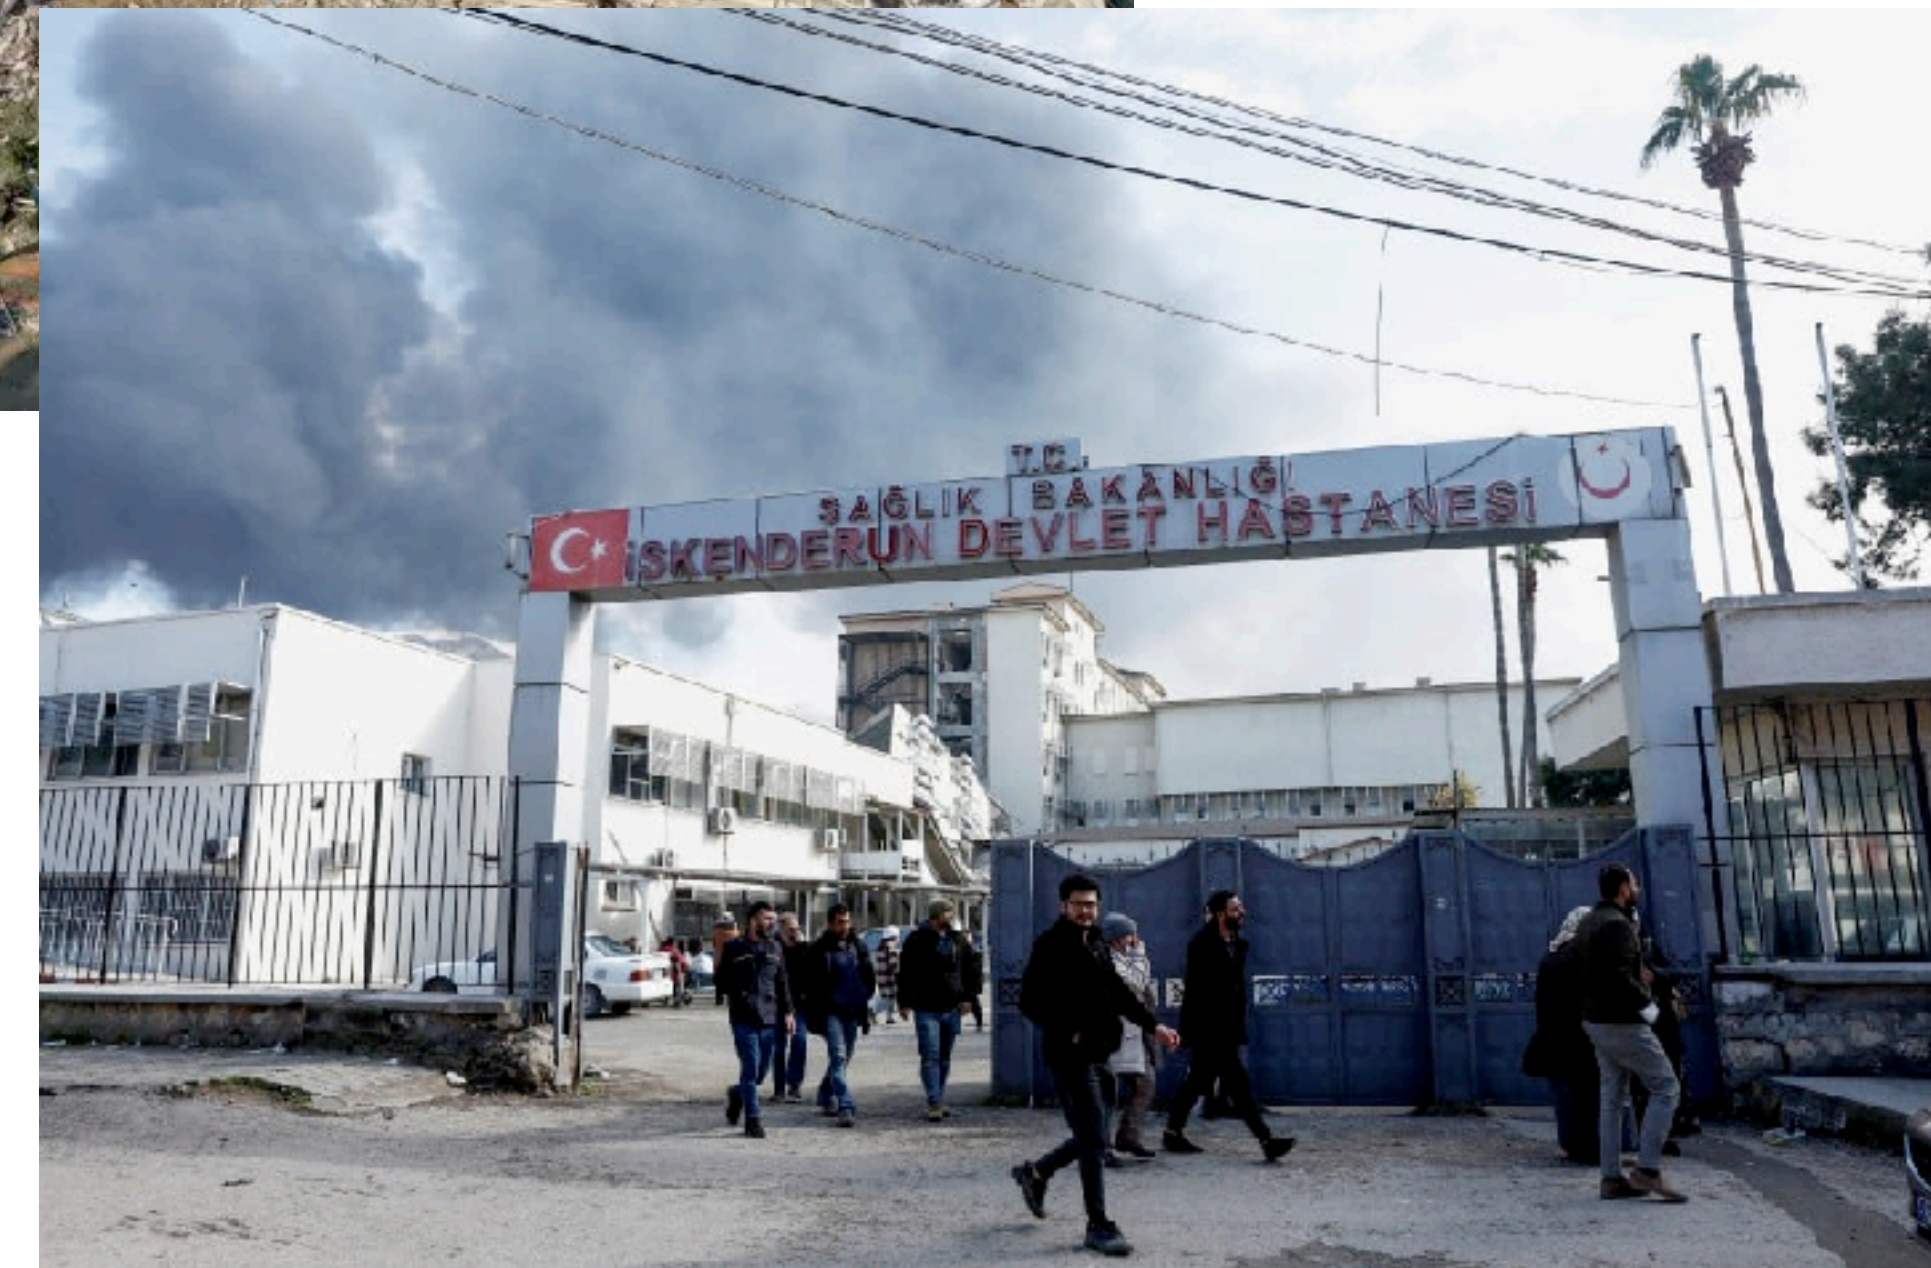
# Performance of Hospital Buildings
