# Highlights of Worst Devastation in Turkey

- Two back-to-back M7.8 and M7.6 earthquakes occurred in Eastern Turkey within 9 hours
- Affected 15 highly populated provinces
- Over 47,000 people lost their lives
- More than 5,000 buildings collapsed

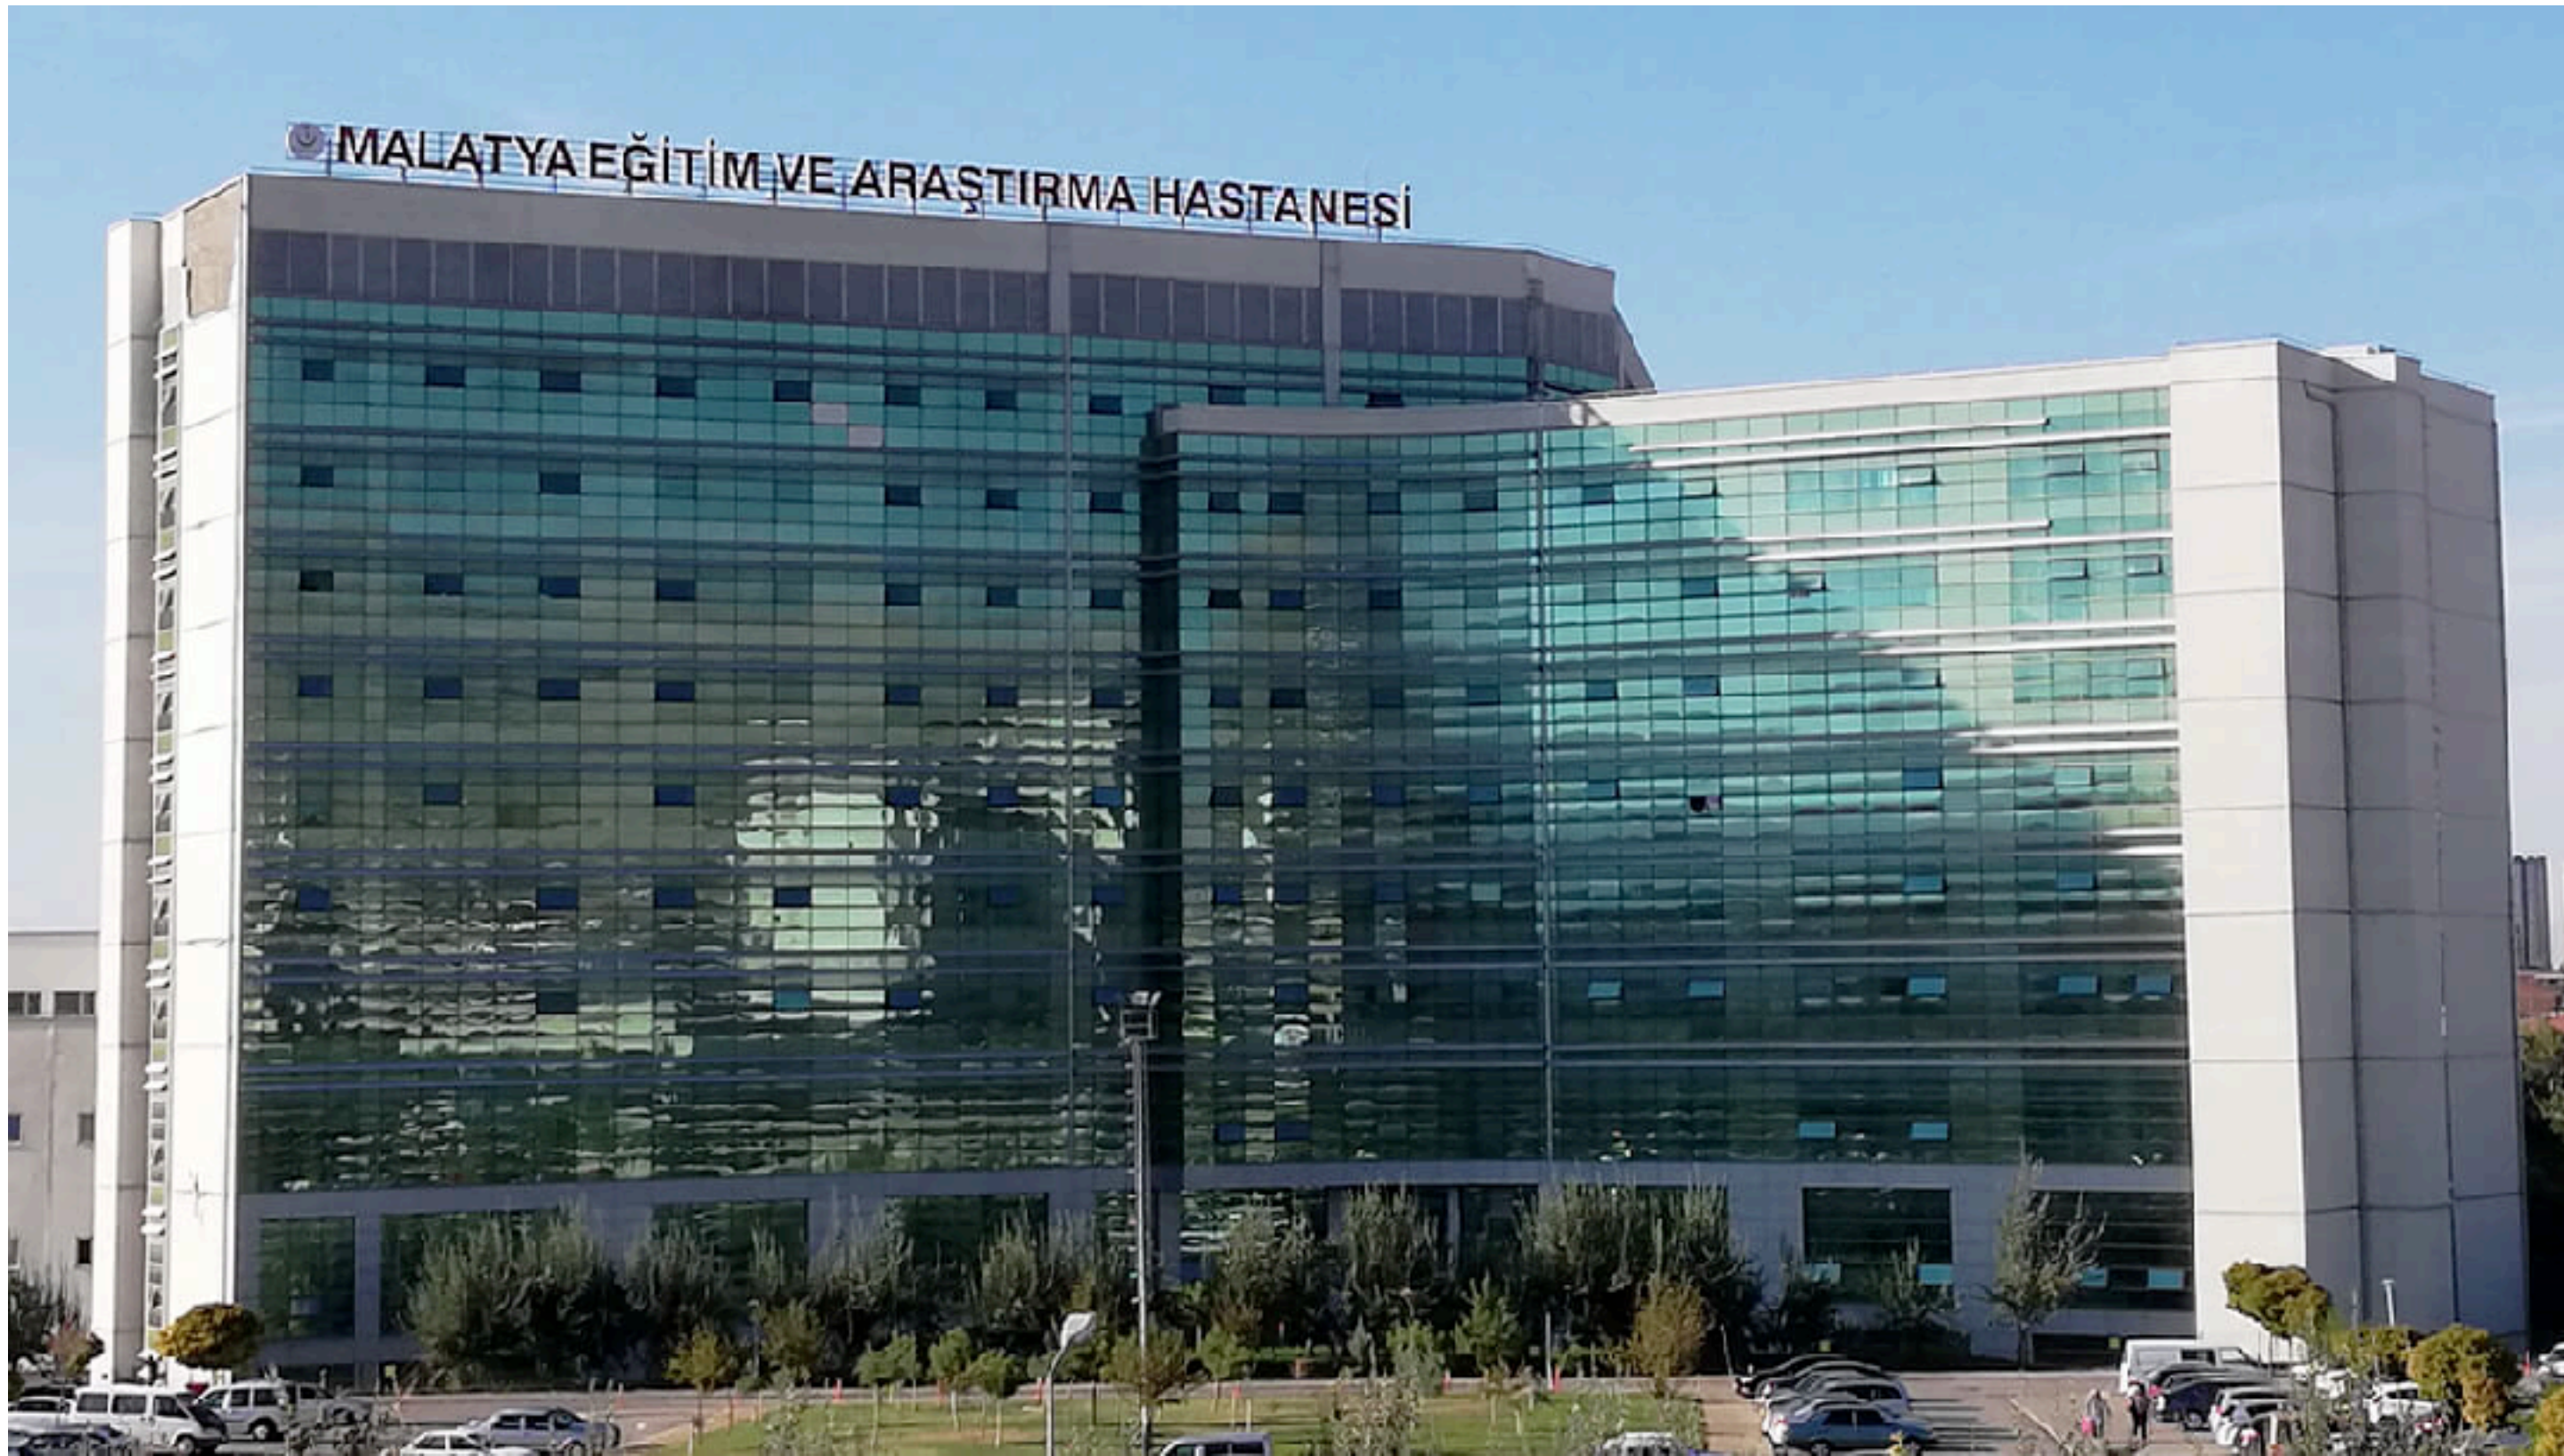
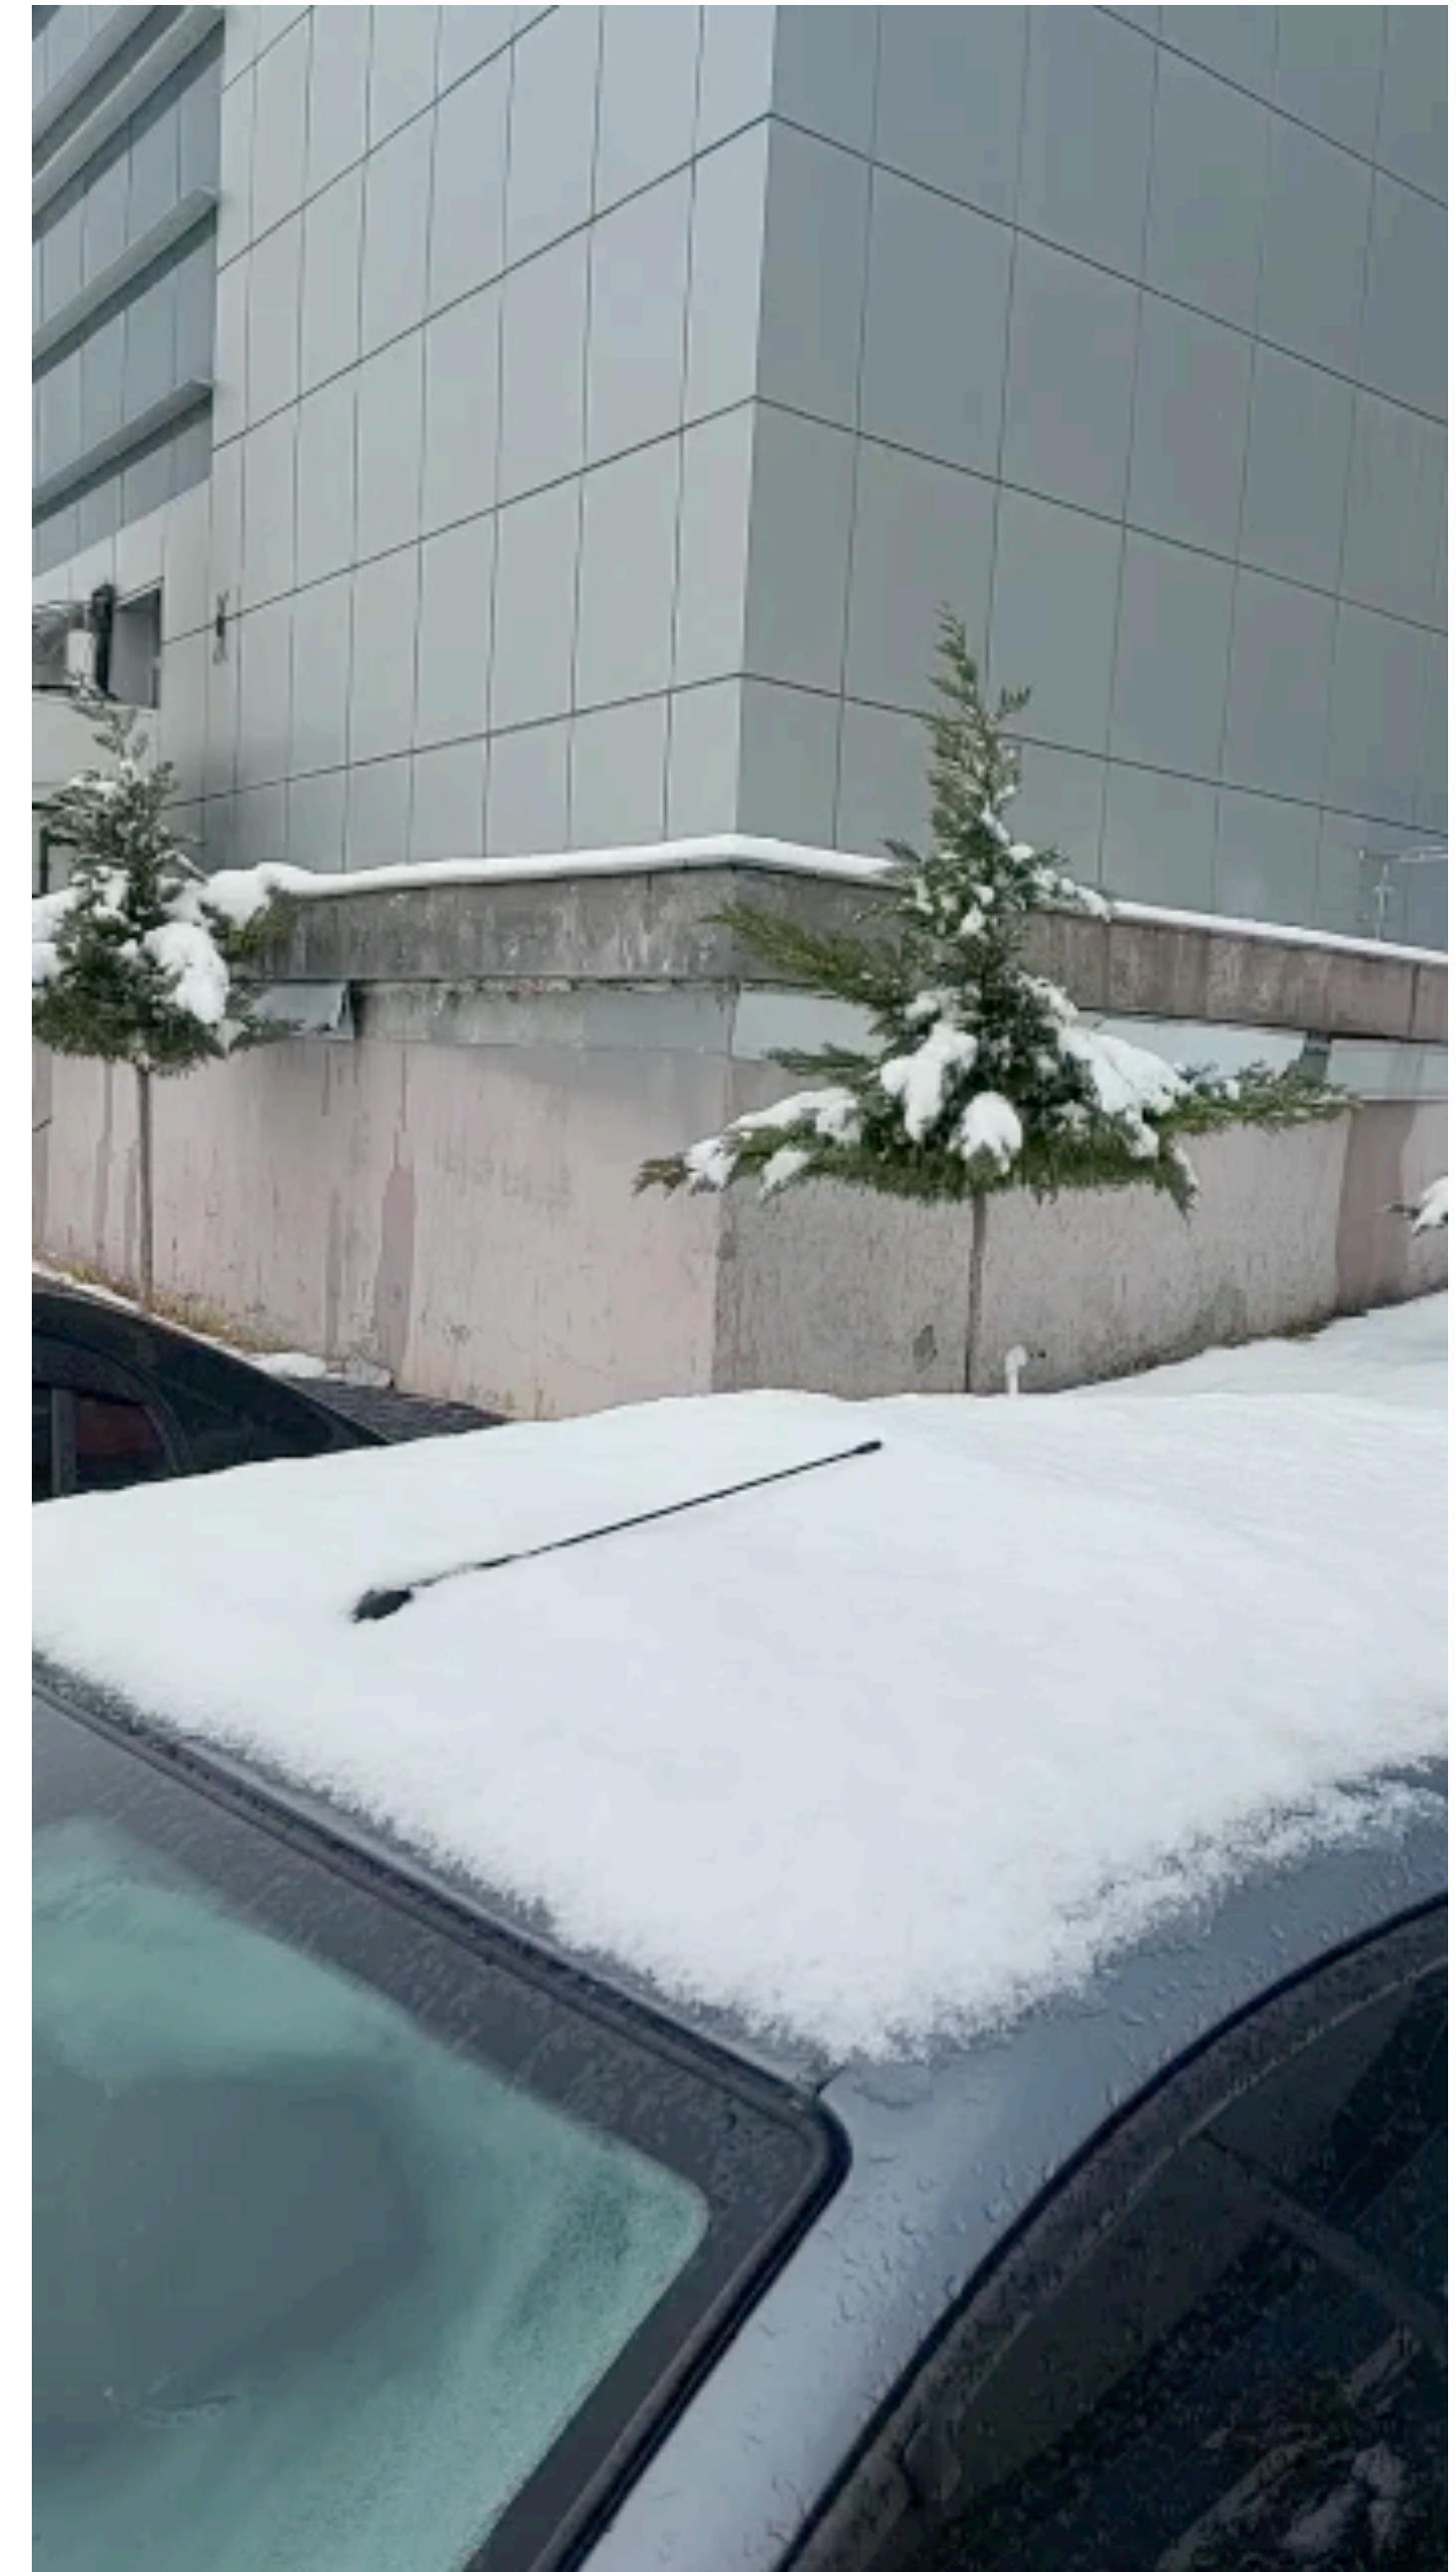
- No structural damage
- Base-isolators have residual displacement of 1.2 cm
- Total displacement +/- 9 cm

# Performance of Based-Isolated Hospitals

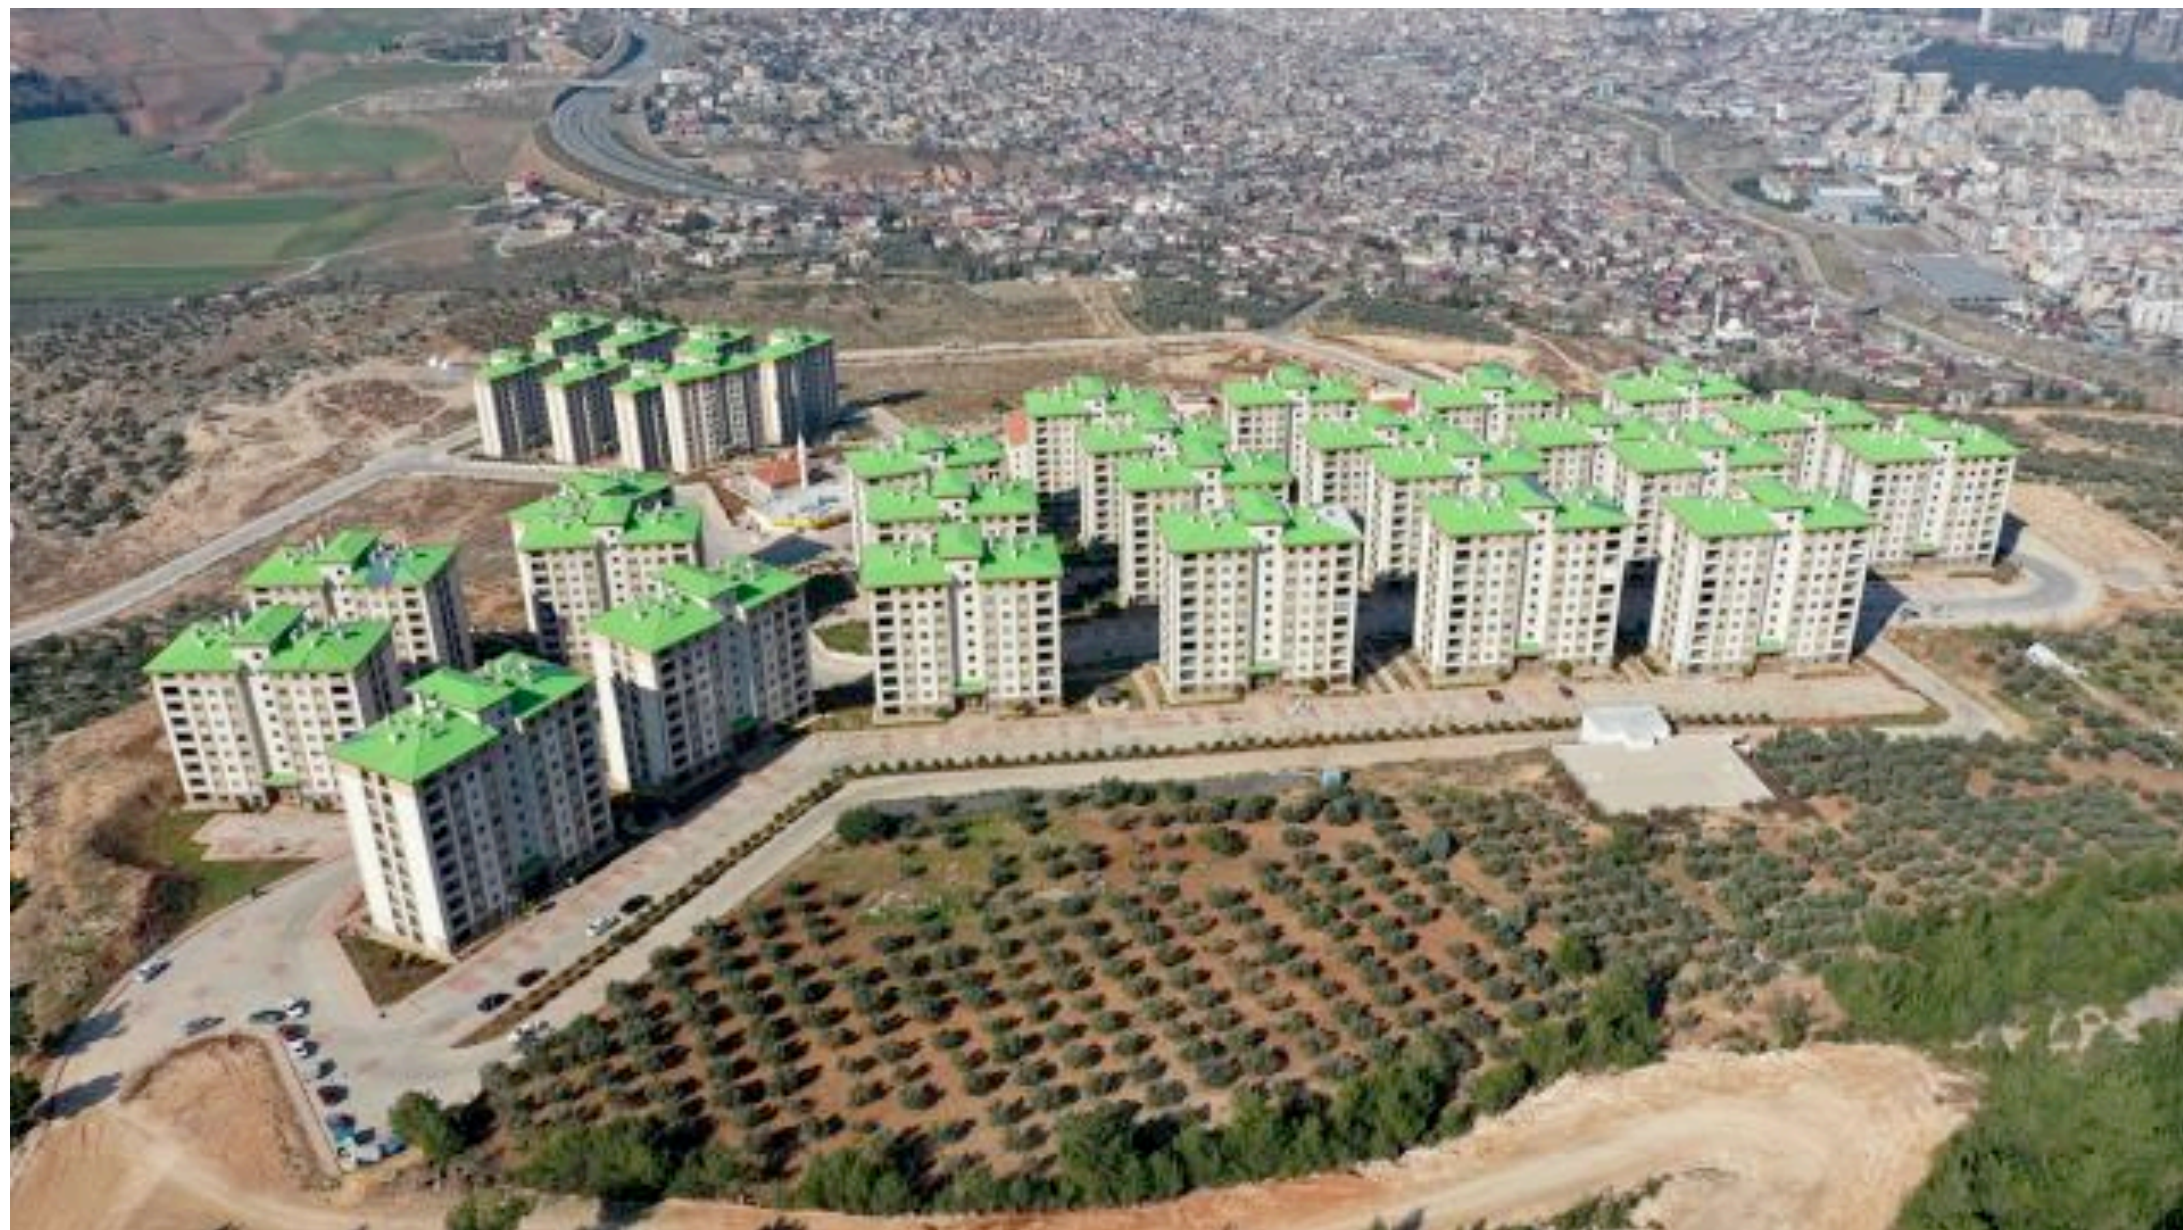
- 130,000 condo unit exposed to earthquakes
- No collapse
- Minor repairable structural damage
