# Structural and Geotechnical Impacts of Surface Rupture on Highway Structures

A. Pamuk<sup>1</sup>, E. Kalkan<sup>2</sup>, H.I. Ling<sup>3</sup>

**Abstract**—The most dramatic and significant damages on highway bridges during the recent earthquakes in Turkey (Mw 7.4 Kocaeli and Mw 7.2 Duzce earthquakes) and Taiwan (Mw 7.6 Chi-Chi earthquake) were the result of the fault rupture traversing the bridge span that devastated many of such transportation structures. The veiling of this phenomenon during the design of highway bridges and its unfortunate consequences accentuated the need to examine the surface rupture hazard, identify possible risk of failures and present remedial actions from both structural and geotechnical engineering stand points. Towards that purpose, damage conditions of highway bridges during these events were overviewed in general, and a totally collapsed highway overpass located in Arifiye during the Kocaeli earthquake was investigated in details. The major problem under consideration is twofold: first, dislodging of bridge span, and consequently, total separation of the reinforced concrete (RC) girders from their decks, that phenomenon necessitates the revision

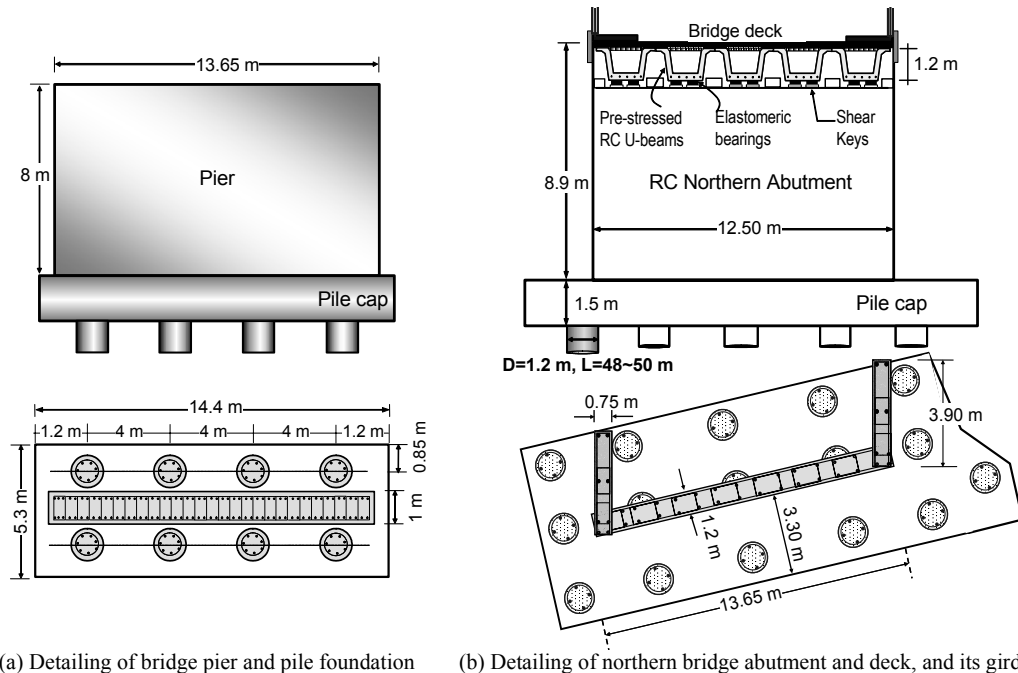
Fig. 3: Structural details of the bridge overpass in Arifiye, units are in meter.

Following to construction of the overpass bridge, the 10m high bridge approach fill with a double faced MSEW system was constructed adjacent to the Northern bridge abutment (Fig. 2). The deck of the bridge constituted five precast and prestressed concrete U-beams supported by five elastomeric bearings (300mm x 300mm in length and 100mm in height). Details of the deck girders and piers are exhibited in Fig. 3.

(a) Detailing of bridge pier and pile foundation (b) Detailing of northern bridge abutment and deck, and its girders

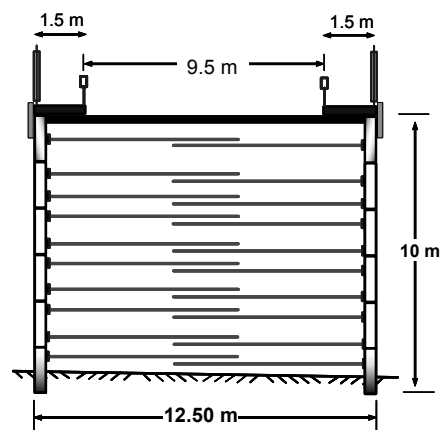
Fig 11: Schematics of the cross section of the reinforced wall system in Arifiye.

The majority of damage at Arifiye Overpass from geotechnical stand points concentrated on its 100 m-long MSEW system. This wall system was built as a “double-faced” or “back-to-back” type wall having parallel reinforced concrete facings with ripped metallic reinforcing inclusions to accommodate a two-way divided roadway as shown in Fig. 11. A reinforced concrete culvert was designed beneath the approach ramp possibly to facilitate storm or flood water discharge in approach ramp area (Fig. 12b). Two slip joints (S1 and S2, Fig. 12) were also designed on each wall face on top of the rigid culvert to protect the walls damaged from differential

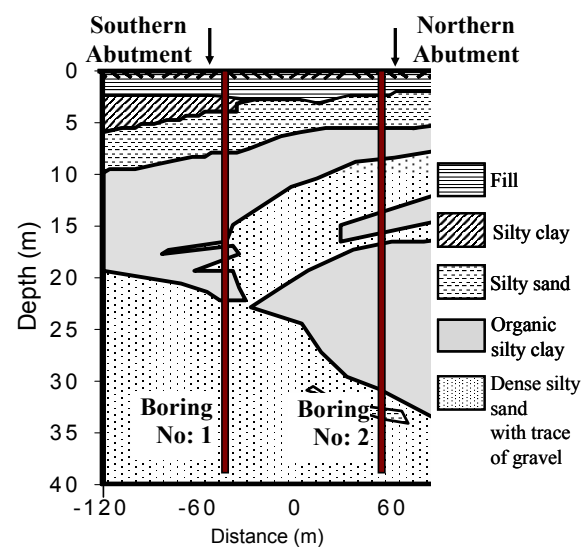
Fig. 13: Visualization of subsoil geology along the axis of Arifiye Overpass (modified based on [15]).

The entire Adapazari region (Fig. 1) is located in a large valley covered by alluvium deposits from a nearby lake and surrounding rivers. Soil deposition extends about 45km long east to west, and 30km long north to south with a varying thickness of more than 200m-deep [14]. The geology of the bridge site in Arifiye is dominated by Pliocene to Pleistocene sedimentary which lie at least 50 m below the younger sedimentary deposits [15]. Standard penetration tests were conducted by the Turkish General Directorate of Highways to gain sufficient subsurface information between both ends of the bridge overpass soon after the earthquake. The locations of the subsurface borings are depicted in Fig. 13. This figure also indicates the 2D visualization for the local subsoil conditions along the axis of the bridge overpass. The ground water table was approximately 5m below the ground surface. Boring No.1 indicates that very soft layers of soil deposits lie under the southern abutment and extend to a depth of 22m where a dense ( $N_{30}=100$ ) layer of sedimentary deposit of silty sand with some gravel was encountered. The loose layers became thicker to the depth of 34m below the northern abutment where Boring No.2 was drilled. Boring No.2 was the nearest boring to the MSE walls and consisted of a 2.5m thick fill followed by varying thicknesses of silty sand and silty clay deposits. Loose silty sand and silty clay layers ( $N_{30} < 20$ ) below the reinforced walls might have been prone to liquefaction or seismic-induced densification during the seismic event.
