NEAR SOURCE EFFECTS AND ENGINEERING IMPLICATIONS OF RECENT EARTHQUAKES IN TURKEY

ABSTRACT

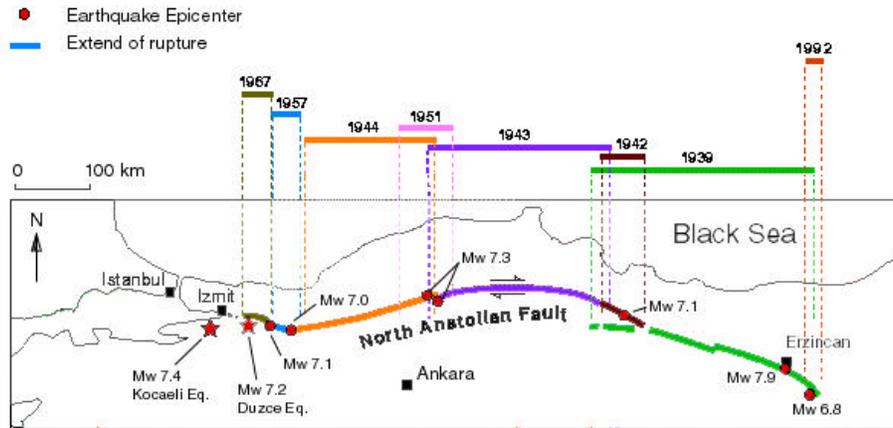
Fig.1. Successive earthquake sequence on the North Anatolian Fault since 1939 (modified from the USGS website, 1999)

Kocaeli and Düzce events were the latest among successive westerly propagating earthquake sequence on the NAF which began with the magnitude 7.9 Erzincan earthquake in the eastern part of Turkey in 1939, and has generated ten destructive earthquakes having magnitudes greater than seven since this date. This earthquake sequence is illustrated in Fig. 1 with the dates of the events and extend of rupture they created. As inferred from this figure, occurrence of large magnitude earthquakes close to cities in Turkey is inevitable due to high seismic-rate of the NAF, and its crossing to the most densely populated environments. In fact, this earthquake sequence similar to the toppling of domino pieces has now arrived at the gates of the most densely populated and the industrialized heart of Turkey, namely the Istanbul metropolitan area. Likelihood of experiencing strong earthquakes on such a high profile area in the near future accentuates the need to understand the near-field strong motion characteristics of the NAF and its unexpected damages occurred during the Kocaeli and Düzce earthquakes. For that purpose, a critical examination of near-field records from these events has been accomplished herein by emphasizing the wave propagation effects of near-source ground motions. The primary findings are presented in this paper aiming at extending the concepts and results based on the supplemental information from post-earthquake field observations.

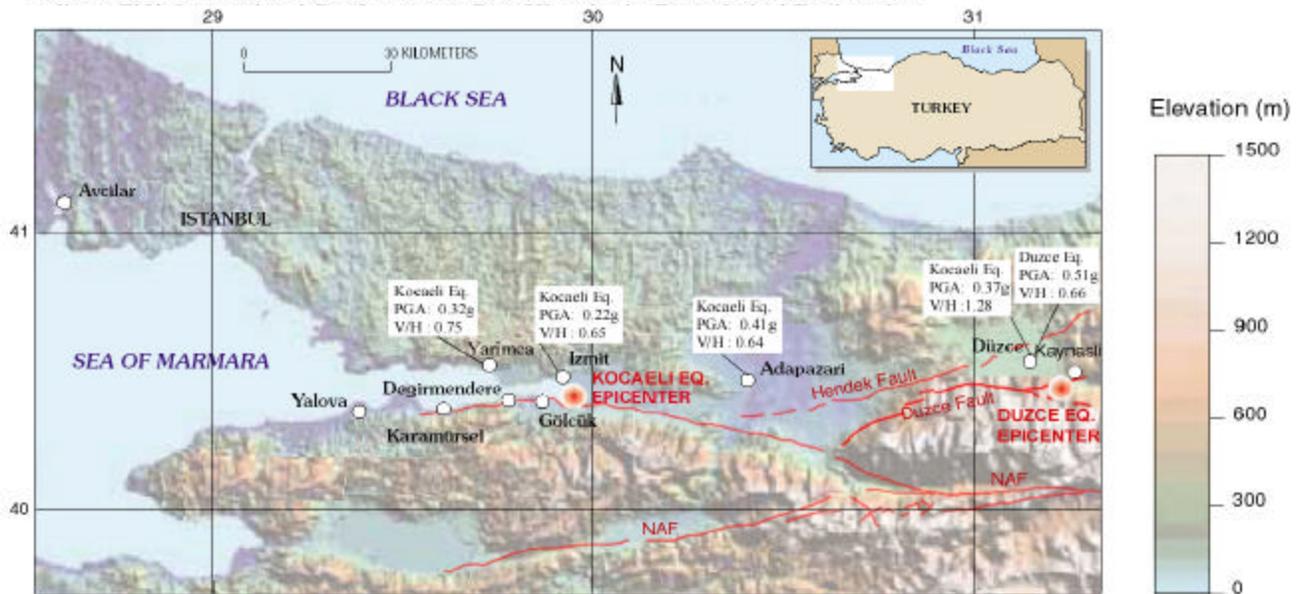
Fig.2. Locations of near-field strong ground motion stations during 1999 Kocaeli and Düzce earthquakes

To clarify the phenomenological impacts of the above mentioned near-field effects, we revisited the near-field strong motion records measured during the recent earthquakes in Turkey. The evident near-source effects were observed from both the recordings and also from field observations of two events. These observations exemplified in the forthcomings suggest the strong influence of rupture directivity and strong velocity and displacement pulses (fling) in increasing the damage in the epicentral area. Locations of the near-field recording stations are shown in Fig. 2. The two stations closest to the fault rupture

Generally, the peak value of the vertical component of motion may exceed those of the horizontal components in the vicinity of the active faulting systems (Ambraseys et al., 1996; Kalkan and Gülkan, 2003). Surprisingly only Düzce record during Kocaeli earthquake follow this general trend, and for the remaining five near-field records, vertical component of motion is remarkably less than that of horizontal. The values of V/H ratio are also marked on Fig. 2 for each recording station.

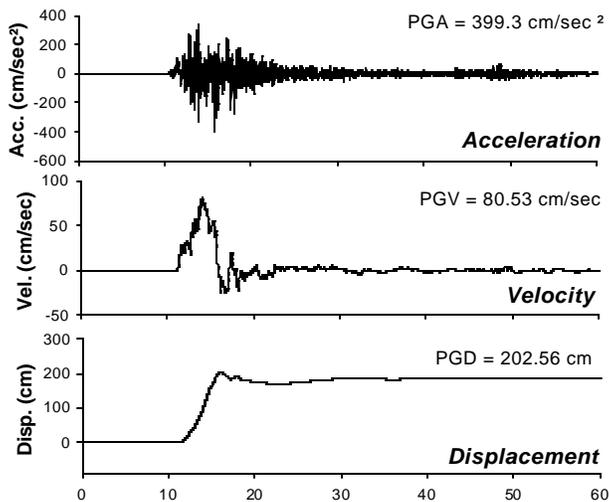
Fig.3. EW direction Sakarya station recordings during the Kocaeli earthquake

during the Kocaeli event are Sakarya (SKR, 3.2 km) and Yarimca (YPT, 3.3 km). Sakarya station is located on rock and the Yarimca station is founded on soft-soil. Of these the largest peak ground acceleration was about 0.4 g recorded at Sakarya station. On the other hand, the maximum peak ground accelerations recorded during the Düzce earthquake were much more than the first event and in the order of 0.8 g at Bolu station (BOL, 20.4 km) and 0.5 g at Düzce station (DZC, 8.2 km). Both of the recording stations are located on soft-soil sites (Gülkan and Kalkan, 2002). The peak ground accelerations recorded by the Sakarya and Yarimca stations are shown in Figs. 3 and 4, respectively. The peak accelerations from near-field records are not as high as expected. That serves as a reminder that these recent earthquakes in Turkey are in agreement with other significant major earthquakes, the 1985 Michoacan earthquake ($M=8.1$), the 1999 Chi-Chi earthquake ($M=7.6$), and the 2002 Denali earthquake ($M=7.9$) for generating considerably lower accelerations than expected. On the other hand, the peak velocities and corresponding peak displacements are more significant for the Kocaeli and Düzce events, and this has been confirmed by highly concentrated structural damage in the disaster belt area. The recorded peak accelerations and general characteristics of near-field recording stations during these events are listed in Table 1. Among the other near-field recordings Sakarya (SKR) and Yarimca (YPT) records exhibited remarkable strong velocity pulses and static offset along the EW direction in the order of 1.8 m and 1.0 m, respectively. As inferred from Figs. 3 and 4 the dominant pulse period is around 2-3 sec.

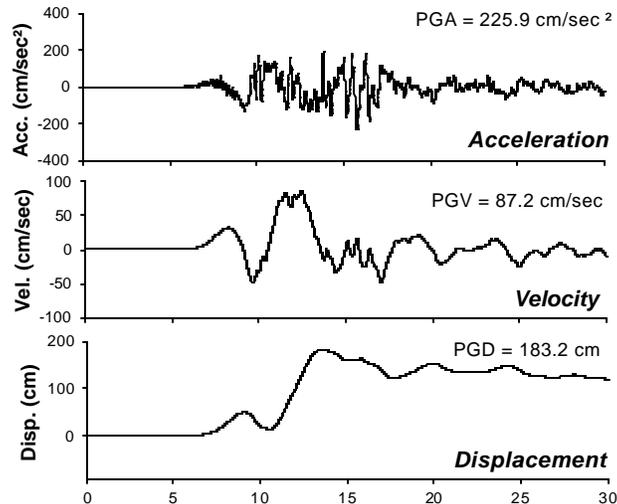
Fig.4. NS direction Yarimca station recordings during the Kocaeli earthquake

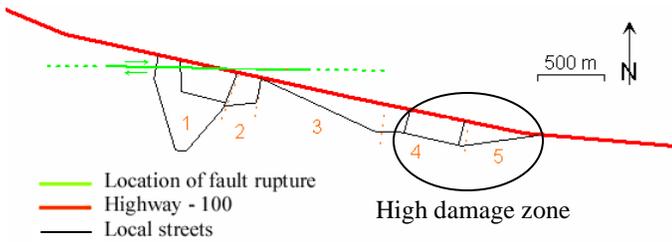
Düzce), which is located in the immediate vicinity of the seismic source of the second event. This unfortunate town suffered high damage during the strong shaking of Düzce event. The damage distribution in Kaynasli is exhibited in Fig. 5. The bounded and marked areas in this figure demonstrate the concentration of damage based on the site-survey conducted by USC-GEES. Zones of high damage were marked as 4 and 5. This figure does not include all the details of the region but comprises a representative snapshot of the observed damage scatter.

Fig.5. Map of Kaynasli and location of high damage zone (modified from the USC-GEES web-site)

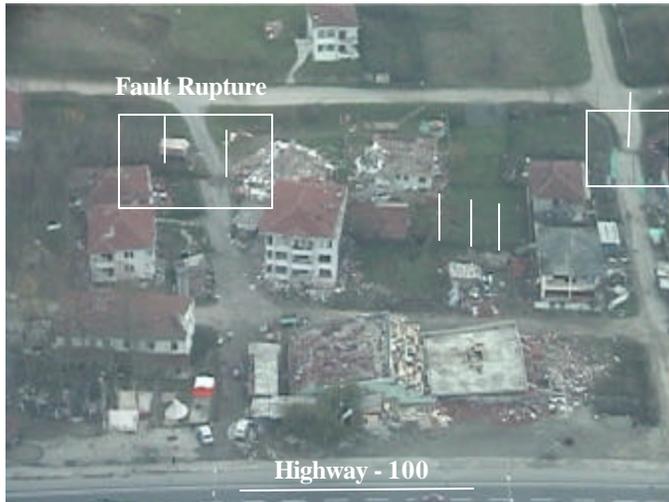
High concentration of damage in Kaynasli region was mainly caused by detrimental effects of the surface fault rupture crossing the town. The surface fault rupture in Kaynasli ran parallel to the Highway-100 and went up the hill, and it is also clearly visible in Fig. 6. Also shown in this figure is the collapsing of many residential buildings due to surface fault traversing their foundations. That caused unrecoverable static displacements and consequently sudden failure of many buildings in Kaynasli. Damaging effects of faulting offset are also shown in Fig. 7 where the water pipe was highly deformed due to striking of the fault. In fact, none of the buildings in this area or even the one designed strictly to the Turkish Seismic Code (1998) could not recover such a destructive faulting offset passing through their foundations. Besides that, the strong near-fault effects exacerbated the damage in the central part of the city as exhibited in Fig. 8. The damaged area in this figure falls in the zone of four according to damage classification given in Fig. 5.

Fig.6. Collapsed and damaged residential buildings along Highway-100 due to fault surface rupture (modified from the USC-GEES web-site)

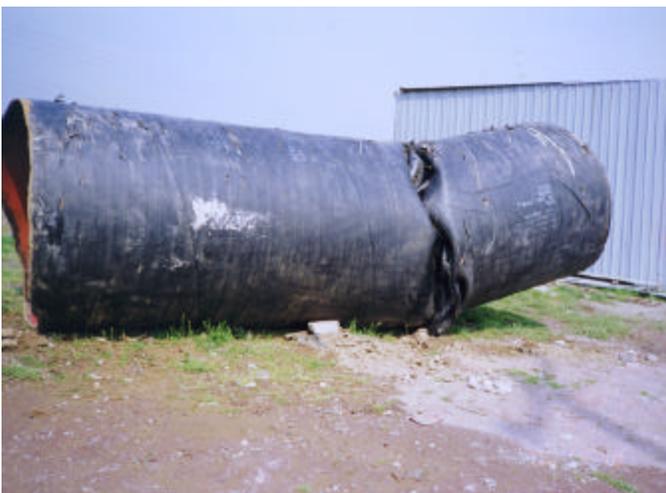
Fig.7. Highly deformed water pipe due to fault striking

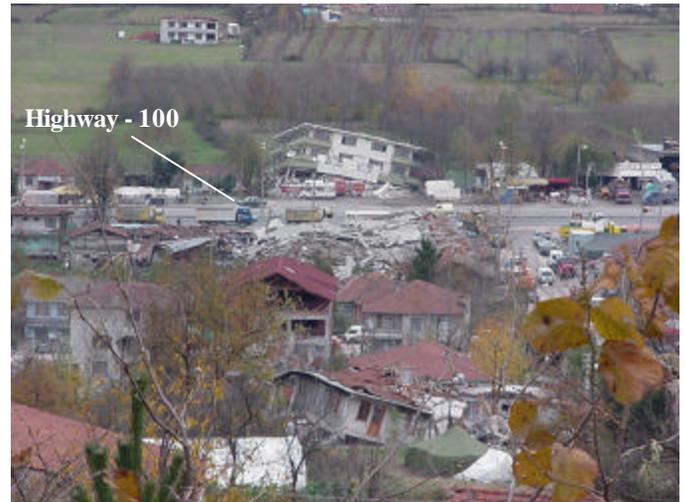
Fig.8. Heavily damaged central section of Kaynasli, (source: USC-GEES)

Unfortunately, the observed evidence of strong pulse effects in disaster belt area (Figs. 8-9) has been veiled due to the lack of densely distributed strong motion transducers in Turkey. Thus, the rare opportunity was missed in understanding the clear mechanism of the directivity and consequently strong pulses (filing) that caused the bump effect from the computed accelerograms in the epicentral area. Nevertheless the synoptic picture that can be drawn from the visual observations suggests

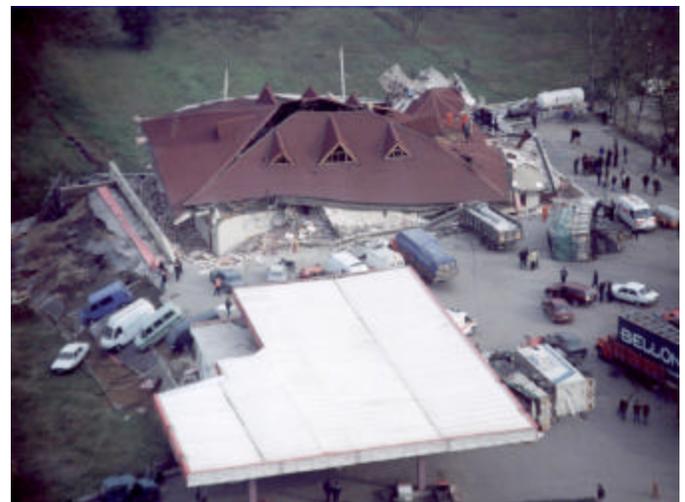
of the shear dislocation of the fault causes the pulse to be mostly oriented normal to the fault-strike, causing the fault normal component of the motion more severe than the fault parallel component (Sommerville, 1998). Indeed, significant damage of bump effect generated due to fault normal component of motion in Kaynasli can also be witnessed in Figs. 8 and 9. In these figures, overturning of fully loaded trucks parked in the parallel direction to fault strike, and fling of several passenger cars parked in the normal direction of the fault serve as a clear evidence of the bump effect.

Fig.9. Strong near-field motion at filling station, Kaynasli, Düzce

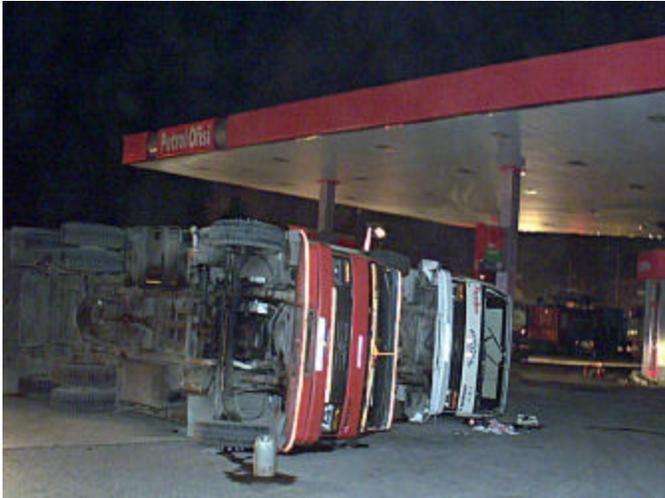
that near-field records with large peak acceleration and long-duration pulses may generate large and rapid displacement excursions. These effects are particularly detrimental to the performance of long-period structures. In fact, the near-field strong-motion records of Kocaeli and Düzce events display such long-period pulses that show the ground motion have frequency bands within the range of vibration period of the 4-5 story buildings that collapsed and/or severely damaged.

Fig.10. Powerful velocity fling in near field, Kaynasli, Düzce

It is also noteworthy that the resulting strong ground shaking during both events in the near-field regions due to large generated rapid displacement pulses are not represented in current regulatory Turkish Seismic Code (1998). As mentioned earlier, such effects tend to increase the long-period portion of the acceleration response spectrum. The 1997 Uniform Building Code (UBC) considers these effects by providing near-source factors N_a and N_v to modify code level spectra for distances less than 15 km from major faults. These factors amplify the average design spectra by about 30 to 60 percent for earthquakes with magnitude (M_w) 7.5 in the near-source region (0 to 15 km from fault rupture) in the normal direction. That suggests the introducing of such representative amplification factors of near-field effects into the future revision of the Turkish Seismic Code (1998).

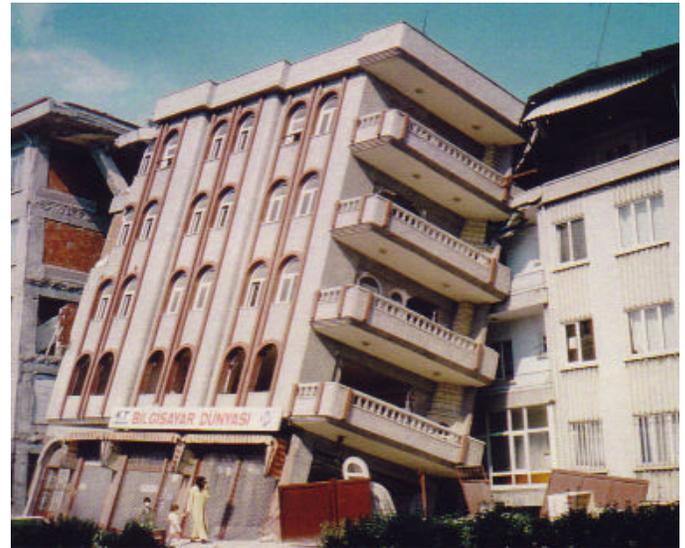
The amplification of motion due to softer layered media and basin effects caused substantial geotechnical hazards in the form of liquefaction, lateral spreading, bearing capacity loss, landslide and subsidence along both coastal regions as well as inland. Particularly liquefaction ground motion weakened soils beneath reinforced mat foundations. That caused many buildings settled, tipped or toppled (Fig.11). More than 60 percent of multistory buildings in the severe liquefaction areas suffered partial or total collapse due to liquefaction induced foundation failure.

Fig.11. Liquefaction induced foundation failure in Adapazari during the Kocaeli earthquake

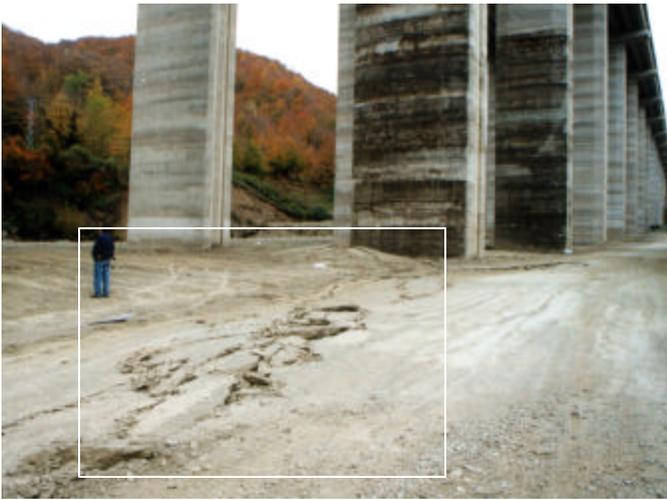
Several highway bridges and freeway viaducts also suffered damage during recent earthquakes due to faulting rupture passing beneath or close to their foundations. As such, the Bolu viaduct located at Kaynasli was crossed by fault rupture during the Düzce event (Fig.12), and that caused significant geotechnical and structural complications. This viaduct is the longest (2.5 km in length) in Turkey, and composed of a pair of independent sixty parallel decks (each has 40 m long and 17.5 m width). The fault traversing caused 1.5 m relative displacement of adjacent piers due to high right-lateral permanent deformations in their foundations. Although the bridge deck was equipped by seismic dampers mounted between pier caps and end of the diaphragms of the deck, they were completely damaged during the main shock of the Düzce event. This high damage on the viaduct caused significant and costly repairs.

Fig.12. Piers of Trans-European-Motorway (TEM) traversed by surface fault rupture, Kaynasli, Düzce

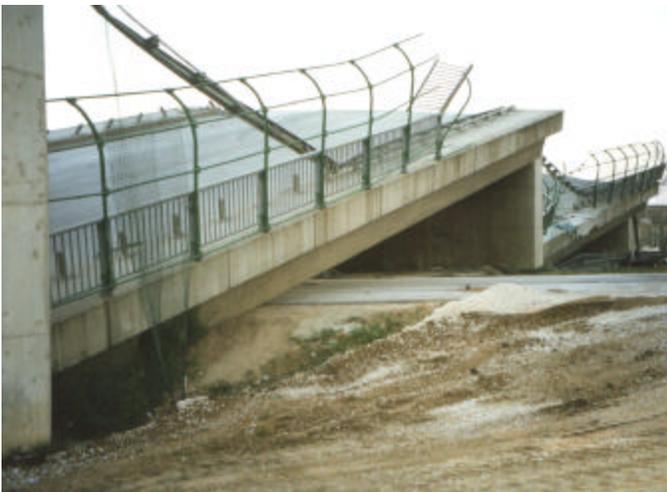
Another example of significant damage induced by fault traversing was observed at Arifiye overpass. The fault-offset and insufficient seating length on the piers caused total collapsed of this four-span bridge onto the Trans European Motorway (TEM) (Fig.13). The approach fill of this bridge reinforced with a double-faced mechanically stabilized earth wall (MSEW) system was lightly damaged. The wall system provided a unique case history under extreme loading conditions as such they show significant

Fig.13. Unseating of bridge decks from piers of the Arifiye Bridge traversed by surface fault
